ATSB TRANSPORT SAFETY BULLETIN
Aviation Level 5 Investigations
AB-2010-103
Final

Level 5 Factual Investigations: 1 October 2010 to 31 December 2010

Issue 4

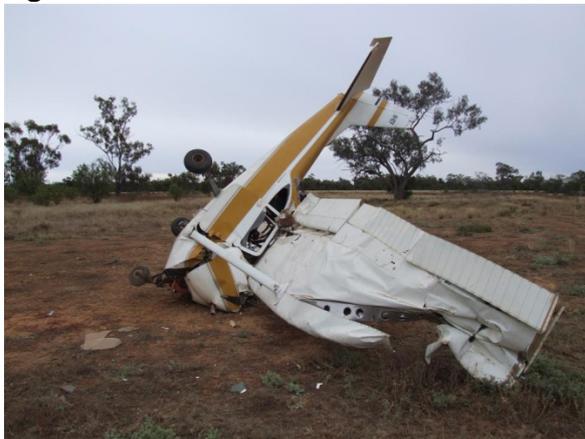
Figure 1: Cessna 172 VH-RZV

A police officer who attended the scene observed that a large tree in the vicinity of the accident site had several freshly broken branches about 10 m above the ground. Severed branches and part of the aircraft's right wing tip were found between the tree and the aircraft.

The damage to RZV was consistent with the right wing colliding with a tree branch followed by the aircraft impacting the ground inverted, with a steep nose-down attitude (Figure 1).

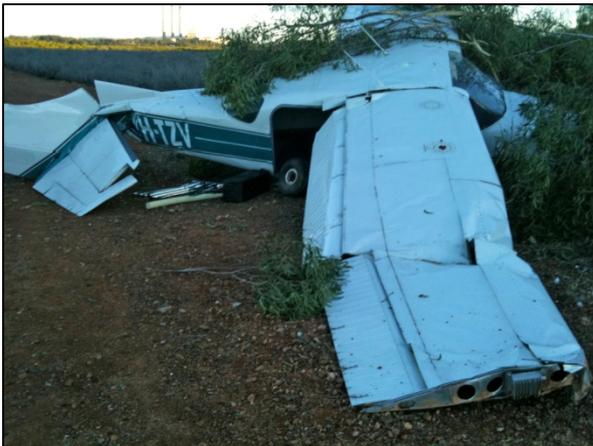
Figure 1: Aircraft accident site

The aircraft landed heavily on the gravel road and sustained serious damage (Figure 1). Two of the occupants sustained serious injuries, while another two sustained minor injuries.

The fuselage of the aircraft sustained significant damage as a result of the landing. The right wing had partly detached from the main fuselage structure and the right wing fuel tank was compromised.

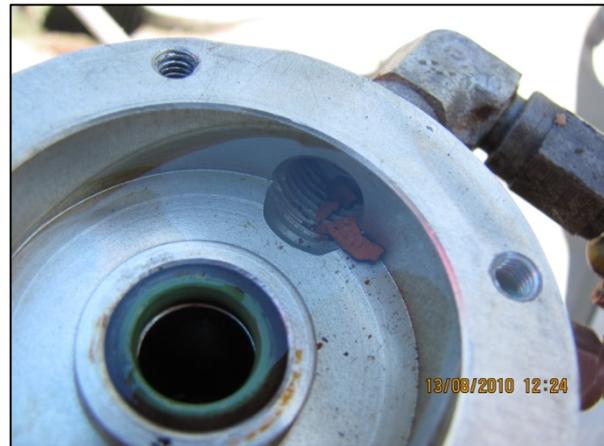
Figure 2: Fuel manifold valve with debris

An inspection of the fuel system found a small amount of orange coloured debris in the fuel manifold valve, before the fuel filter screen (Figure 2).

The Australian Transport Safety Bureau (ATSB) obtained a sample of the debris for identification and found that the debris appeared to be an agglomeration of fine particulate matter. The composition of the debris was primarily iron and oxygen with traces of cadmium, manganese and zinc. The investigation could not determine the exact origin of the debris.

It was unlikely that the small quantity of debris found in the fuel system lead to the total power loss of the engine.

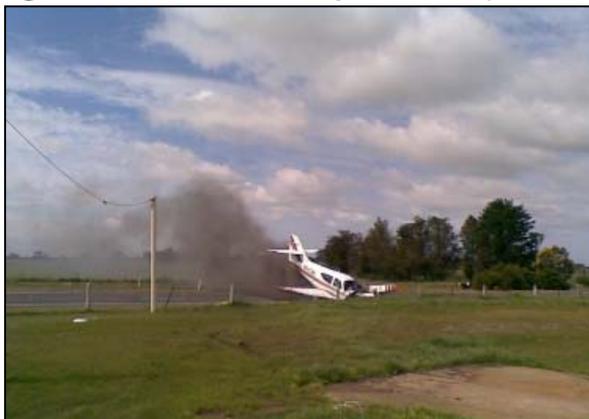
Figure 1: VH-CSH immediately after the impact

With assistance, the pilot and passenger exited the aircraft through the windscreen. The pilot sustained serious injuries, including a fractured ankle, while the passenger sustained minor injuries. After the occupants egressed, the aircraft caught alight, resulting in serious damage².

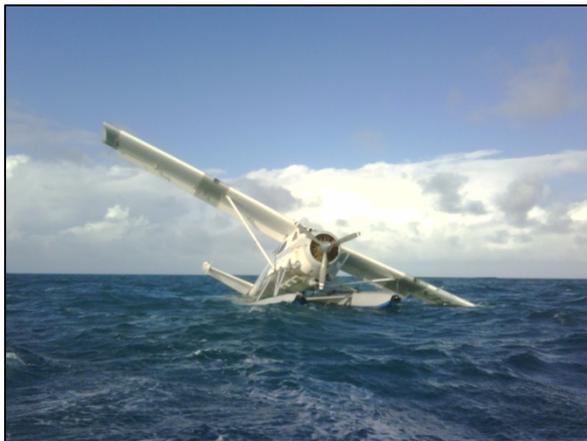
Figure 1: VH-PCF

The aircraft sustained serious damage to the left float, left and right wing tip and left elevator.

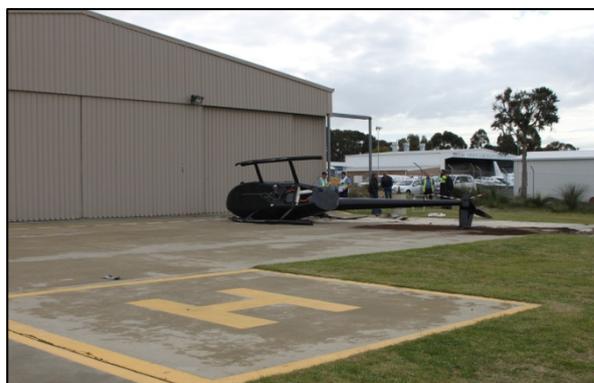
Figure 1: VH-ZVF at the accident site

A Jandakot tower controller reported that at 0714 they observed the helicopter rise above the hangar, tilt towards it and then descend out of their view. About a second later, they heard a loud bang. The helicopter sustained serious damage in the impact (Figure 1). The pilot sustained minor injuries while the passenger was uninjured.

The helicopter came to rest on its right side and fuel leaked from the fuel vent lines, about 70 litres was recovered by emergency services. As a result of the main rotor blades impacting the apron, fragments of blade were deposited over a large area. The furthest of these fragments was found 352 m from the accident site within an area of parked aircraft. Main rotor blade fragments also penetrated the hangar doors adjacent to the accident site.

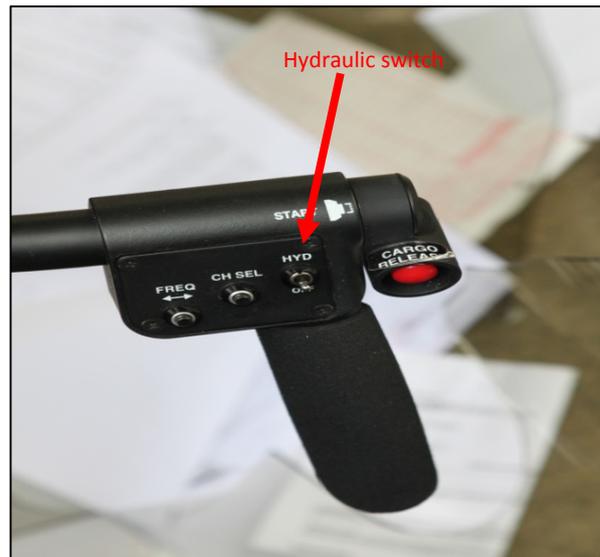
Figure 2: VH-ZVF Cyclic mounted hydraulic switch

The pilot had been taught a supplementary method of checking the hydraulic system that, in addition to the preceding check, involved the momentary deactivation of the hydraulic circuit breaker. Once the circuit breaker was re-set, the cyclic hydraulic switch must be returned to ON. It was after this supplementary procedure that the pilot believes he may have inadvertently forgot to switch the hydraulics switch back to ON.
