# **Aviation Occurrence Report**

**TransAsia Airways Flight GE222**

**ATR72-212A, B-22810**

**Report Number: ASC-AOR-16-01-002**

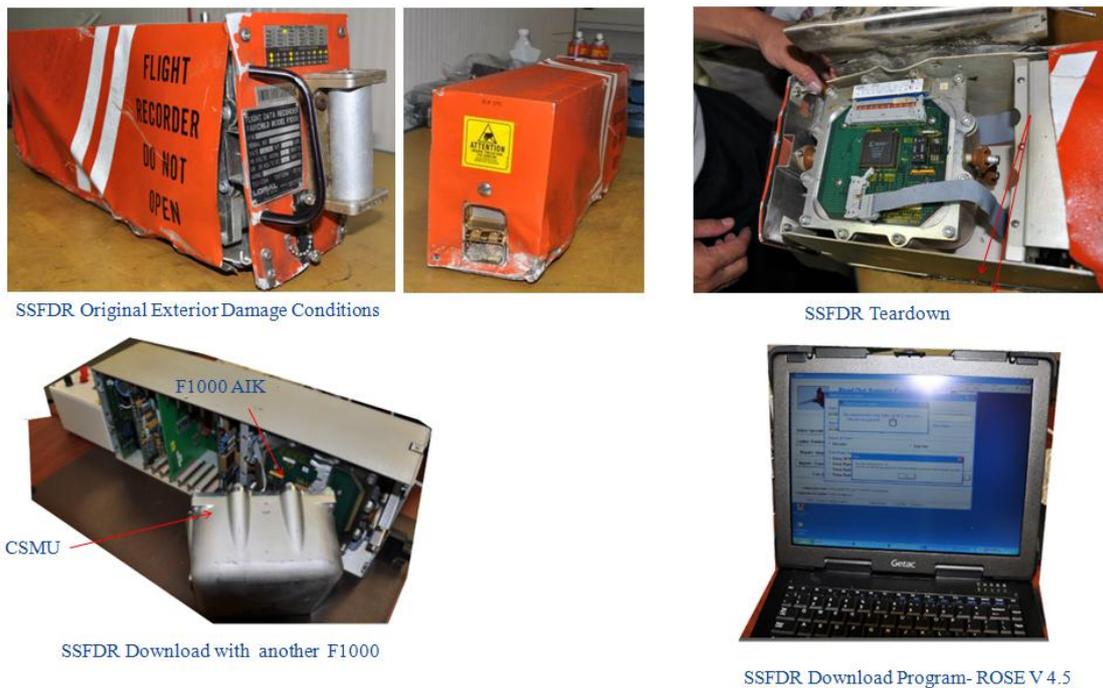
Figure 1.11-2 FDR exterior view, teardown and download process

support units were broken. The CSMU was not damaged and all applicable data was recovered. Figures 1.11-2 shows the FDR exterior view, teardown and download process.

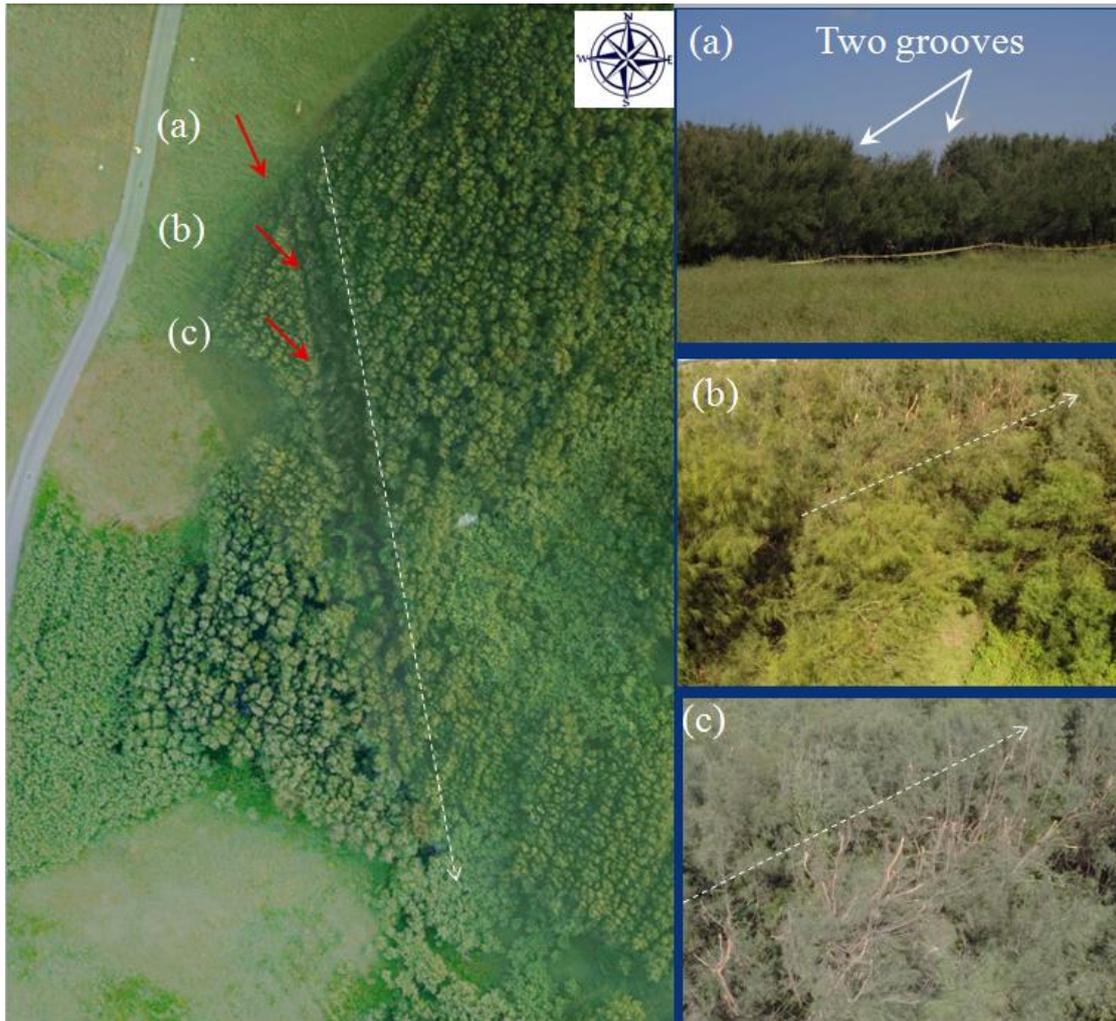
Figure 1.12-4 Initial impact point and damaged foliage in Zone 1

The damaged tree tops indicated where the aircraft first impacted the foliage. The area contained many bent trees and broken branches.

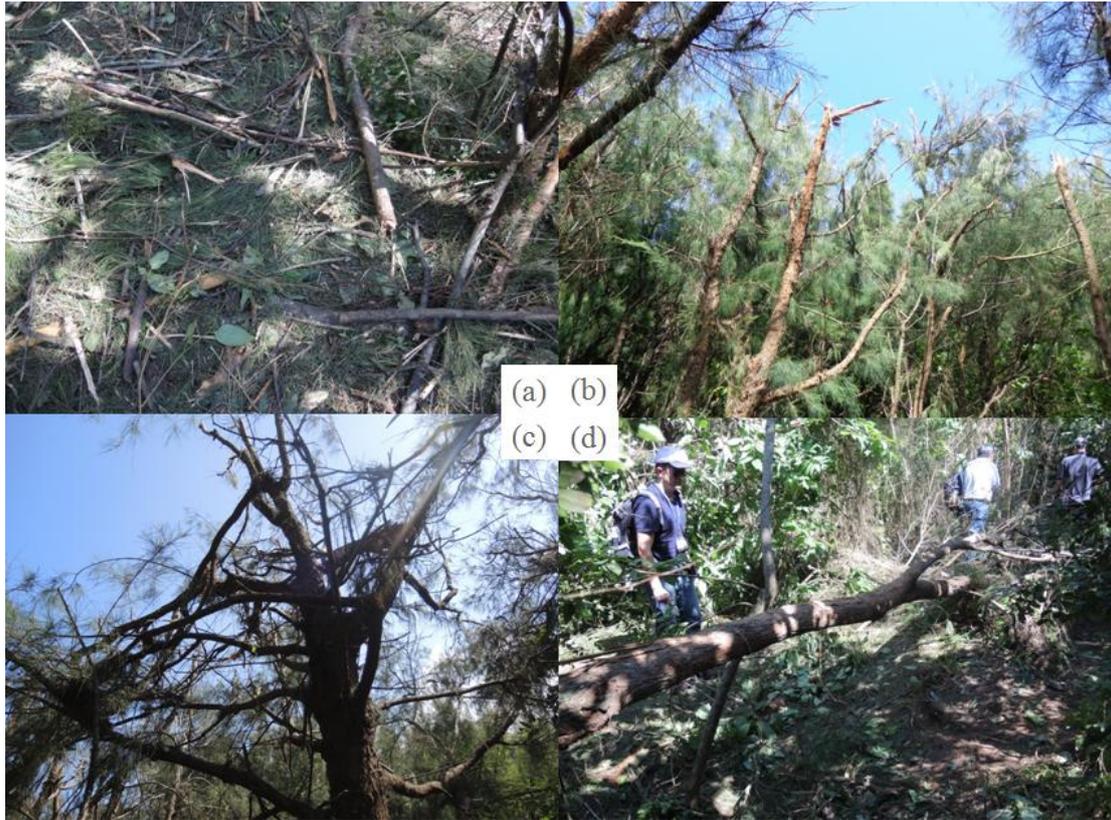
Figure 1.12-5 Damaged foliage and relevant trees

Damaged foliage and relevant tree height (H) information is depicted in Figure 1.12-5 [ (a) Damaged trees on the ground, (b) Damaged tree in canopy (H=6.3 meters), (c) Damaged tree in canopy (H=5.5 meters), (d) Felled trees) ]. The largest damaged tree had a diameter of about 25 cm.

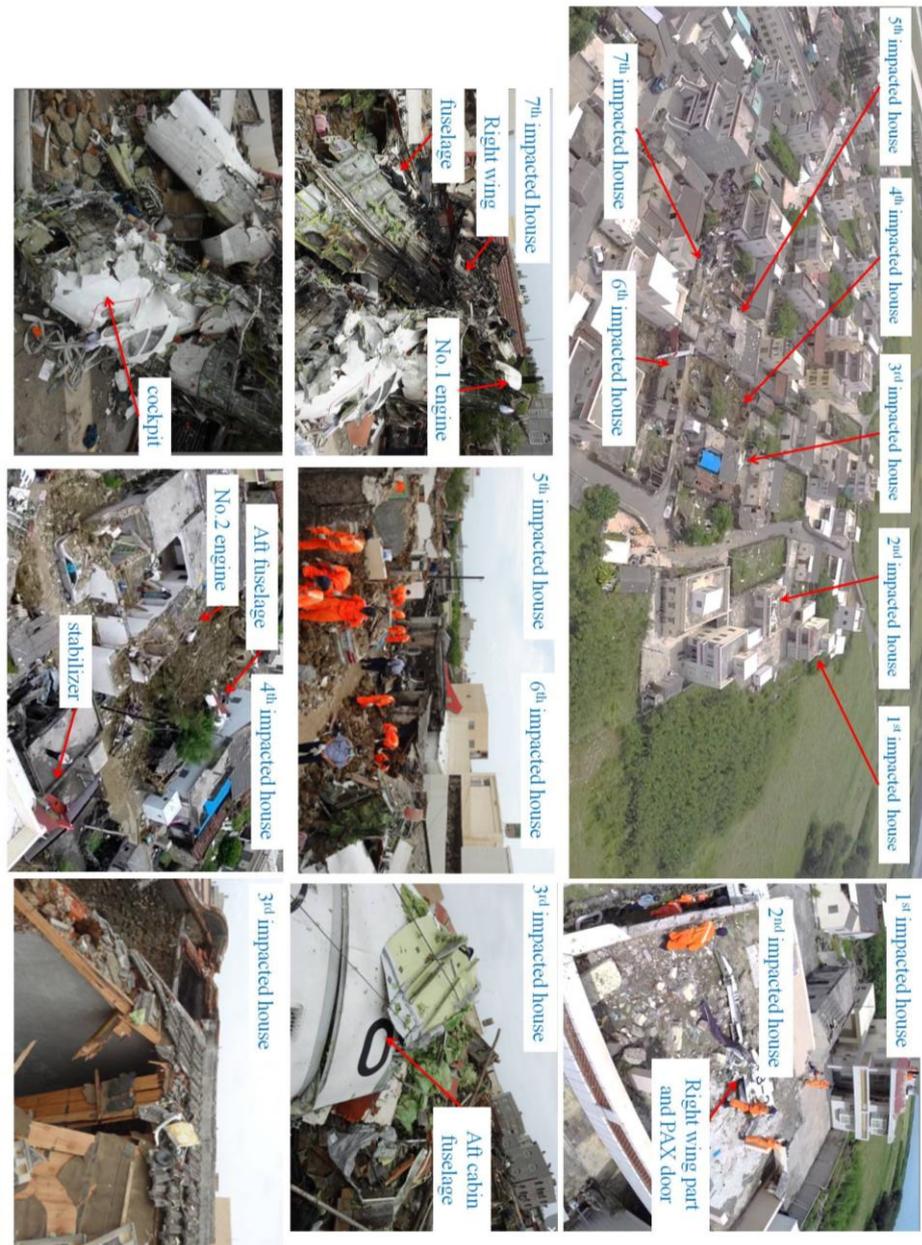
Figure 1.12-8 Aircraft main wreckage distribution and damaged buildings

Zone 2 was located in a residential area of Xixi village. The trajectory of the aircraft was from north to south. The aircraft collided with multiple buildings and broke apart into several major sections. The main wreckage site, which included the cockpit, forward fuselage, left wing, and no.1 engine came to rest in a street in the south of Zone 2. The distance between the main wreckage site and the first building collision was about 120 meters. Figure 1.12-7 depicts the aircraft wreckage distribution overlaid on a Xixi village street map. The red area indicates extensive damage to housing; the yellow area indicates houses with minor damage; and the light blue area indicates undamaged houses. In addition, smaller items of debris such as passenger seats, window frames, baggage, and fuselage skin were scattered throughout Zone 2 over an area of approximately 80 meters by 120 meters. The aircraft main wreckage distribution and damaged buildings are shown in Figure 1.12-8.

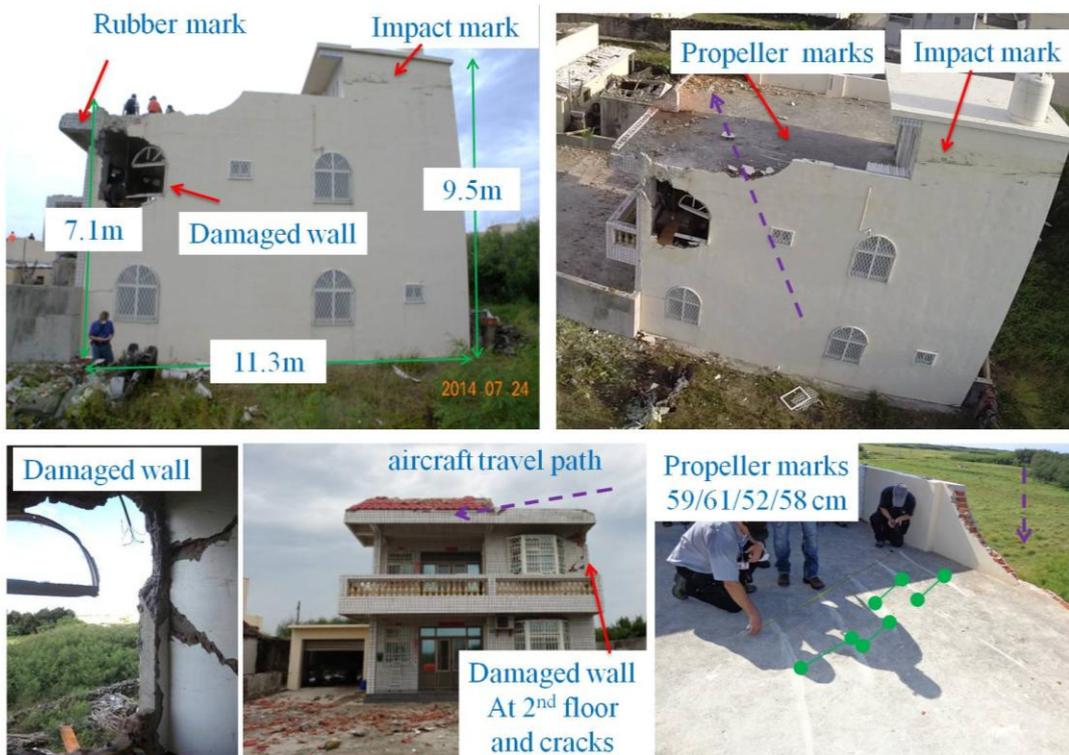
Figure 1.12-9 Initial aircraft impact, propeller, and rubber marks on building

distributed, witness marks were visible on the top of the roof. Those marks were consistent with contact from the right side propellers. There was also a long prominent mark almost as wide as the wall, at the top of the northern side of the building. It continued on to the western wall. The mark was close to horizontal (approximately 10 to 15 degrees). That damage was consistent with right-wing impact. Figure 1.12-9 depicts the relevant aircraft impact marks, propeller marks, rubber marks and cracks at no. 7-1 building.

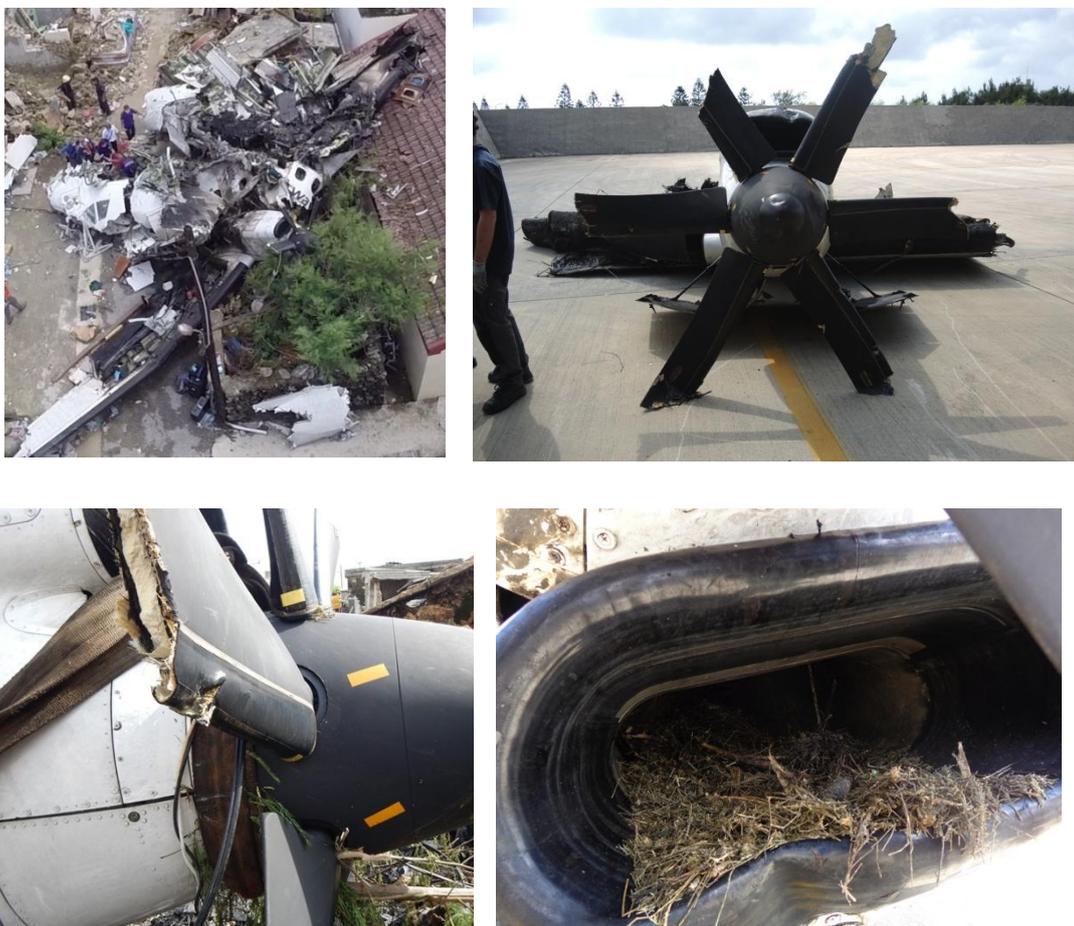
Figure 1.12-10 No.1 Engine

Both engines were recovered from the occurrence site. The no.1 engine was still attached to the left wing. The propeller pitch angle was estimated to be  $-10^{\circ}$ . The no.1 engine air inlet was found full of tree debris. An impact dent was located at the lower part of the intake (see Figure 1.12-10).

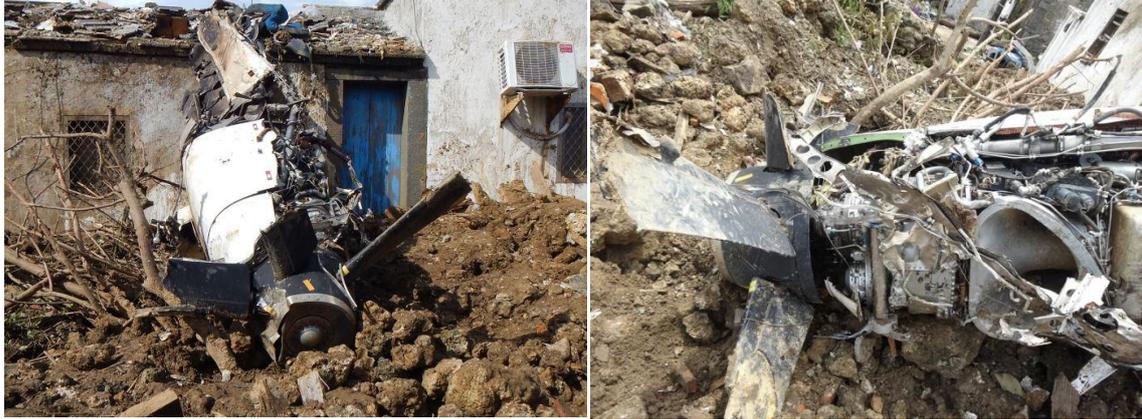
Figure 1.12-11 No.2 Engine

The no.2 engine had separated from the wing but was located in wreckage Zone 2 (see Figure 1.12-11). The propeller pitch angle was estimated to be  $10^{\circ}$ . No tree debris was found in the air inlet. The remaining propeller blades from the no.2 engine sustained more impact damage than the propellers from the no. 1 engine.
