Republic of Lebanon
Ministry of Public Works & Transport

Investigation Progress Report

Ethiopian 409 Accident – Boeing 737-800

25th January 2010

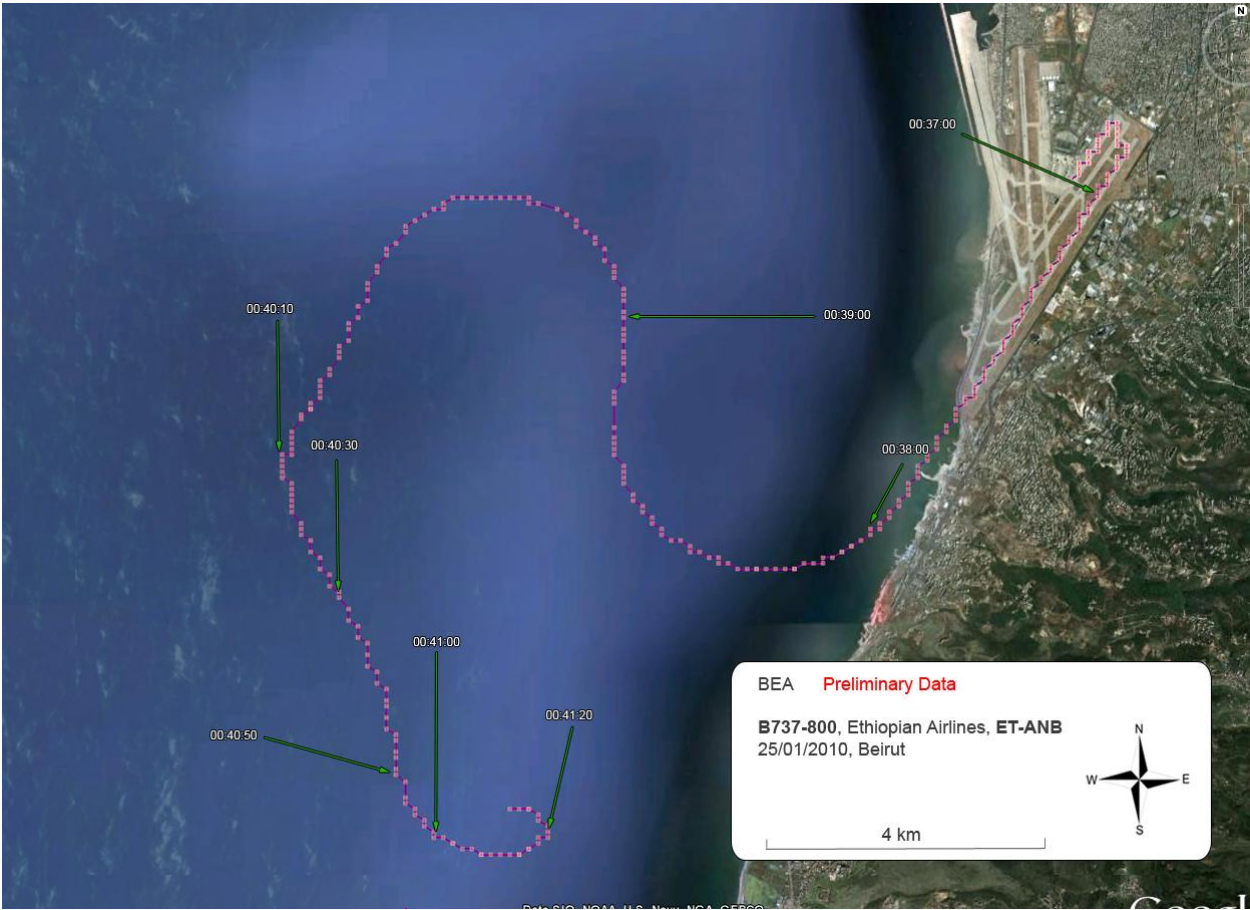
Figure 1: ET 409 horizontal tracks

The DFDR and CVR were retrieved from the sea bed and read, as per the Lebanese Government decision, at the BEA facility at Le Bourget, France. The recorders data revealed that ET 409 encountered two stick shakers respectively at time 00:40:01 for a period of 29” and at 00:40:56 for a period of 26”. 10 “Bank Angle” warnings were registered between 00:38:41 and 00:40:54; an over-speed clacker was also registered from time 00:41:25 till the end. The maximum registered AOA was 32° at 00:40:14, maximum registered bank angle was 118° Left at 00:41:14, the maximum registered speed was 407.5 knots at 00:41:28, the maximum registered G load was 4.412 at 00:41:28 and the maximum registered nose down pitch value was 63.1° at 00:41:16.

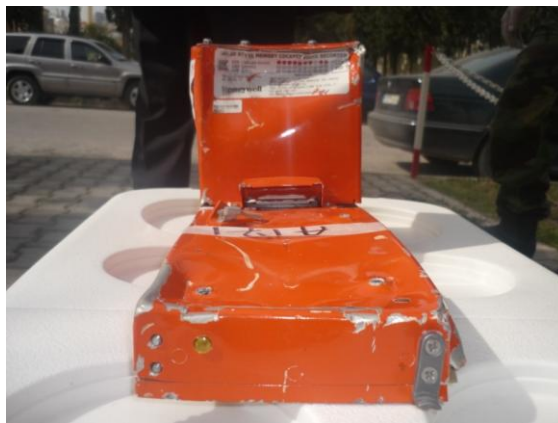
Figure 3: CVR Chassis

The CVR unit chassis exhibited external and internal structural damage with the CSMU detached from the chassis; the CSMU was in good condition. The opening, extraction of the double memory board from the CSMU and the read-out operations were performed following BEA procedures and Honeywell “*Reference Procedure for SSCVR Data Recovery after an Incident or Accident*” document. The memory extraction operations were successful and videotaped.

The quality of the audio information recorded by the CAM was good. Synchronization with the DFDR was performed using VHF communications recording on the DFDR allowing a preliminary transcription. Nevertheless, 1 of the 24 memory chips (U16) was found externally cracked and is likely to be the unreadable memory chip that is causing a 10 seconds gap every 4 minutes of recording on the CAM channel. Additional work is needed to confirm this and to assess how a read-out of the chip could be attempted.

Upon the request of the Investigation Committee, a recovery attempt of the information on the externally cracked CVR chip U16 will be carried by the BEA in coordination with Honeywell. This will include additional work required to assess the extent of damage to that chip and how a read-out could be attempted.

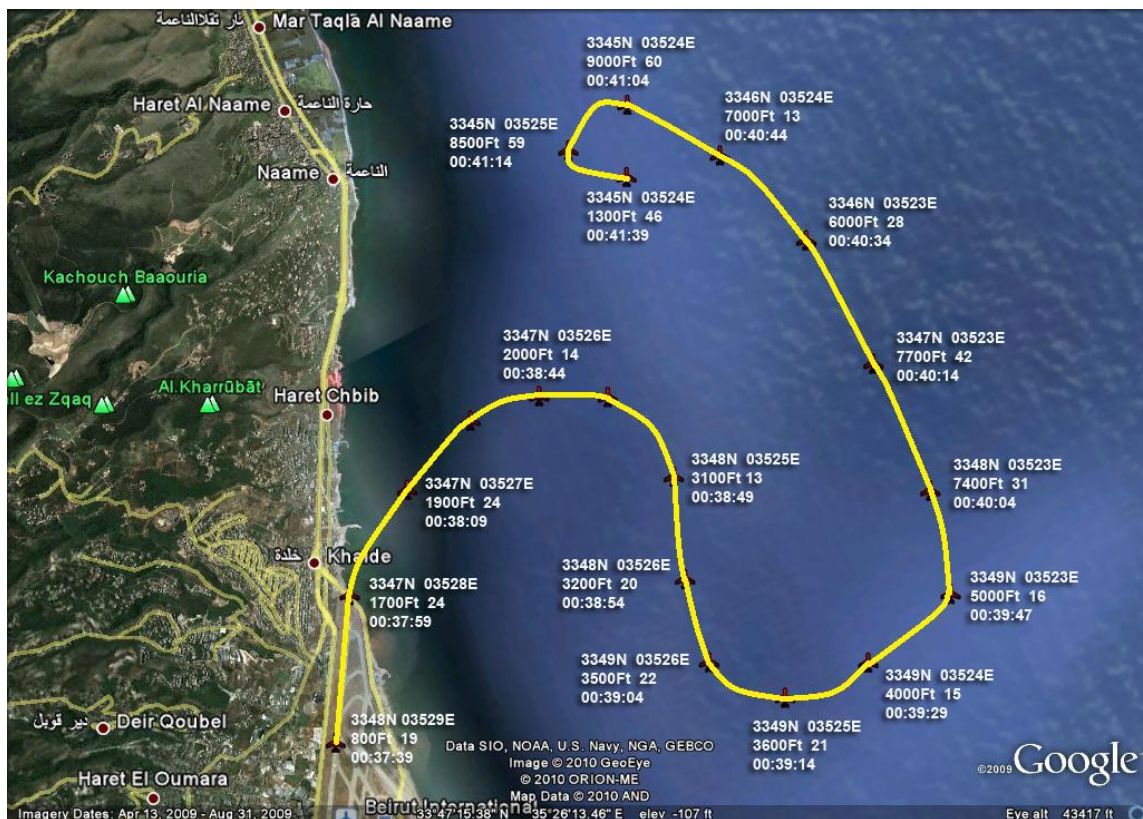
Figure 5: ET 409 Radar Tracks

Prior to the retrieval of the CVR and DFDR data, a reconstruction of ET flight path was carried out by the Lebanese CAA IT technician. This is shown in figure 5 below.
