# National Transportation Safety Board

## Aircraft Accident Brief

**Accident Number:** LAX03MA292  
**Operator:** Sundance Helicopters, Inc.  
**Aircraft and Registration:** Aerospatiale AS350BA, N270SH  
**Location:** Near Grand Canyon West Airport, Arizona  
**Date:** September 20, 2003  
**Adopted On:** October 30, 2007

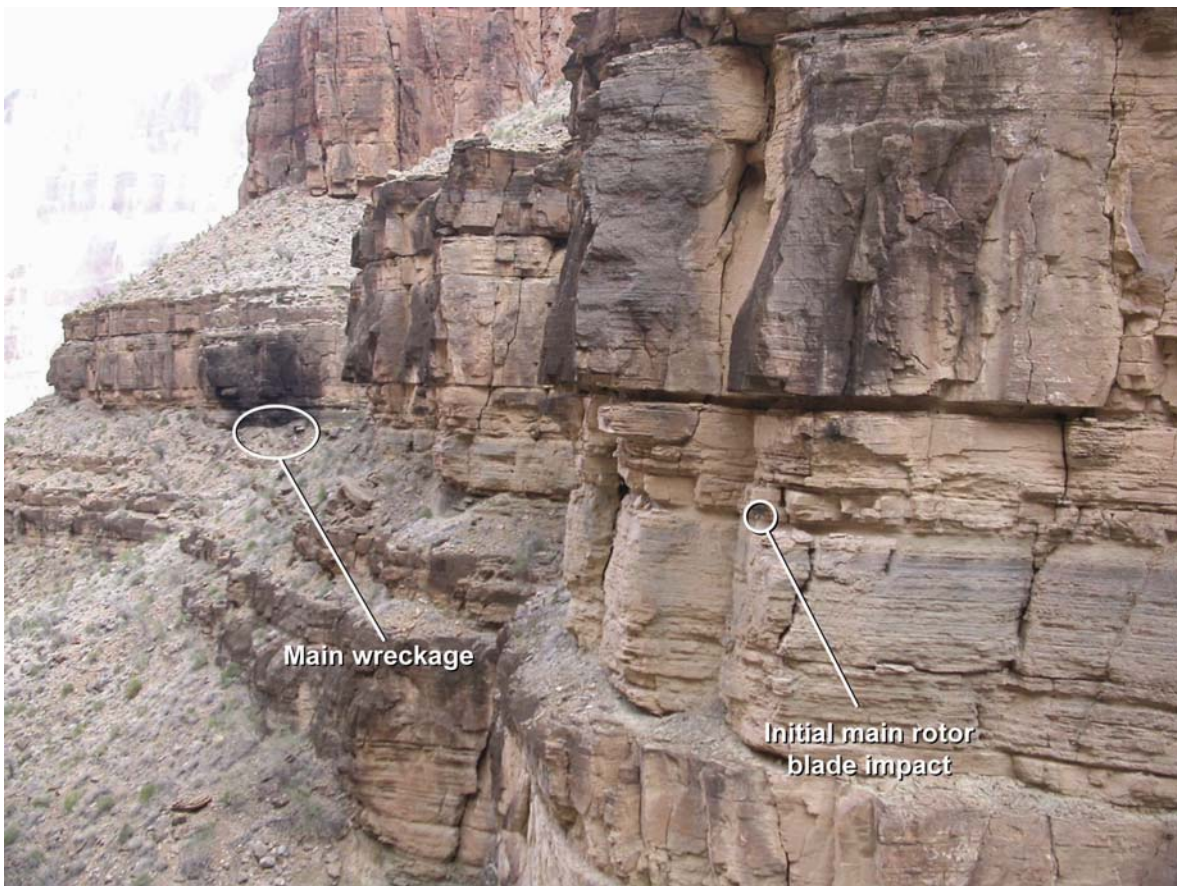
The main wreckage was located on a canyon wall ledge about 400 feet beyond a near-vertical canyon wall that showed evidence of gouging consistent with a main rotor blade strike (see figure 2).<sup>6</sup>

**Figure 2.** Initial main rotor blade impact location and main wreckage location.

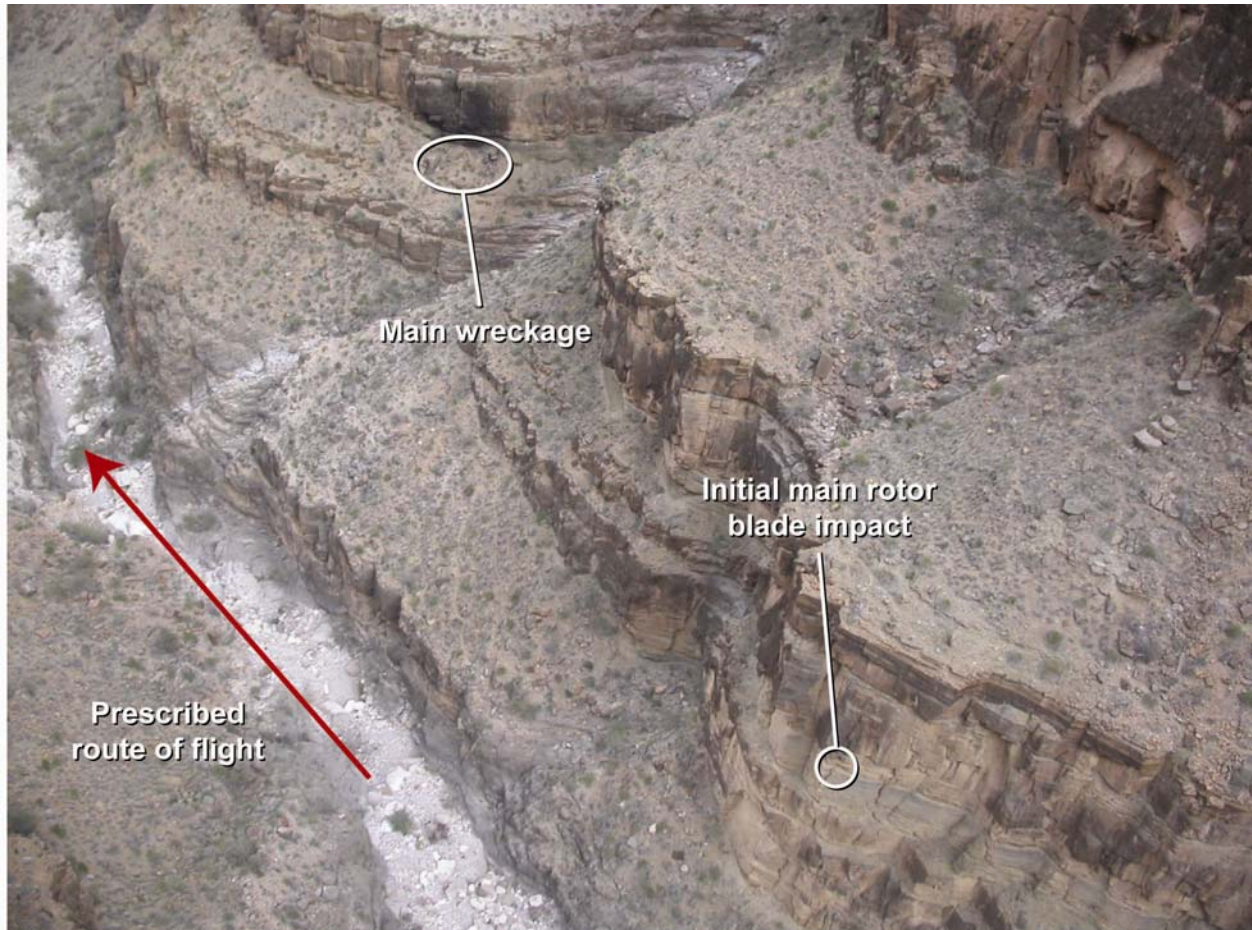
Examination of the accident site and surrounding area revealed the initial impact point was a gouge in a near-vertical canyon wall about 1.2 nm from the canyon rim at an elevation of about 2,000 feet msl. The gouge was of a size and shape consistent with a main rotor blade impact, and a fragment from the tip of a main rotor blade was found near the base of the wall near this location. The main wreckage was located on a canyon wall ledge about 400 feet beyond the gouge location at an elevation of about 1,960 feet msl (see figure 3). The main debris field measured about 70 feet long by 40 feet wide.

**Figure 3.** Overview of initial main rotor blade impact location, main wreckage location, and prescribed route of flight.

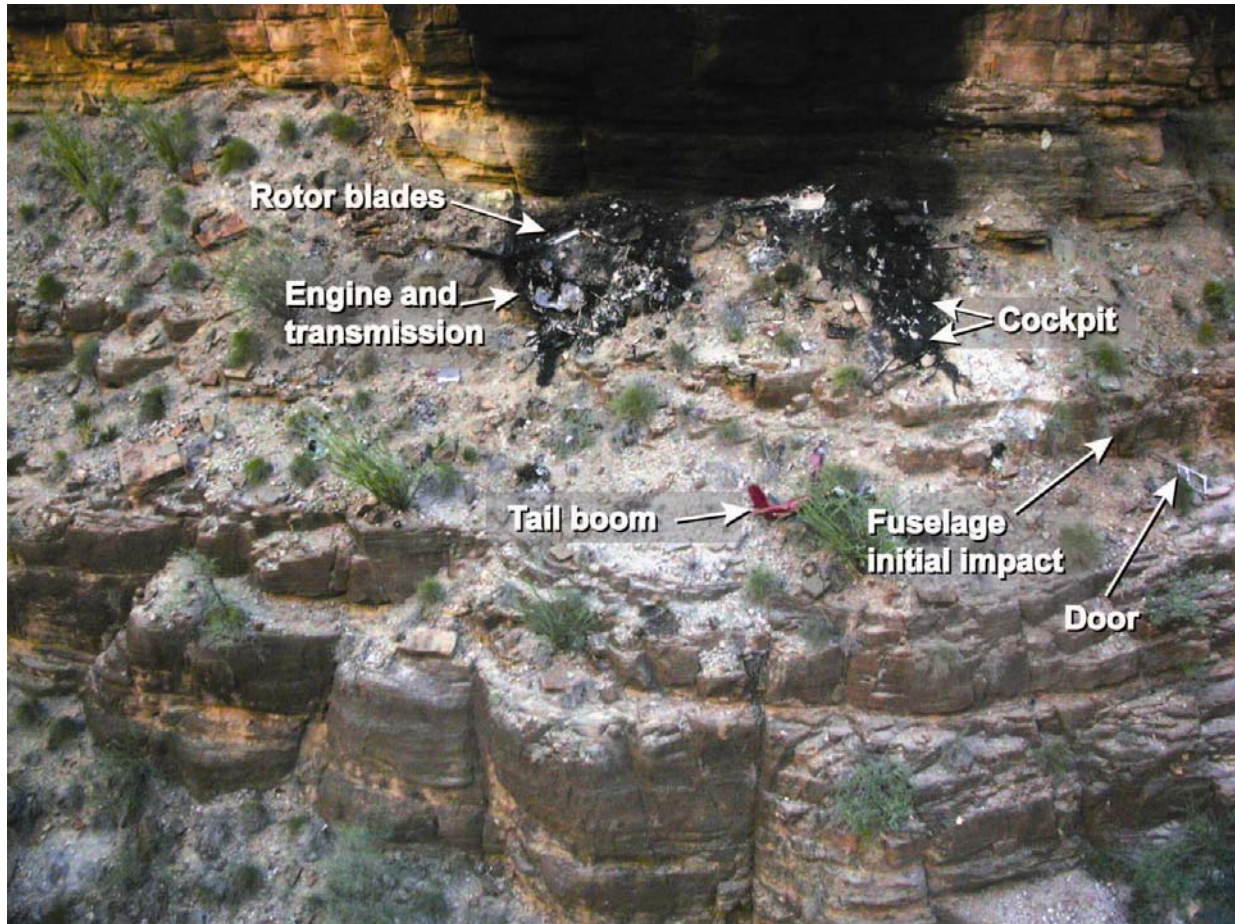
The fuselage body structure was destroyed by impact forces and postcrash fire. The left and right cabin forward doors were found in the main debris area and did not exhibit fire damage. They were found structurally complete with no window plastic attached. The doors exhibited vertical crushing on the lower forward area with a crush angle of about 30°, consistent with horizontal flight into upsloping terrain. Crush damage to both doors was symmetrical in appearance (see figure 4).

**Figure 4.** Main wreckage debris field.

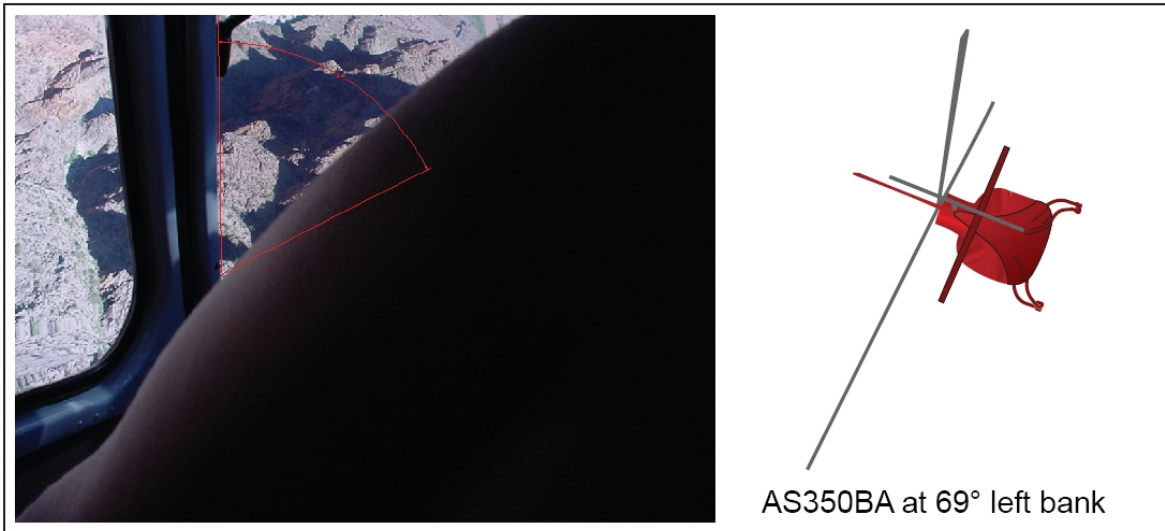
Figure 6 shows a left bank angle of  $69^\circ$ , calculated using the obtained level attitude values for the helicopter. Figure 7 shows the helicopter in a  $55^\circ$  nose-low pitch. Figure 8 shows the accident helicopter in flight near the bottom of the canyon. The airspeed indicator shows an airspeed between 145 and 150 knots, and the artificial horizon indicates that the helicopter is in a slight left bank with near-level pitch. The helicopter appears to be at low altitude and close to the right canyon wall.<sup>20</sup>

**Figure 6.** Passenger photograph showing the accident helicopter in a 69° left bank and a tail-view graphic depicting an AS350BA at that bank angle.

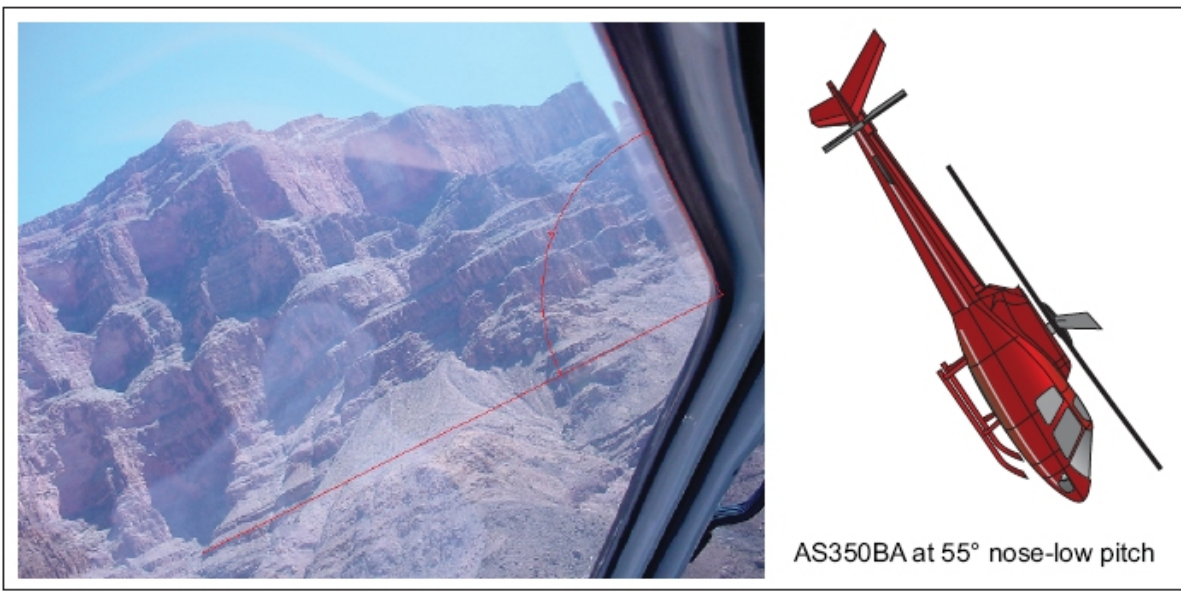
**Figure 7.** Passenger photograph showing the accident helicopter in a 55° nose-low pitch and a side-view graphic depicting an AS350BA at that pitch angle.

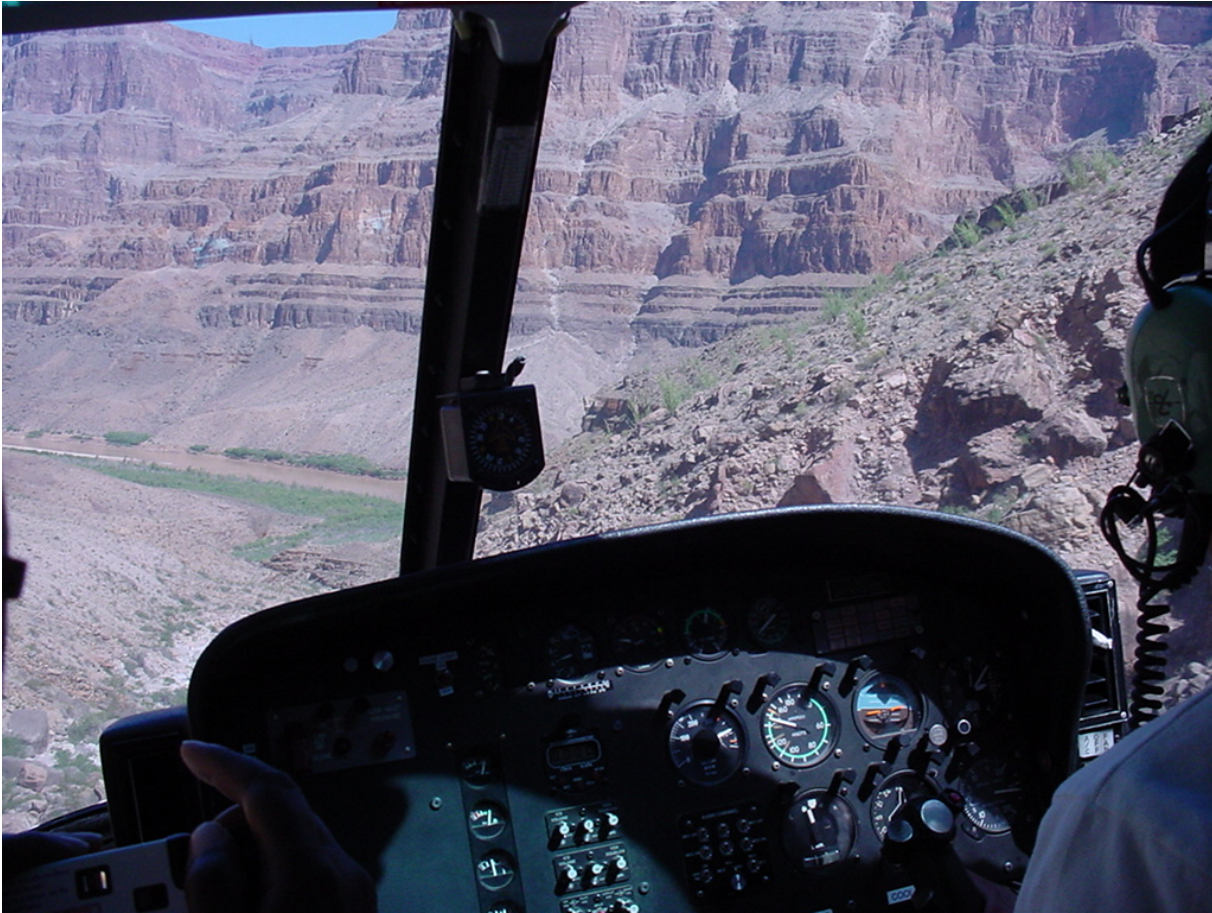
<sup>20</sup> The Sundance CEO reviewed the photograph depicted in figure 8 and estimated that the helicopter's altitude was about 100 to 150 feet agl and that its horizontal clearance from the right wall of the canyon was about 75 to 100 feet.

**Figure 8.** Passenger photograph showing the accident helicopter at low altitude, close to the canyon's right wall, and flying at an indicated airspeed between 145 to 150 knots.

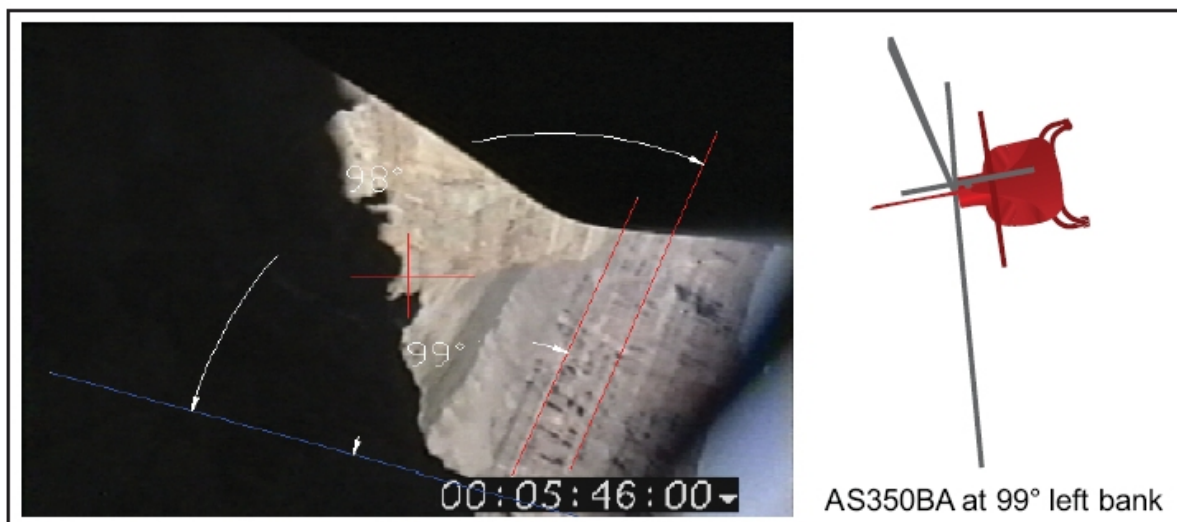
turns; one to the left and one to the right. The maximum left bank angle was about  $99^\circ$ , about 25 seconds into the flight, and the steepest right bank angle was about  $53^\circ$  during the helicopter's exit from the canyon (see figures 9 and 10).<sup>21</sup>

**Figure 9.** Passenger videotape image showing the helicopter in a  $99^\circ$  left bank and a tail-view graphic depicting an AS350BA at that bank angle.

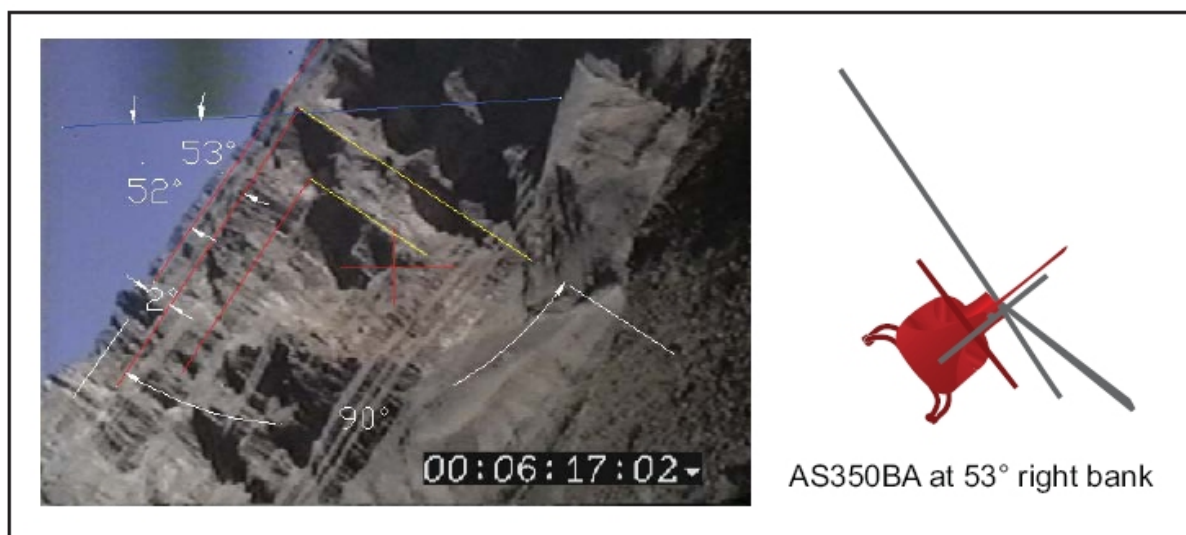
**Figure 10.** Passenger videotape image showing the helicopter in a  $53^\circ$  right bank and a tail-view graphic depicting an AS350BA at that bank angle.
