Assessment Summary Sheet for UKAB Meeting On 11 September 2013

AIRPROX REPORT No 2013020

Date/Time: 20 Apr 2013 1315Z (Saturday)

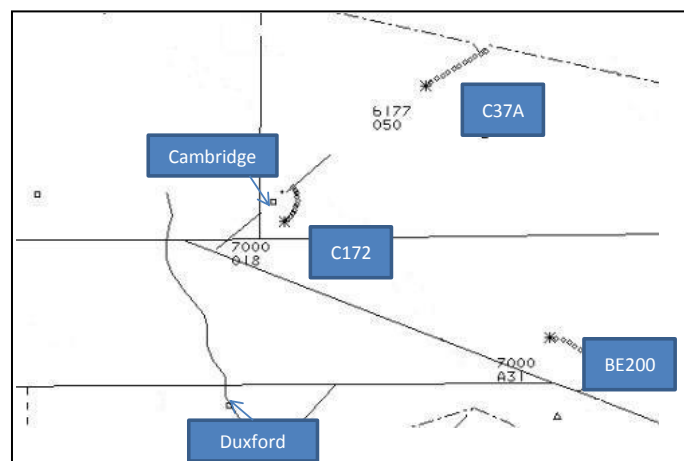
Figure 2: Stansted 10cm radar – 0709:20 UTC. Note: for reference the extended centreline markers for Cambridge RW05/23 represent 2nm.

At 0709:20 the Cambridge APP passed TI to the C37A pilot on a C172 at 2000ft holding over the A/D and on the BE200, "on your er left-hand side westbound last reported three thousand feet." The C37A pilot reported, "searching". See Figure 2 below.

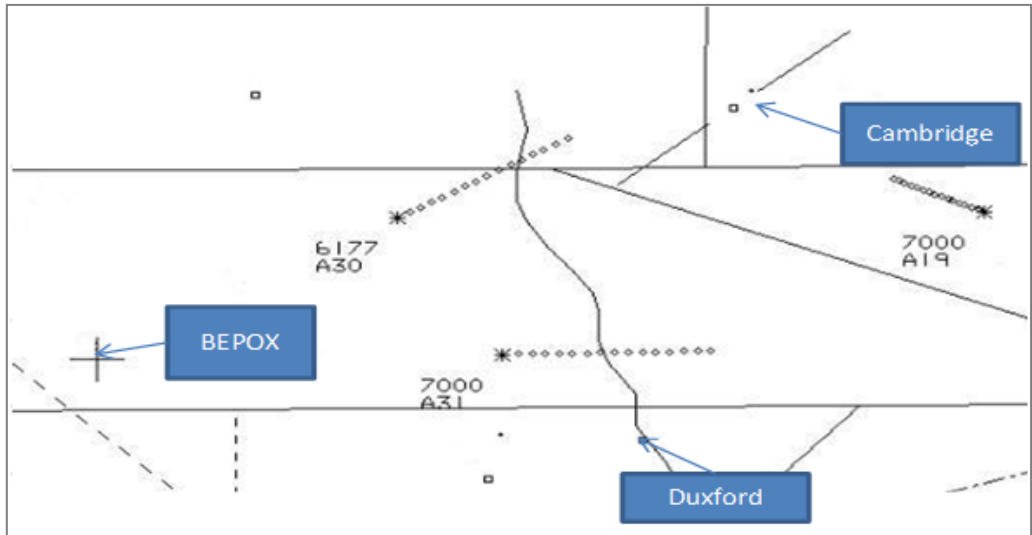
Figure 3: Stansted 10cm radar– 0713:10 UTC. Note: the BE200 passed 1.7nm N of Duxford A/D.

At 0713:00 the Cambridge APP informed the C37A pilot, "the previously mentioned Beech Two Hundred traffic no longer on frequency however I'm visual from the control tower [0713:10] on your left hand side three thousand feet." The C37A pilot replied "has him in sight". See Figure 3 below.

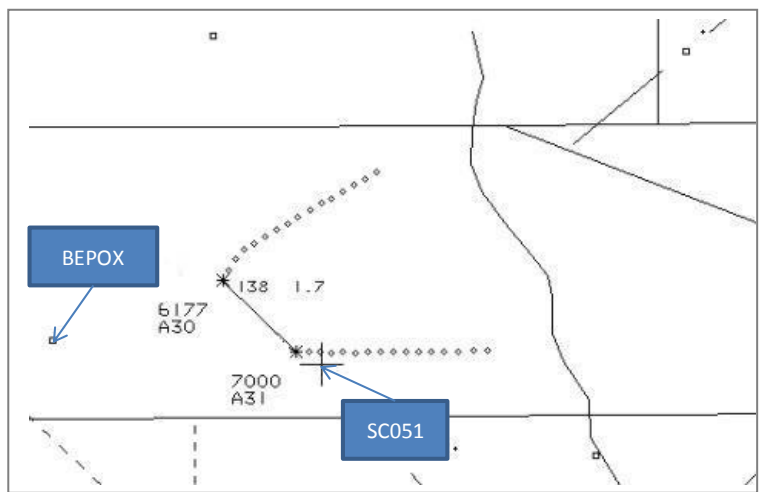
Figure 4: Stansted 10cm radar – 0714:02 UTC.

At 0714:02 the C37A was in a L turn maintaining altitude 3000ft (approximately 3.5nm short of BEPOX). The BE200 was westbound at 3100ft, having just passed the SC051 waypoint. See Figure 4 below (waypoint SC051, which follows BEPOX in the RNAV procedure, is shown).

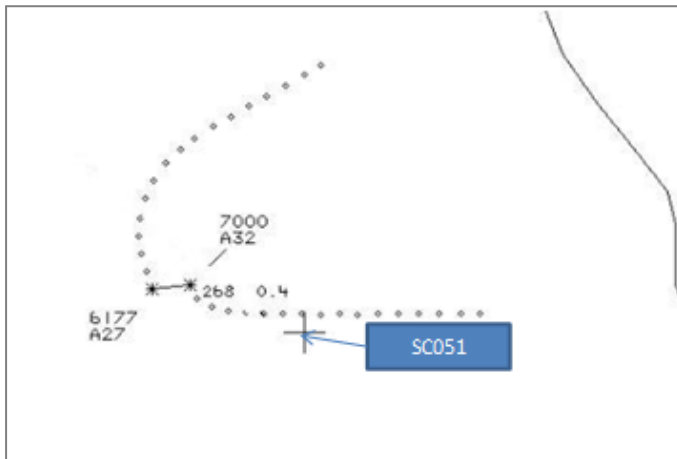
Figure 5: Stansted 10cm radar – 0714:20 UTC. Closest radar recorded distance.

The C37A's L turn then appeared to stop as it descended to 2700ft. The BE200 turned R and climbed to 3200ft as the ac passed 0.4nm abeam. Figure 5 shows the closest distance between the two ac as recorded by the Stansted 10cm radar (ac-to-ac distance was 2481ft). The ac were 9nm SW of Cambridge.

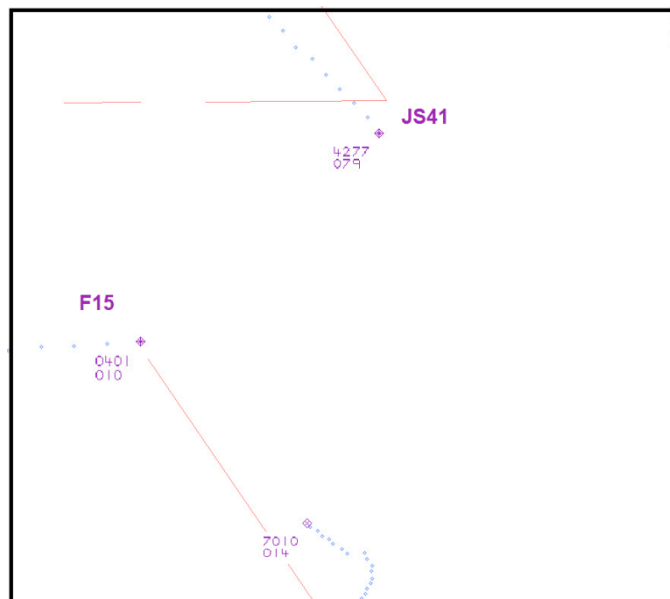
Figure 1 – Claxby & Manchester MRT at 1549:43

The JS41 was in receipt of a DS from LATCC(Mil) NE and at 1549:43, the controller, having placed the JS41 on a radar heading, contacted Humberside Radar with a radar handover. Radar showed the JS41 squawking 4277 at FL79 (Figure 1) as well as two other ac, one squawking 7010, indicating FL014, and the second, the F15, squawking 0401 indicating FL010 (an altitude of 676ft using the Humberside QNH 1001 hPa, with 1hPa equivalent to 27ft). The F15 was 4.6nm SW of the JS41.

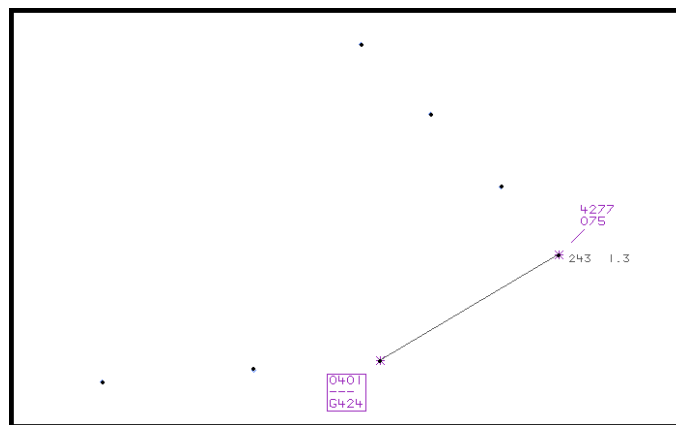
Figure 2 – Claxby single source at 1550:20

controller reported that the JS41 was bearing 350° from OTR at 15nm heading 140° and squawking 4277. The Humberside Radar controller responded, “Contact” and the LATCC(Mil) NE controller continued, “Descending flight level seven zero deconfliction service just turned him right ten degrees to get a gap on the seven zero one zero squawk erm but we’re happy to come to Otringham now if you are.” Humberside Radar replied, “Er no (JS41)c/s is identified continue that heading contact Humberside radar one one nine decimal one two five.” The Humberside Radar controller’s written report indicated that, from the relative speeds of the ac, he judged the 0401 squawk would pass in front of the JS41 and considered that a turn towards OTR would place the JS41 overhead the 0401 squawk. There was no discussion during the handover regarding the unknown 0401 squawk. The call was terminated at 1550:14 and at this point radar showed the two ac (JS41 and F15) converging at a range of 1.7nm. At 1550:20 the range had reduced to 1.3nm and the Mode C of the F15 was no longer shown on the Claxby radar (FL012 on MRT). The groundspeed of the F15 was 424kt (Figure 2).

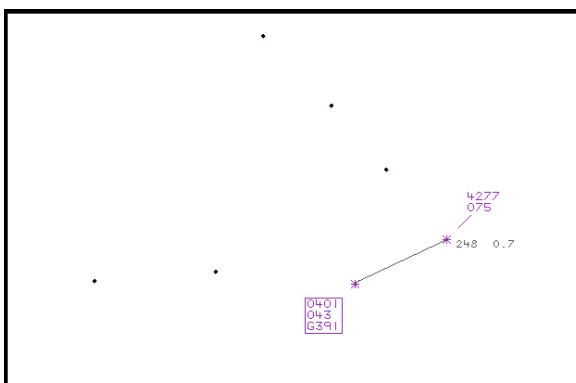
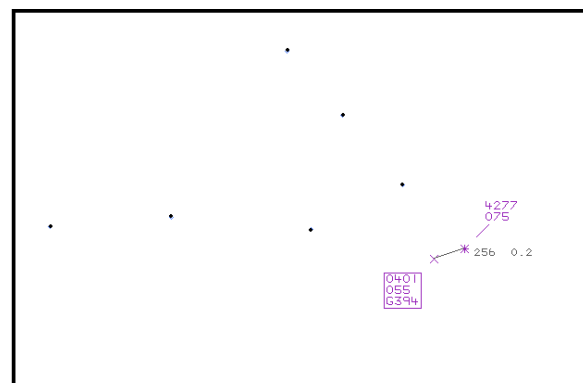
The next two successive sweeps of the Claxby radar, at 1550:28 and 1550:36, showed the F15 Mode C indicating FL043 and then FL055. (Figure 3 and Figure 4).

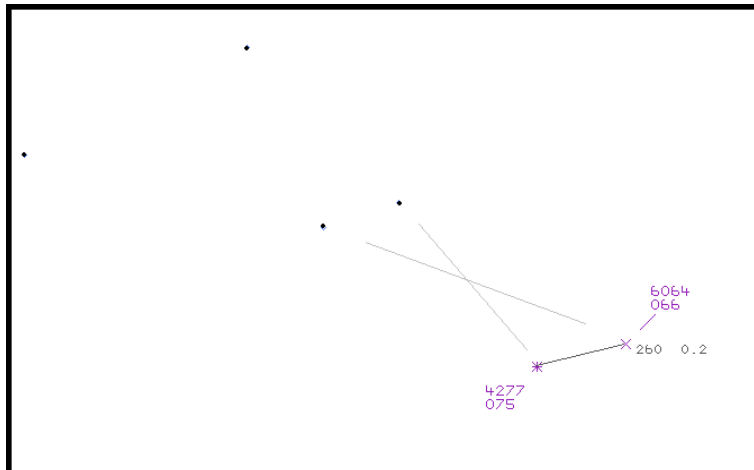
Figure 5 – Claxby single source 1550:44

At 1550:32, the F15 pilot was instructed to squawk 6064 by LATCC(Mil) E and the new SSR code was displayed on the next sweep of the radar at 1550:44. The Claxby radar showed that the tracks had crossed with the JS41 at FL075 and the F15 at FL066 (Figure 5).

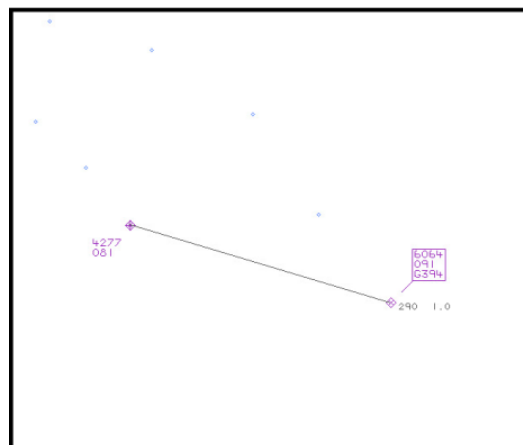
Figure 6 – Claxby & Manchester MRT at 1551:06

The JS41 pilot’s report indicated intermittent IMC at FL75 and the F15 pilot’s report indicated VMC with flight visibility 20km. At no time was the F15 pilot visual with the other ac. The two ac continued to diverge and at 1551:06, the F15 was 1000ft above the JS41 (Figure 6).

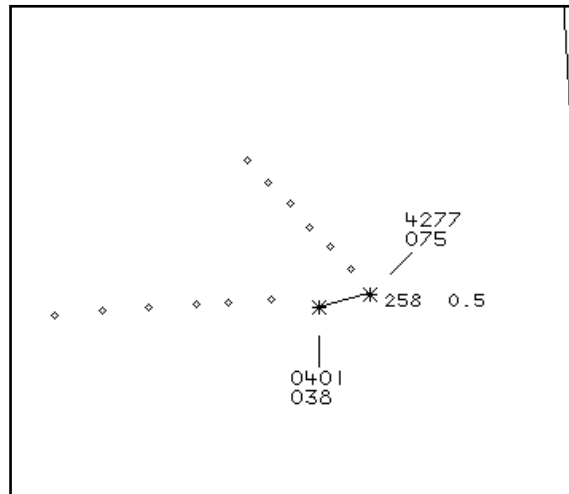
Figure 7: Incident Geometry at 1550:30

At 1550:23, the F15 crew free-called LATCC(Mil) E Tac, passing their callsign and were instructed by LATCC(Mil) E Tac to, "squawk 6-0-6-4, pass message." The F15 crew read back the squawk at 1550:30 and stated that they were, "requesting to route Flight Level one hundred, traffic service... [garbled but believed to be en-route to a point of destination]." As the F15 crew read back the SSR mode 3/A code, the Mode C data became visible on the radar replay, indicating a climb through 3800ft, 0.5nm WSW of the JS41; Figure 7 depicts the incident geometry at this point.

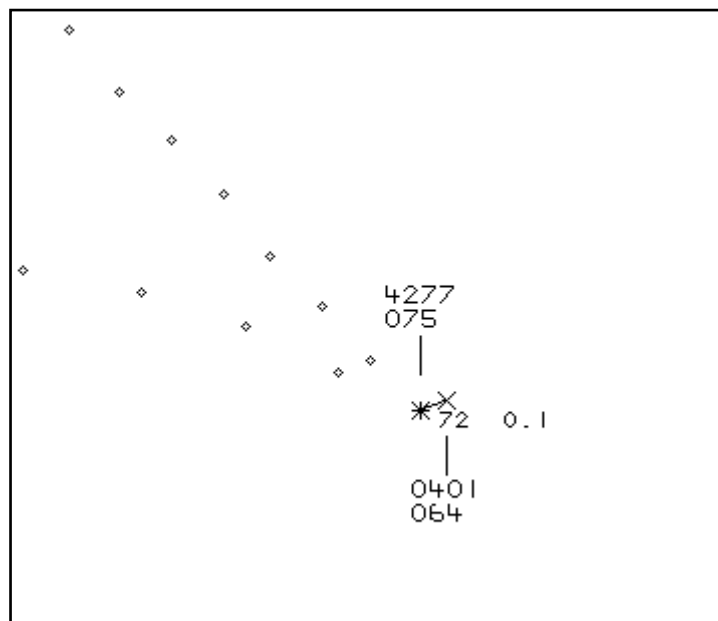
Figure 8: Incident Geometry at 1550:42

Although the F15 crew reported that they were VMC and utilising their radar to search for conflicting ac, they did not acquire the JS41 visually or electronically. Although the JS41 crew were alerted to the presence of the F15 by TCAS, they did not visually acquire the F15.

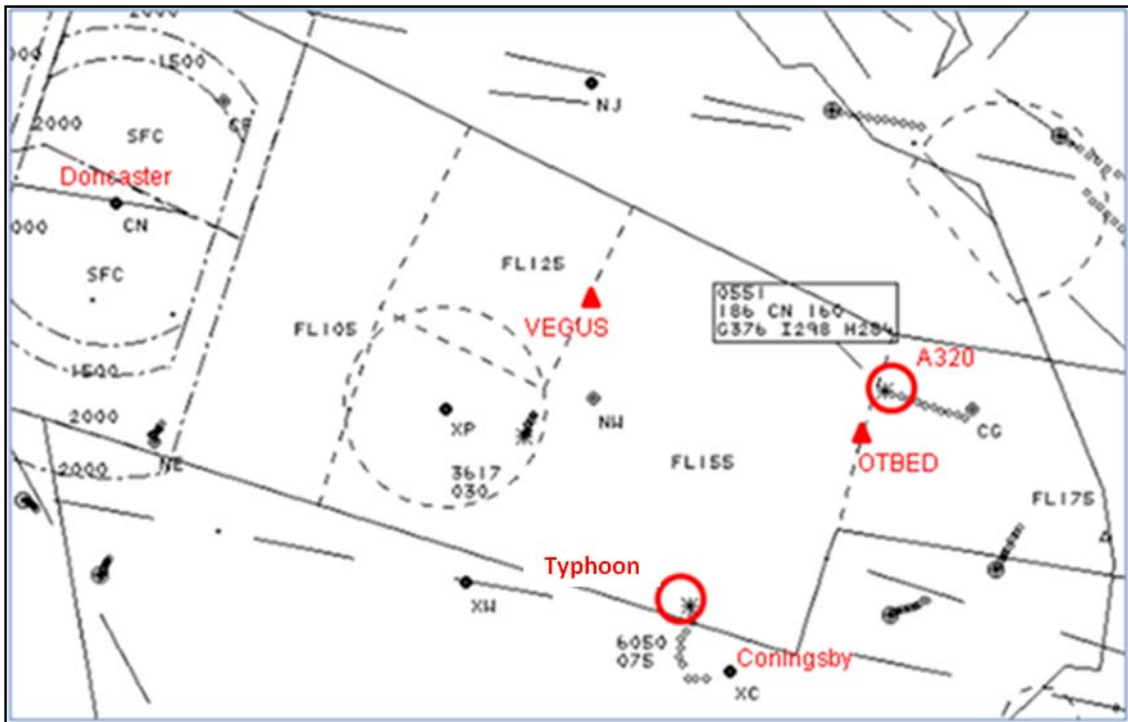
Figure 1: Area Multi Radar Tracking – 1055:40 UTC

The A320 called Doncaster APR at 1055:20, "descending flight level 160 on course to VEGUS information Romeo ready for deconfliction service." APR replied, "...vectors I L S approach runway 20 and er descend [1055:40] initially flight level 130." This was read-back correctly. See Figure 1.

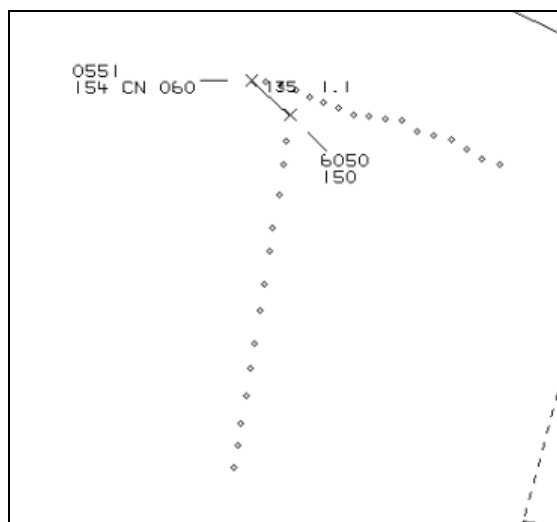
Figure 3: St Annes – 1057:11 UTC

At 1057:11 the A320 passed FL154, leaving CAS, still descending as the Typhoon, maintaining FL150, flew behind it from left to right at a range of 1.1nm (Figure 3). This was the closest radar-derived point of approach: 6695ft ac to ac distance. [UKAB Note 1: The Claxby Radar indicates a CPA of 1nm/400ft V.] The Typhoon subsequently reported a minimum slant range of 6357ft.

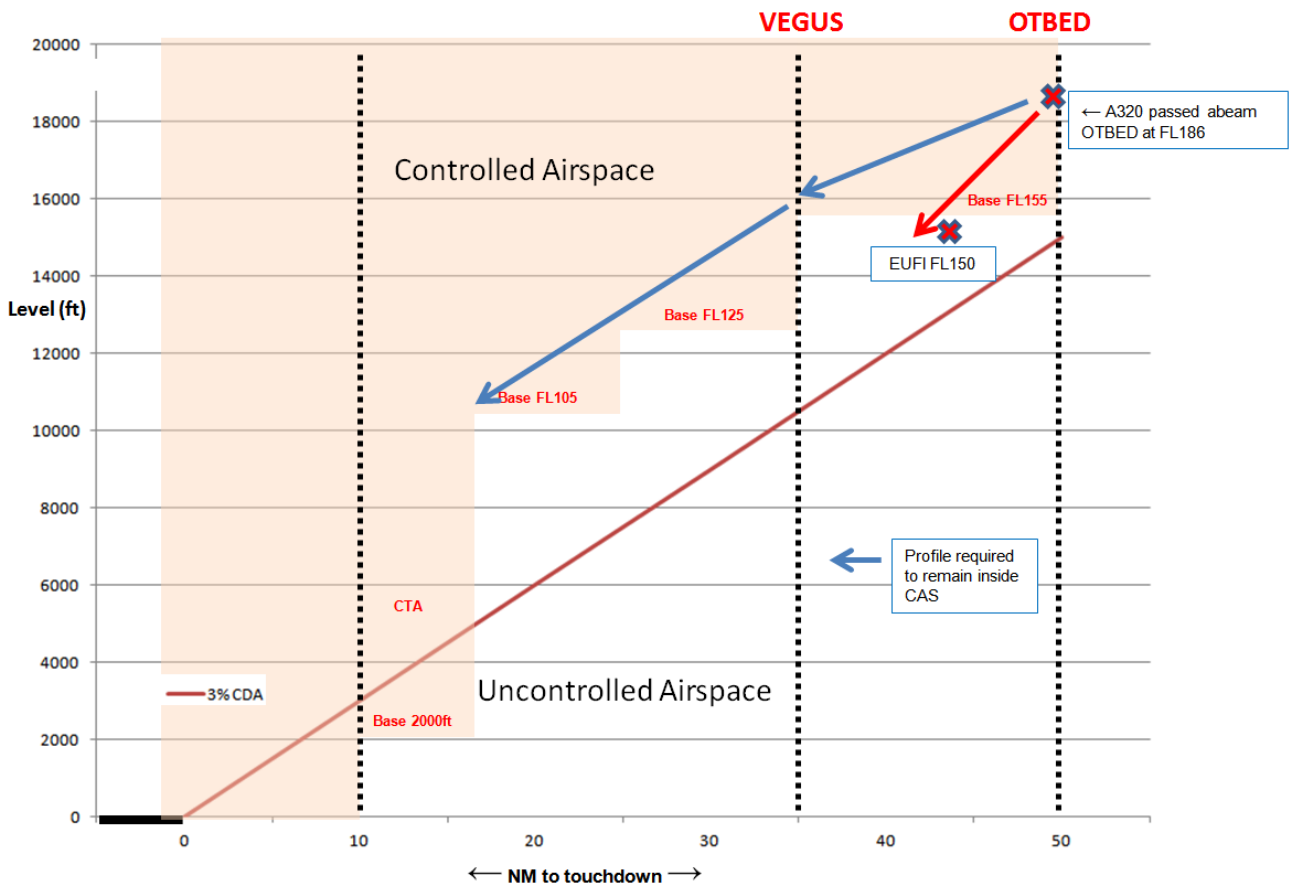
Figure 4: Descent Profiles

The A320 passed abeam OTBED at FL186. The Figure 4, annotated with a nominal 3% continuous descent from OTBED (50nm from touchdown), shows that the A320 would have needed a shallower rate of descent to remain inside CAS until VEGUS. The blue arrows on Figure 4 illustrate the descent profile required to remain inside CAS; it can be seen that, for a straight-in approach (with no extending vectors), the base of CAS only reduces from FL105 to altitude 2000ft at approximately 16nm from touchdown.

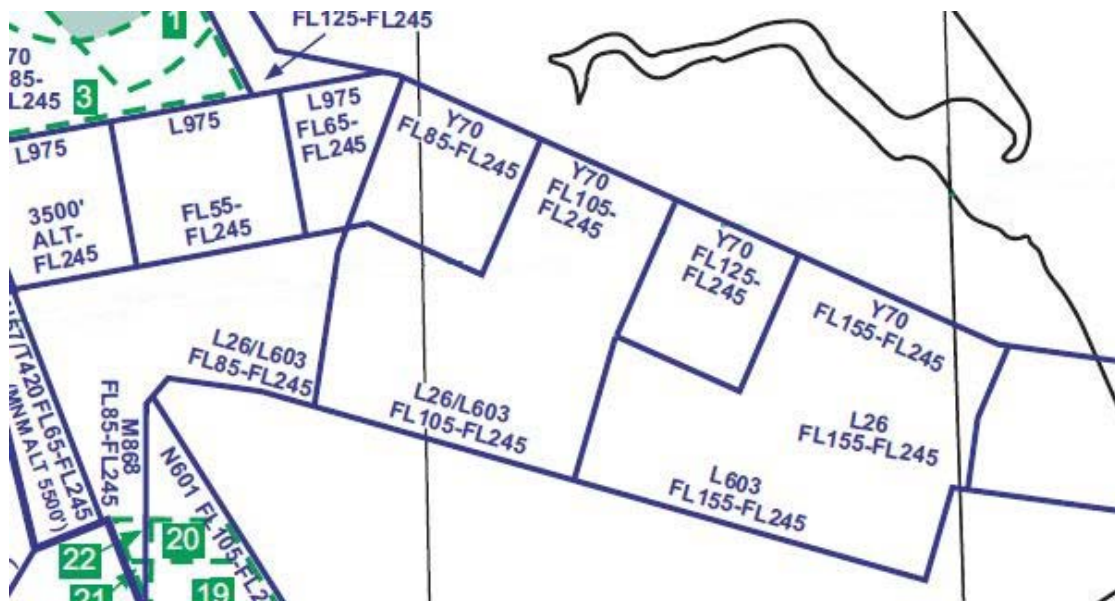
Figure 5: UK AIP ENR 6.1 AIRAC 08/2008

Prior to the establishment of CAS in the vicinity of Doncaster Airport in 2008 the pre-existing airways structure was as shown below in Figure 5. It can be seen that the bases of airway Y70 were, as they are now, from N to E: FL85, FL105, FL125, FL155. This facilitated climbs and descents for Manchester TMA and Leeds-Bradford traffic. When the Doncaster's CTAs were introduced there was no similar allowance made in airspace design.

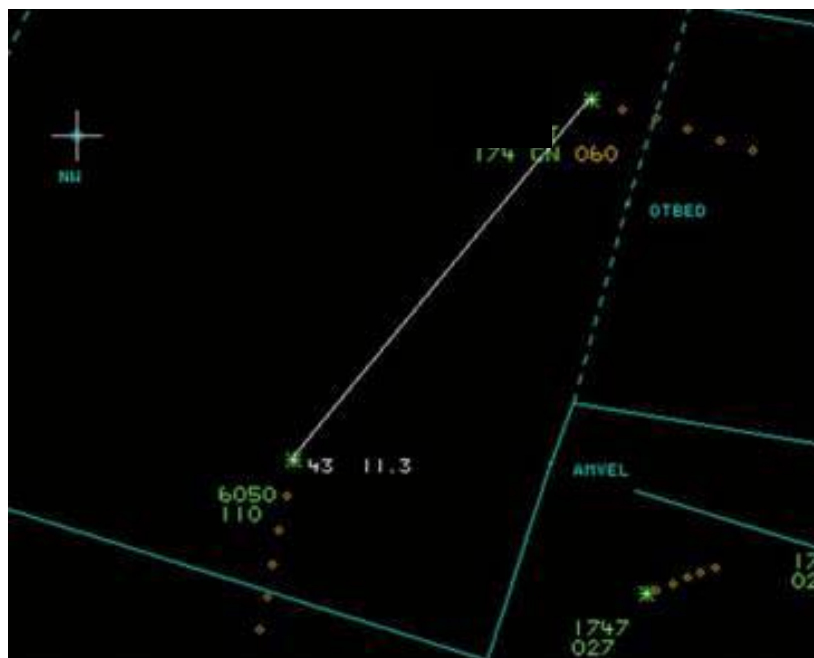
Figure 6: Incident Geometry at 1056:07.

The incident sequence commenced with the handover of the Typhoon from Coningsby ATC to NE Tac, which occurred between 1056:16 and 1056:45. Immediately prior to the handover, at 1056:07, the Mode S 'selected level' data for the A320 changed to indicate that the pilot had selected FL60; Figure 6 depicts the incident geometry at this point, with the Typhoon climbing to FL150.

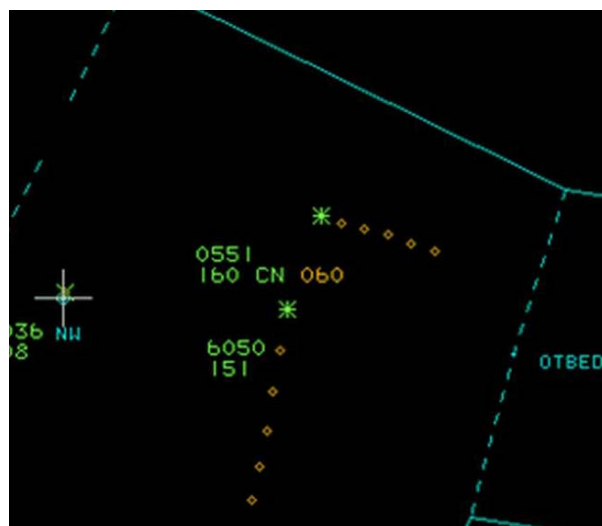
Figure 7: Incident Geometry at 1056:53.

At 1056:53, the Typhoon made initial contact with NE Tac who replied immediately "[Typhoon c/s] London Mil, identified FL150 Traffic Service. Traffic 12 o'clock, 3 miles, crossing right-left, indicating 800ft above, descending inbound to Doncaster." The Typhoon's pilot replied that they were "visual", later reporting that they had acquired the A320 on AI radar at 12nm and visually acquired it at 10nms. Figure 7 depicts the incident geometry at the time of the Typhoon's initial call to NE Tac.

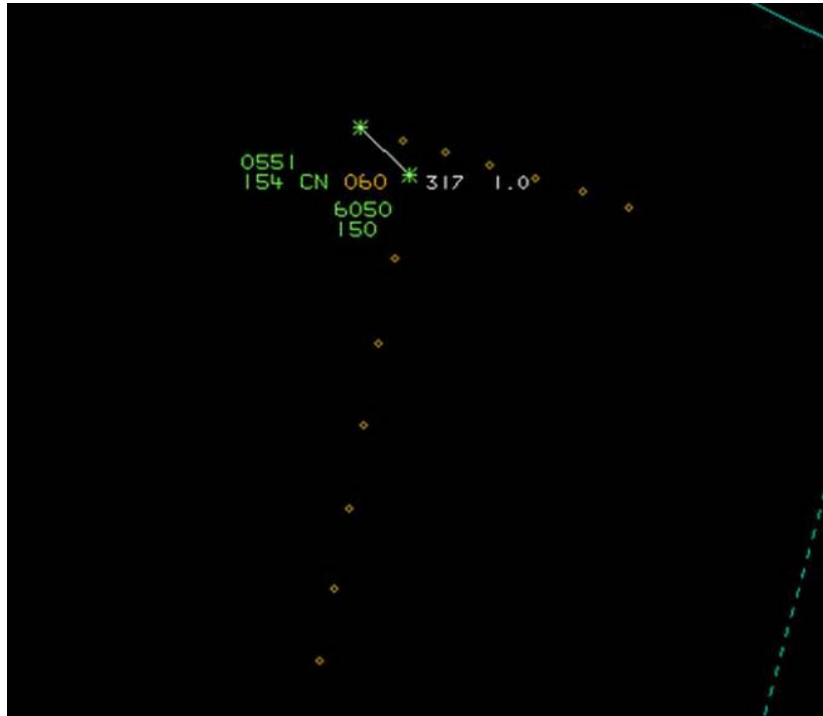
Figure 8: Incident Geometry at 1057:10

At 1057:03, the A320 indicated descent through FL157. Based upon the report of the A320 pilot, there may have been some confusion between the A320 and the Doncaster Sheffield controller over the A320's cleared level, which appears to have resulted in the A320 descending beneath the Base of CAS. The CPA occurred at 1057:10 as the Typhoon passed 1nm ESE of the A320; Figure 8 depicts the incident geometry at this point.

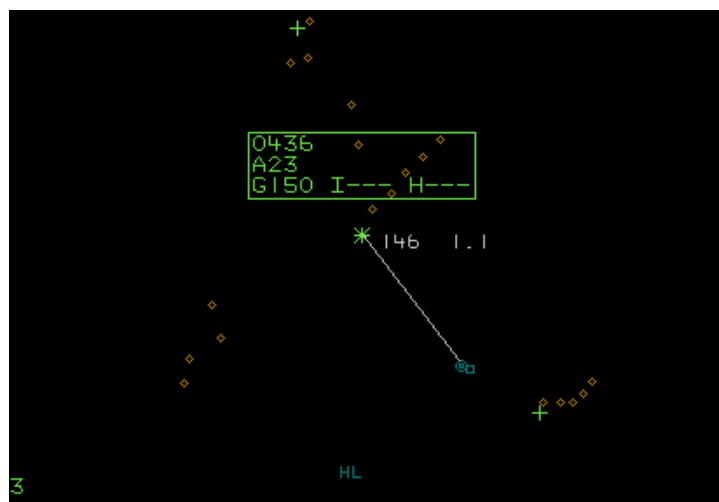
Figure 1: 0937:10

At 0937:10, as the PA32 was 1.1nm to the NW of Lasham, the Farnborough LARS controller advised the pilot "...*just caution Lasham very busy at the minute winch launch gliding up to three thousand seven hundred feet there's a couple of gliders just southwest of you by a mile but they're all around*" (See Figure 1). The PA32 pilot acknowledged the call.

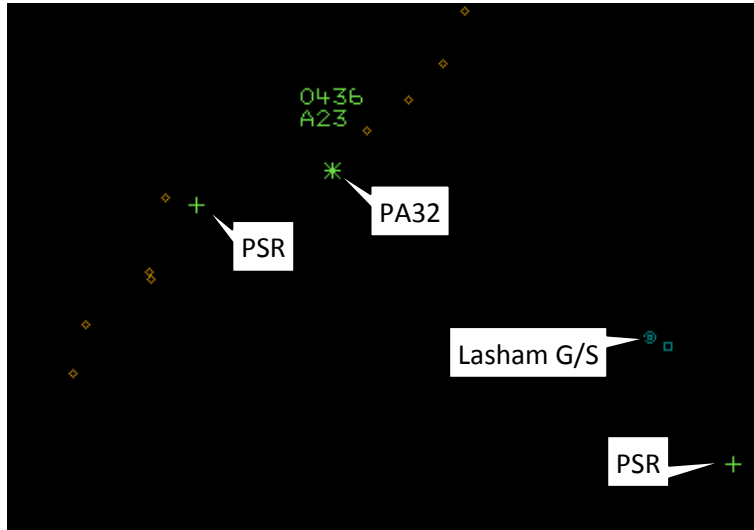
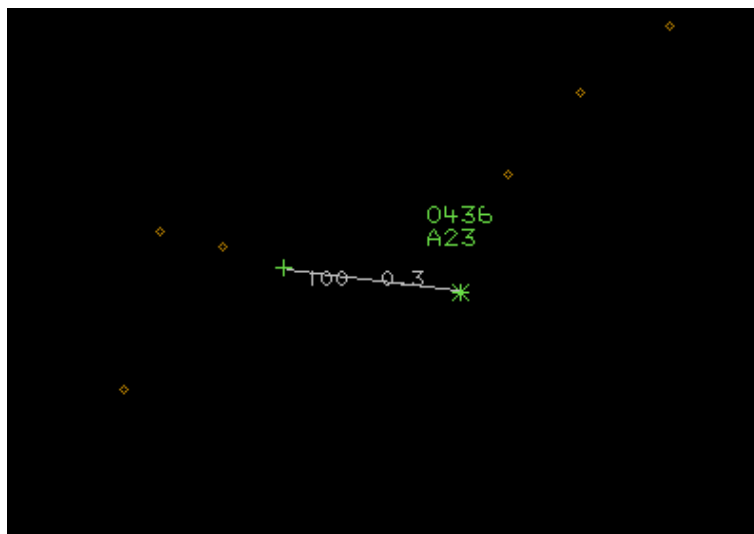
Figures 2 and 3 show radar recording screenshots indicating the PA32 about 1nm NW of Lasham with a primary contact crossing R to L. Figure 3 shows the PA32 pilot appears to have conducted a sharp L turn, whilst the primary contact appears to have conducted a sharp R turn. It is possible that the screenshots show the reported Airprox but, as the DR400 cannot be positively identified, this cannot be positively asserted.

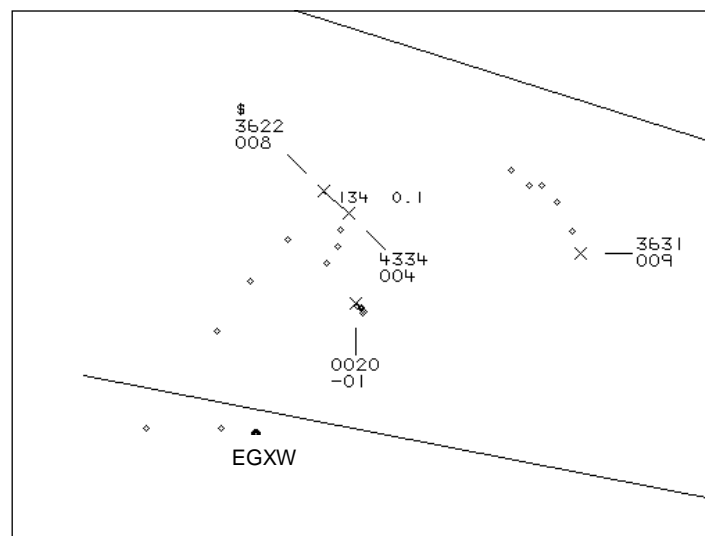
Figure 4: Incident Geometry at 0953:22.

The CPA occurred at 0953:20 as the BE200 passed 0.1nm down the BN2's L side, indicating 400ft above; Figure 4 depicts the incident geometry. At 0953:26, the BE200 passed 0.2nm through the BN2's 12 o'clock, breaking downwind at 0953:50, 0.8nm NE of the BN2 and co-altitude with it.

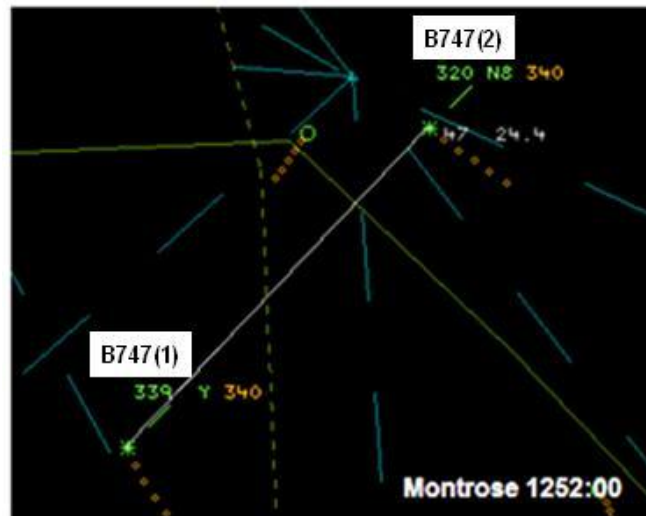
Figure 2.

At 1252:00, the B747(1) pilot contacted the Montrose sector maintaining FL340 (indicating FL339). The two ac were 24.3nm apart on converging tracks (see Figure 2 below). ATCO(1) reported that his usual method of working was to put the electronic strips of conflicting traffic together and suitably highlighted. On this occasion ATCO(1) had not done this.

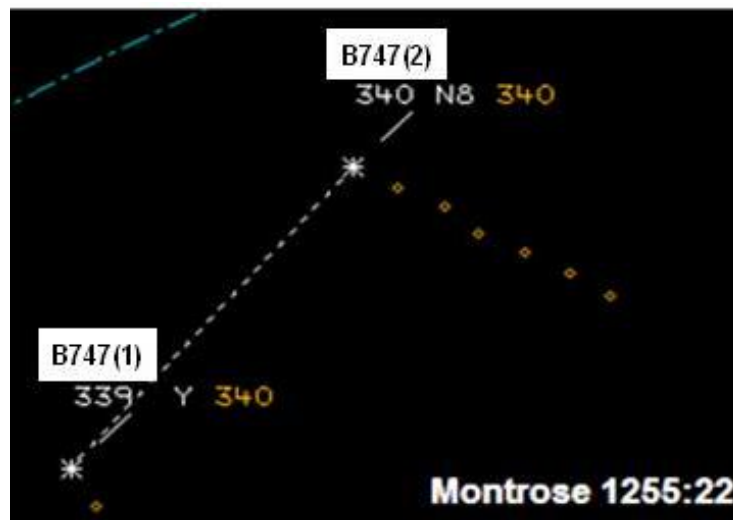
Figure 3.

At 1255:22, low-level STCA was triggered as the two ac were 9.8nm apart (see Figure 3). Just prior to this ATCO(1) had realised that the two ac were in conflict; however, he was unable to issue instructions due to another ac transmitting on the frequency. At the end of this transmission ATCO(1) transmitted, *“avoiding action [B747(1) C/S] turn left immediately heading two seven zero degrees, traffic in your right one o’clock.”* The B747(1) pilot read back, *“two seven zero [B747(1) C/S]”*. Avoiding action was then passed to the B747(2) pilot, *“[B747(2) C/S] avoiding action turn right immediately heading zero five zero degrees traffic in your left eleven o’clock”*. The B747(2) pilot replied using his C/S digits only.

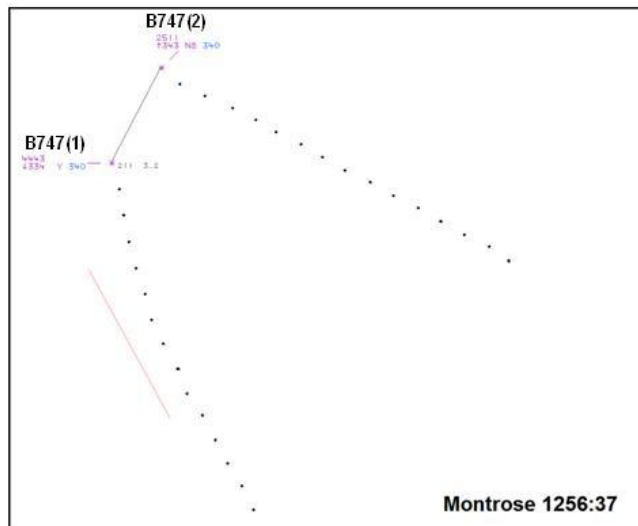
Figure 6.

At 1256:37, vertical separation between the two ac was regained as B747(1) was at FL332 and B747(2) was climbing through FL344. The lateral distance was 2.8nm with the tracks of the two ac not appearing to have changed significantly (see Figure 6).

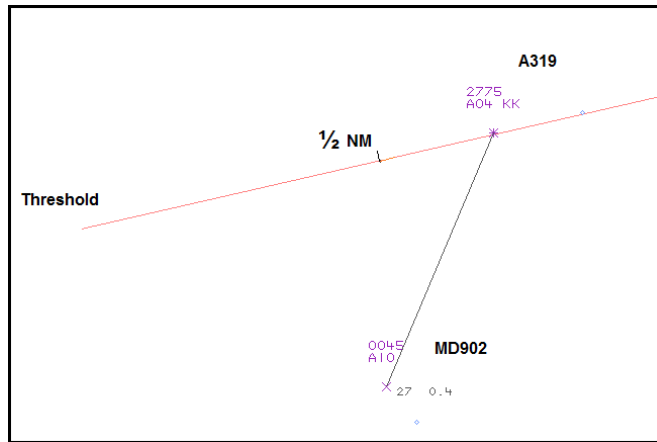
Figure 1 – MRT at 2137:58

At 2137:58, the A319 was 0.5nm from touchdown at an altitude of 400ft, with the MD902 at a distance of 0.4nm at 1000ft (Figure 1).

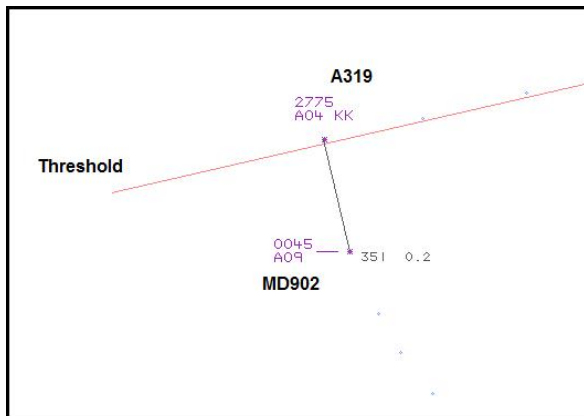
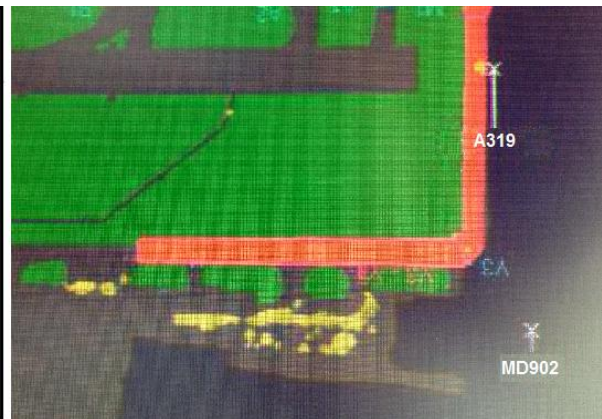
The MD902, then started a R turn [2138:06] to position behind the landing A319, which was just crossing the airfield boundary at a range of 0.2nm from touchdown, see Figure 2 and also Figure 3, the corresponding image taken from the Gatwick SMR.

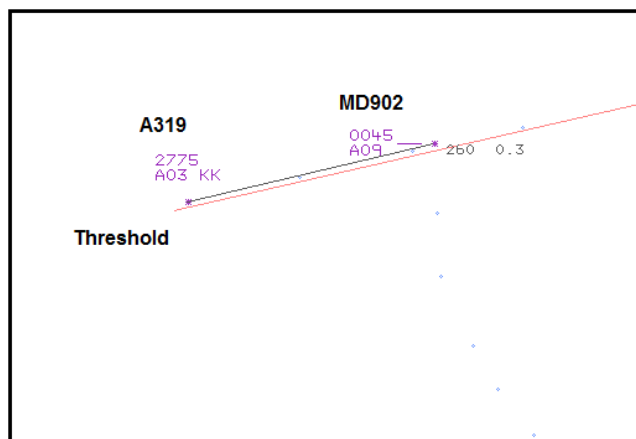
Figure 4 – MRT at 2138:14

At 2138:14 the MD902 passed 0.3NM behind the A319 as it approached the touchdown point on Runway 26L (Figure 4).
