PAKISTAN CIVIL AVIATION AUTHORITY

(SAFETY INVESTIGATION BOARD)

INVESTIGATION REPORT

AIR BLUE FLIGHT ABQ-202 A-321 REG AP-BJB PAKISTAN
CRASHED ON 28 JULY 2010
AT MARGALLA HILLS
ISLAMABAD

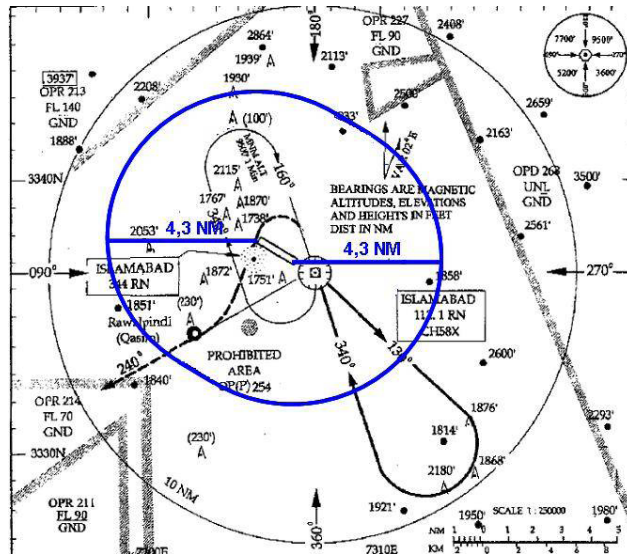
6.7.1 These conditions give an arc radius of 4.3 NM, and the following visual maneuvering area:

6.7.2 The highest obstacle in this area on the AIP Pakistan chart has an elevation of 2,115 ft. ICAO Doc 8168 requires an obstacle clearance of 394 ft for category C aircraft (in line with the published MDA of 2,510 ft). The accident aircraft left the protected area, and impacted the hill 7.3 NM from runway 12 threshold (9.6 NM from VOR).

- 10.20 The protected circling airspace to fly at MDA was available till 4.3 NM. Contrary to the recommended procedures, the mishap aircrew took the aircraft out of the protected area to 7.3 NM from RWY-12 threshold.

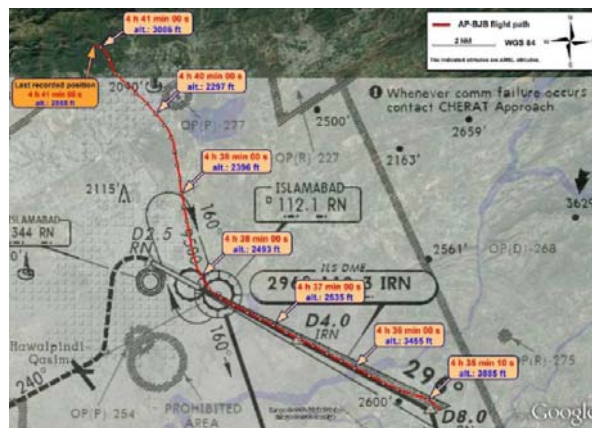
8.58 Final Flight Path

- 8.58.1 The sequence of events from time 0415 UTC up to the crash has been depicted (Pictorial) in the final flight path in the figure below. The depiction is the portrayal of the data retrieved from the CVR and DFDR. Final flight path does not indicate any significant variation from the FCOM procedures till ILS finals. However, subsequent flight path till impact with the hills at 0441:08 (last recorded position) is full of events.
