FINAL REPORT

Serious incident

3-12-2016

ATR72 202

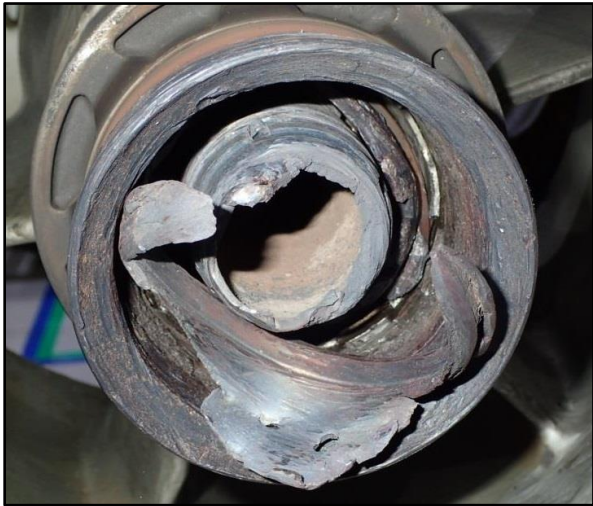
The tear down examination revealed extensive engine damages and indicated failure of the engine no. 2 bearing most likely causing the engine seizure.

No. 2 bearing housing distress

- The fracture end of PT shaft was observed with solidified molten metal;*
- The #1 bearing was observed fracture at the outer ring;*
- The #2 bearing found distressed (Part and serial number not visible), no rollers retrieved during disassembly;*

- The RIC was found with metal deposits at the bottom tank and impact damage at the No.1 bearing mating area;*
- The #2 bearing housing was found distressed*

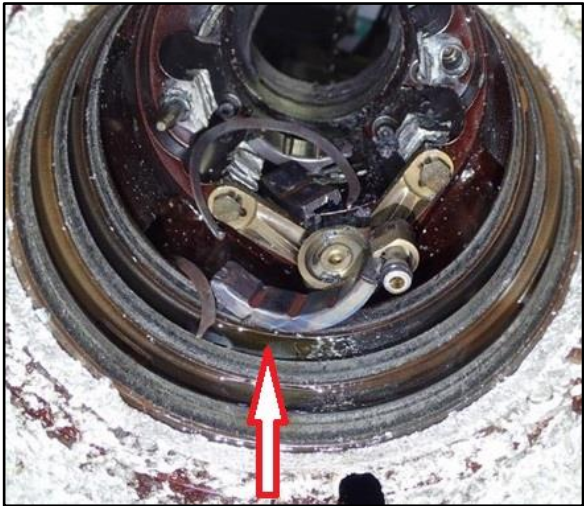
Remains of no. 2 bearing

During the investigation, although the #2 bearing oil nozzles were found partially blocked during the oil flow test, the blockage of the oil nozzle was likely caused by secondary contamination of the oil passage as a result of the event. Post discussion with Service Investigation concluded that the cause of the event is attributable to the distressed no.2 bearing. However, due to the amount of damage sustained, evidence of the causes have been destroyed and therefore the root cause of the bearing distress cannot be determined at this shop visit.

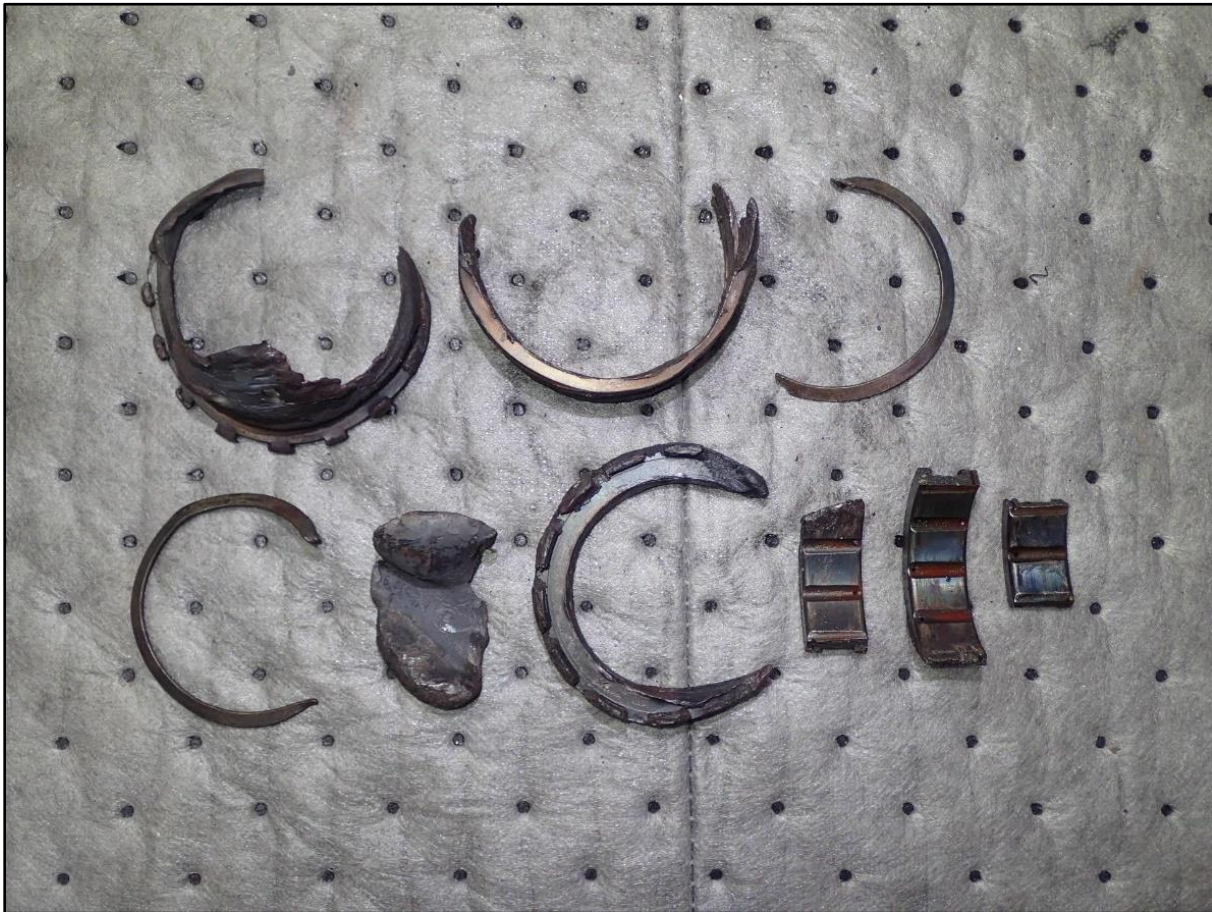
Because the number of remaining parts of the no. 2 bearing was limited, the remaining parts were substantially damaged, and no serial numbers were identifiable, the AIB finds the decision of the manufacturer to open an engineering investigation into the possible cause(s) of the increased rate of distressed no. 2 bearings across the engine fleet to be appropriate.

Remaining of no. 2 roller bearing, no. 2 bearing airseal, and no. 2 bearing nuts

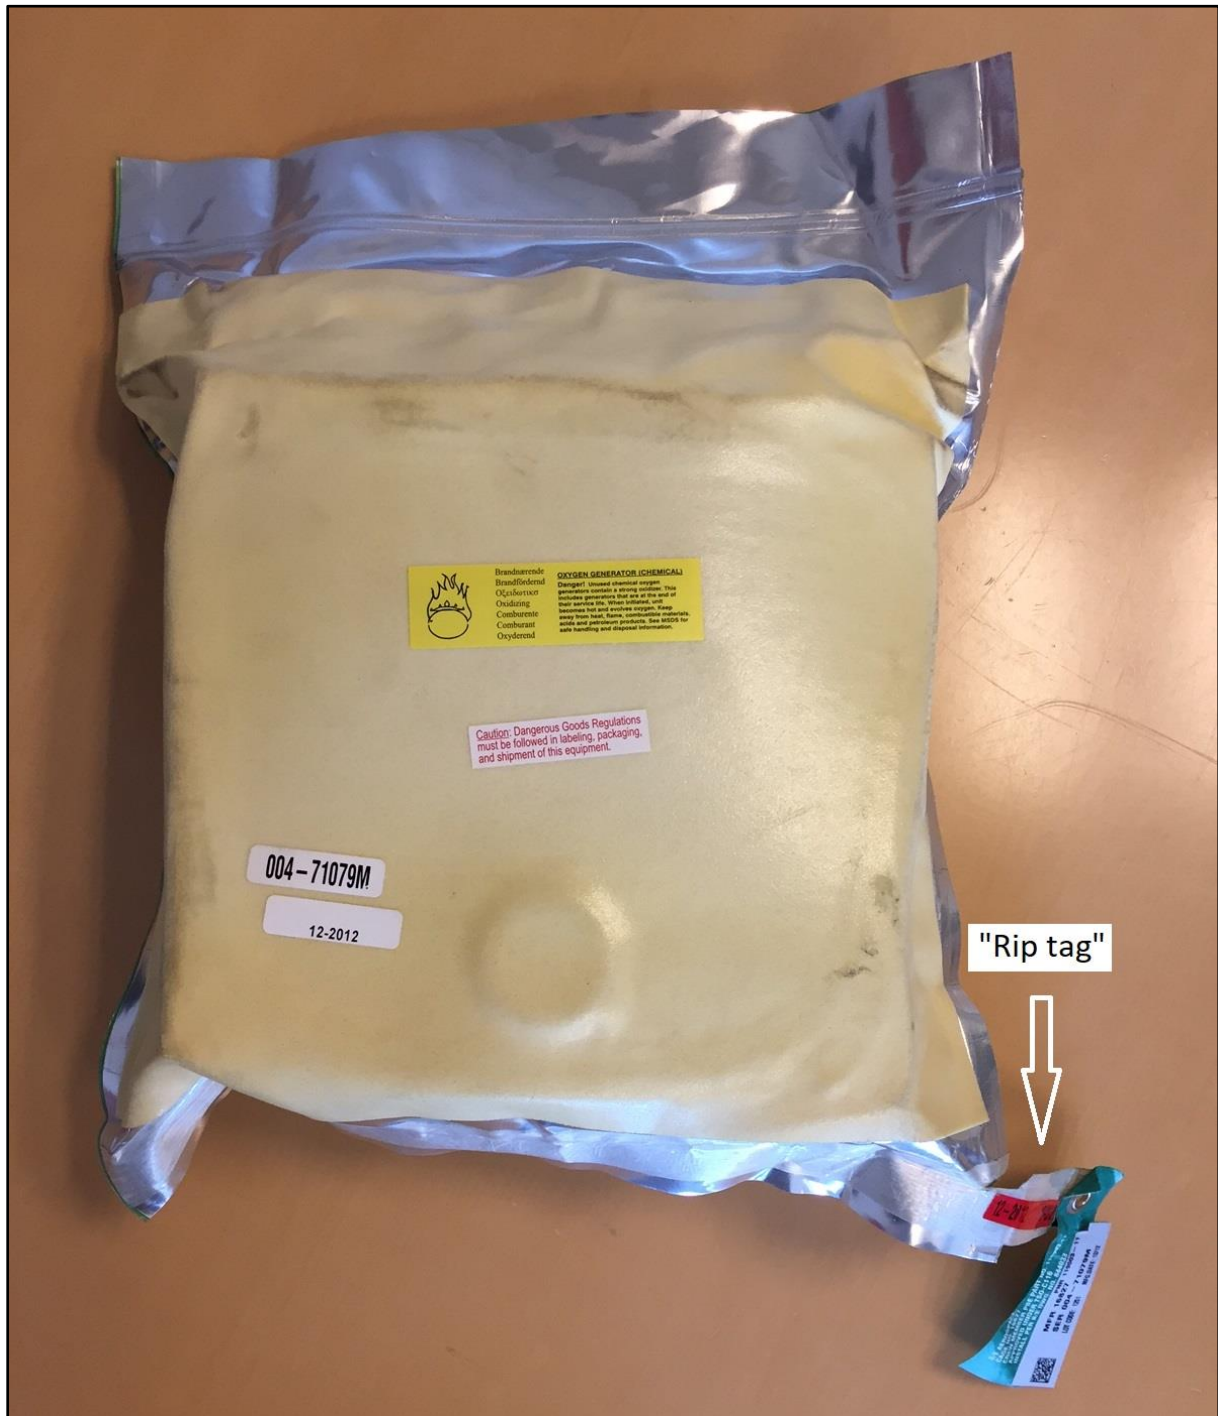
5.11 PBE with “rip tag”

Due to the presence of smoke in the cabin, the CA 1 decided to don her PBE. She tried without success to open the PBE protective bag.

1. Engine no. 1 seized approximately one minute after take-off, most likely due to the failure of the bearing no. 2.
2. The CA 1 was unable to open her PBE protective bag.

Due to this serious incident, the operator recognized the PBE opening issue and replaced all their PBE's similar to the one installed on this serious incident flight (part number 110093-11) with an updated version of the PBE (part number 110093-21).
