Laptop Battery Fire in the Cabin of an Airliner on 7 March 2017

Investigation report: L2017-01

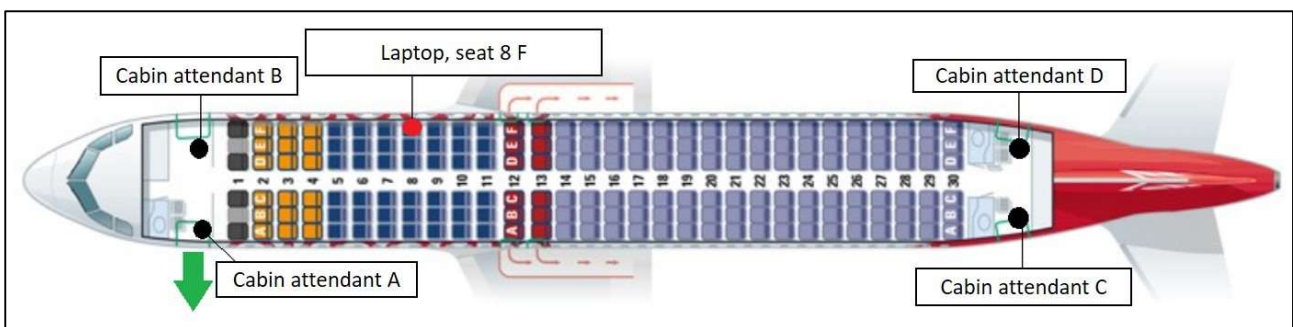
Figure 1. A typical cabin configuration for Air Berlin's Airbus A320 aircraft. The laptop was in the footwell of seat 8F, indicated with the red dot. The passengers disembarked through the front left door in the direction shown by the green arrow. (Plan view: Air Berlin)

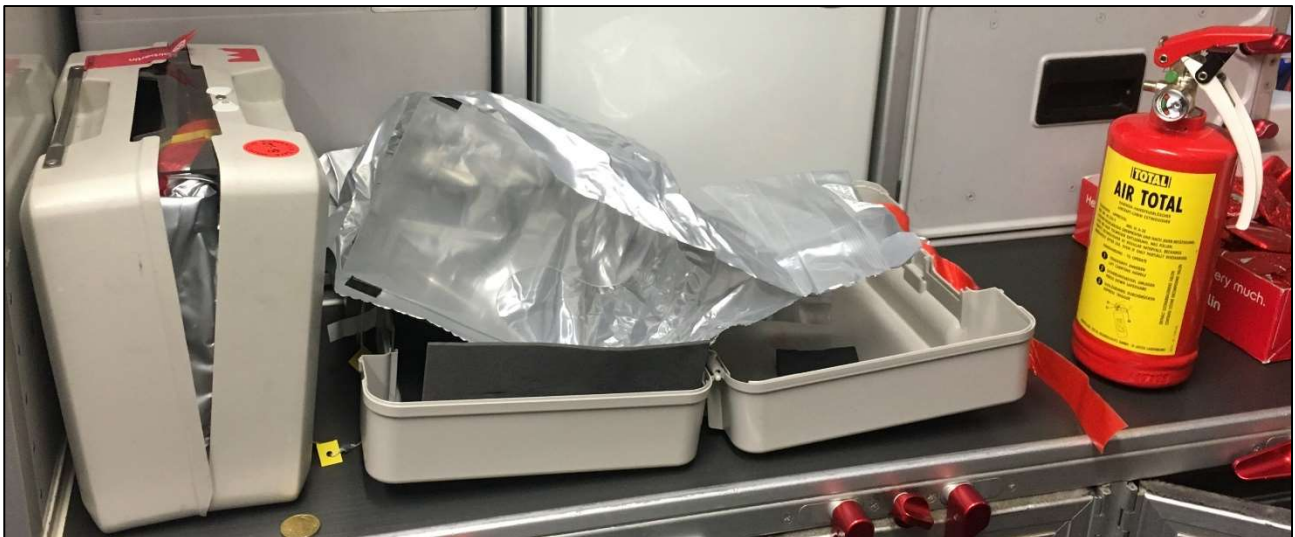
Figure 2. Smoke hood bags and containers as well as a portable fire extinguisher on the table of the aircraft's front galley (Photo: Air Berlin)

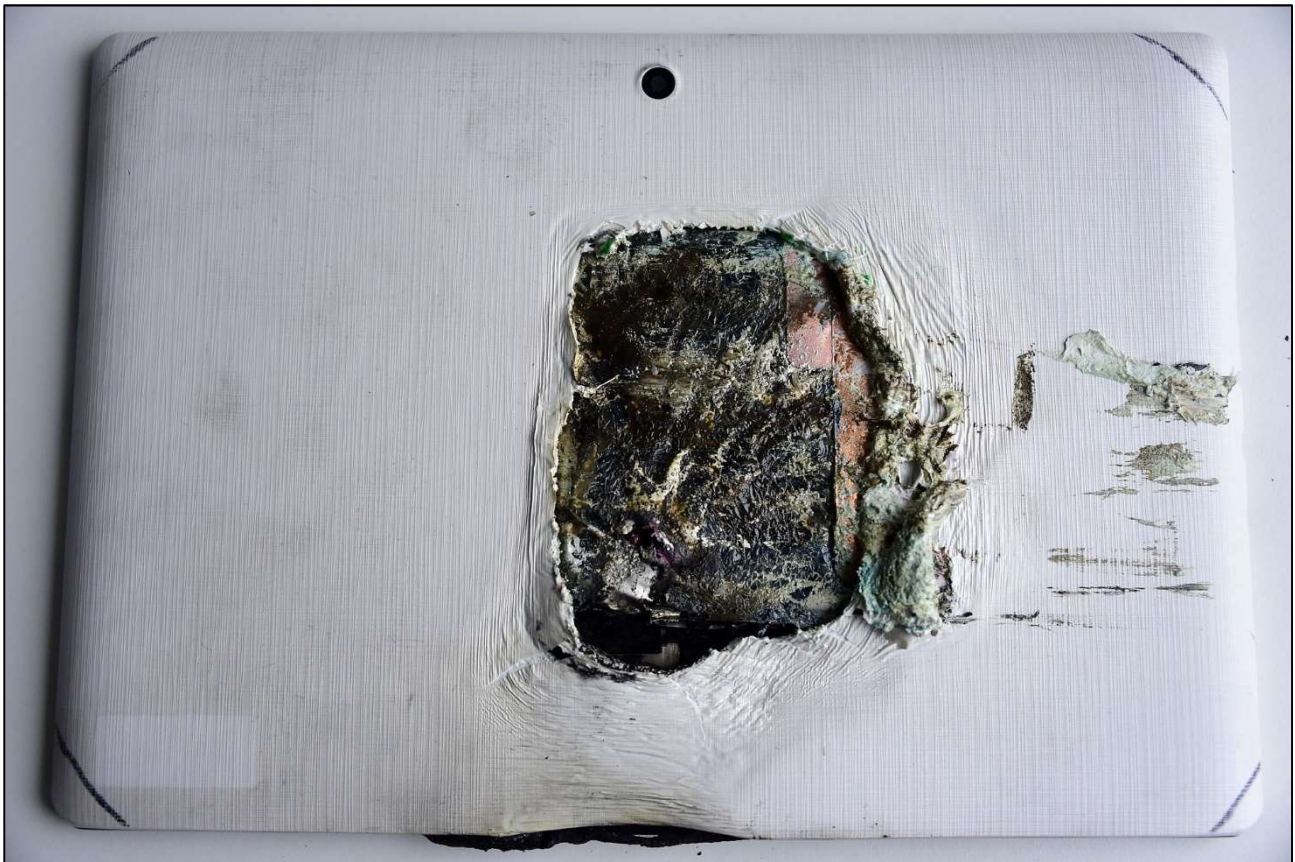
Inside the cabin the fire left a few burn marks on the lower cushion of a passenger seat as well as on the floor and the wall. The laptop, the backpack and all items in it were destroyed.

Figure 4. The back side of the laptop computer damaged by the battery fire. The dimensions of the laptop are 27 x 19 x 2 cm. (Photo: SIA)

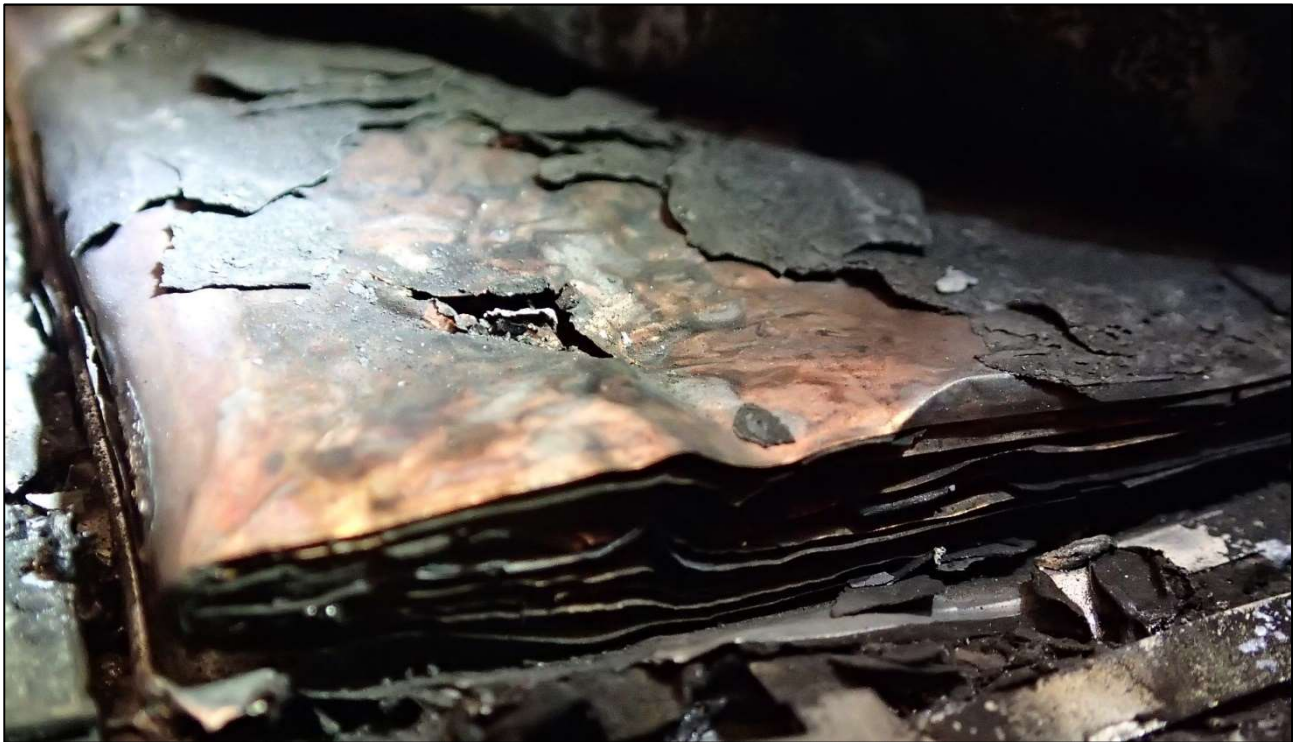
According to the manufacturer's technical information **the laptop** had a double-cell 3.5 volt (V) lithium-ion polymer (LiPo) battery with a 30 Wh¹² rating. The stated capacity of the battery was 8060 mAh¹³. The family that owned the laptop had bought two laptops approximately six months before the occurrence. Both laptops had their original CE-marked batteries. According to the owner the laptop did not heat up unusually during use. The damaged laptop was switched off for the duration of the flight. Both laptops were X-rayed at the National Bureau of Investigation (NBI) laboratory. The tests confirmed that the fire originated in the laptop battery.

According to the laptop's manufacturer no quality issues had been detected in this model's batteries. Together with the SIA's investigators, and a representative of the NBI, the battery manufacturer's representatives inspected the battery. According to the experts the laptop fire was possibly caused by external damage to the battery. While a hole was detected on the outer surface of the battery, the investigation could not confirm whether the hole had been there prior to the fire or caused as a result of it.

Figure 5. Close-up of the laptop battery's damages (Photo: SIA)

A lithium-ion battery can be forced into thermal runaway because of, among other things, an internal or external short circuit, physical damage to the battery, overcharging or exposure to high temperatures. Laptop battery fires are rare in flight but they are not altogether unheard of. While different bodies have collected information on these fires, there are no consistent global statistics. The computer had an original battery with a genuine CE marking. The fire damaged the laptop to the extent that it proved impossible to determine the ultimate cause of ignition.
