DUTCH
SAFETY BOARD

Gear collapse during landing

The Hague, May 2018.

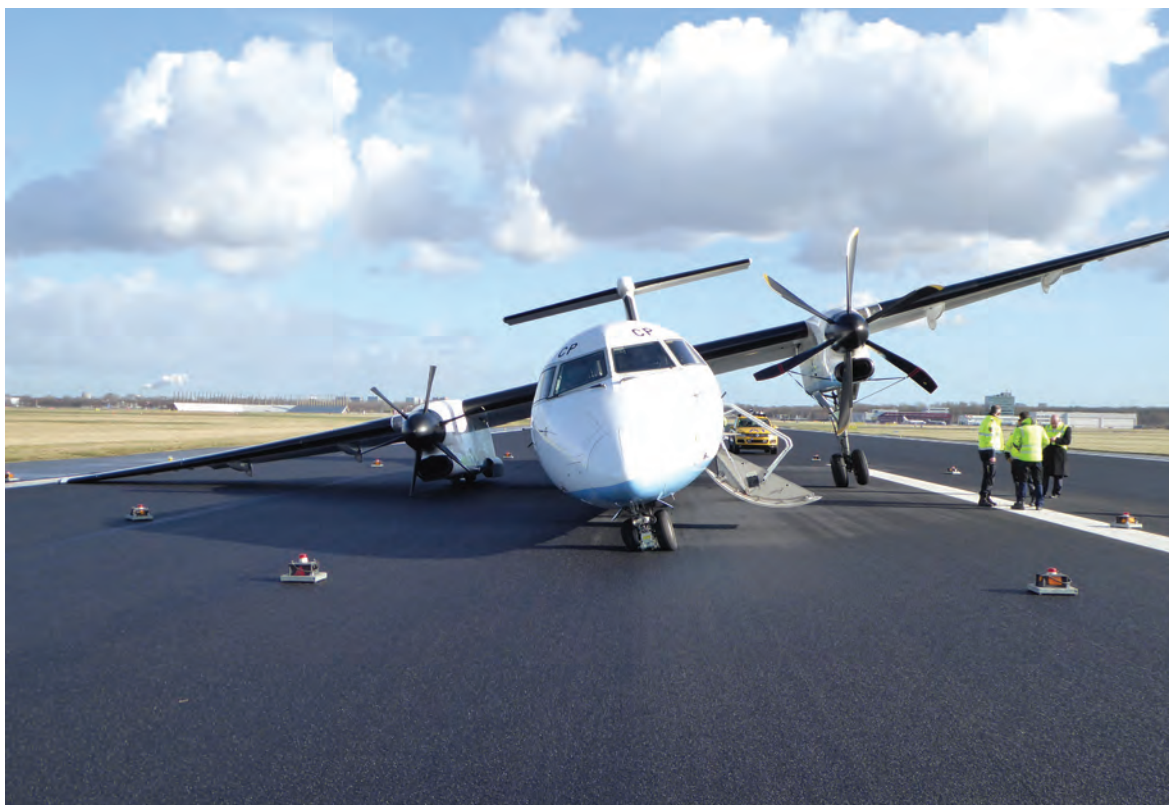
Figure 1: aircraft on runway after occurrence. (source: Dutch Safety Board)

The right-hand propeller, right-hand engine nacelle, lower fuselage, wing tip and aileron collided with the runway and the aircraft continued for several hundred meters before coming to a complete stop. This resulted in damage to the right hand propeller, the lower fuselage structure and right-hand outboard wing tip. The right-hand fuselage was also damaged due to fragments from the right-hand propeller and stone strikes. The left-hand main landing gear and nose gear remained extended.

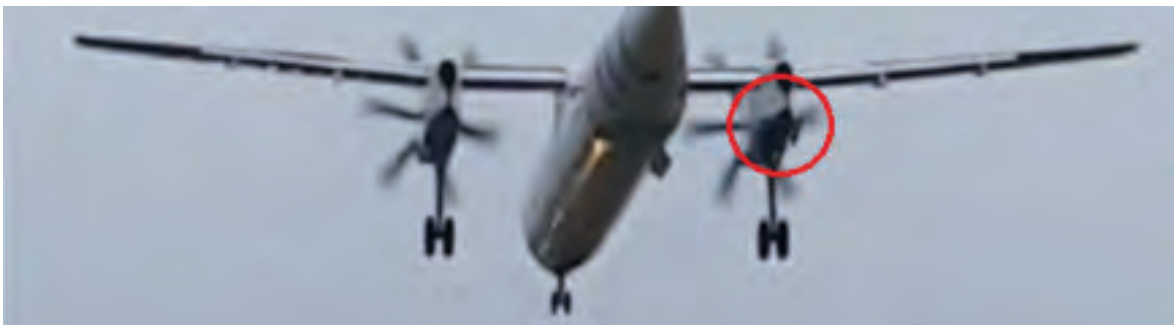
The landing of the aircraft was filmed from several different positions. One of the passengers sitting close to the RH engine and landing gear filmed the RH MLG aft doors just prior to landing, two local TV stations recorded the landing as part of two separate television documentaries on the hard winds on the day of the accident. All video evidence indicates that the right hand MLG aft doors were open at the time of the landing.

Figure 2: moment just before landing, viewed from rear, showing aft doors open on RH MLG. (still of video)

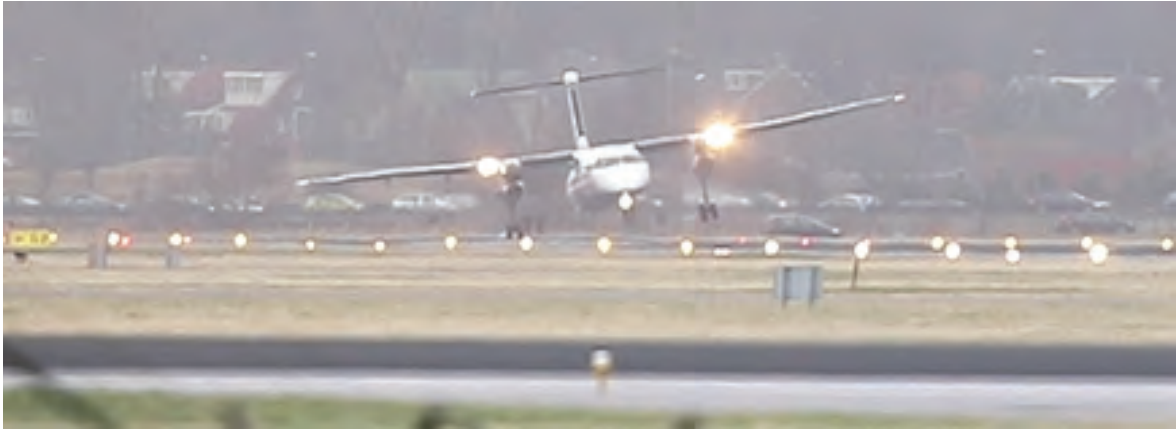
Figure 3: moment of touchdown, frontal view. (still of video)

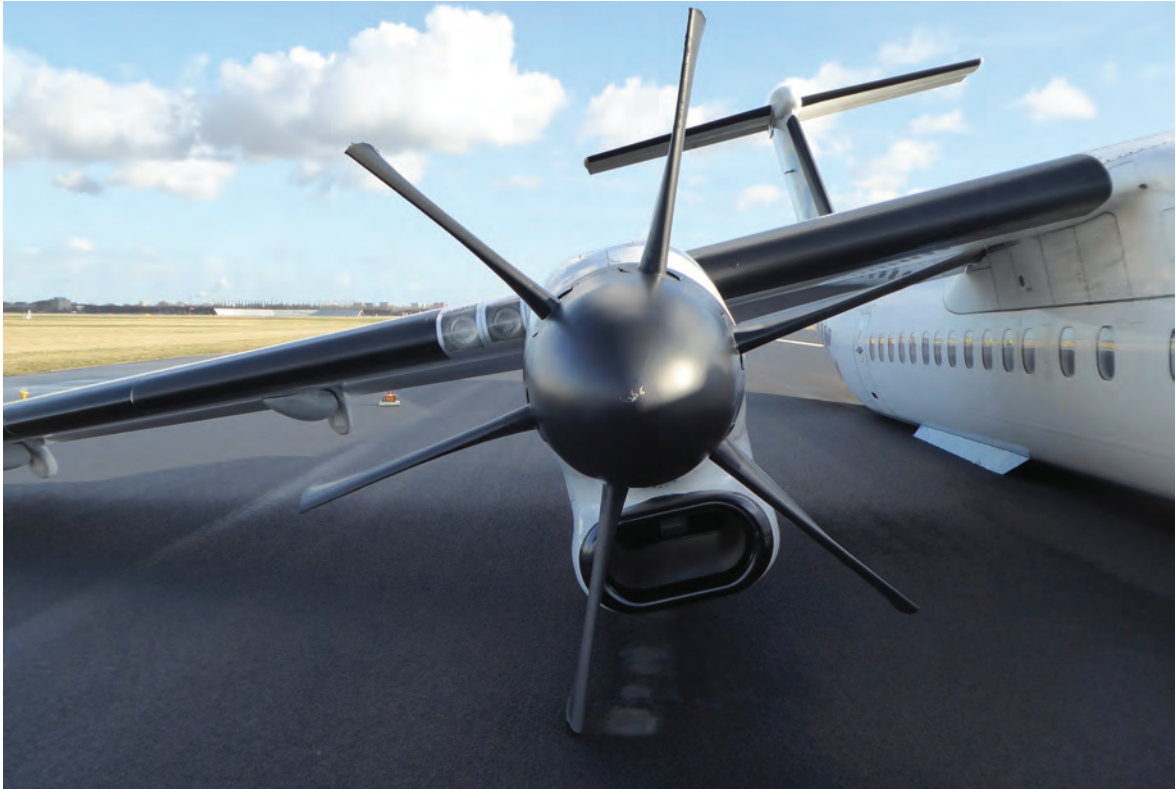
The nose landing gear right-hand tire was damaged during the incident. There were no visible signs of deformation to the nose gear, except for damage to the right-hand tire and outer wheel hub. The right-hand main landing gear was found to be partially within the nacelle.

The right-hand (number 2) engine propellers contacted the runway surface, causing all blades to be ground down to approximately half their original length. The nacelle did not make contact with the ground, except at the outboard, aft MLG door. The engine nacelle centre and aft sections were not damaged. No damage was noted on the nacelle frames.

Figure 4: right-hand nacelle and MLG after occurrence. (source: Dutch Safety Board)

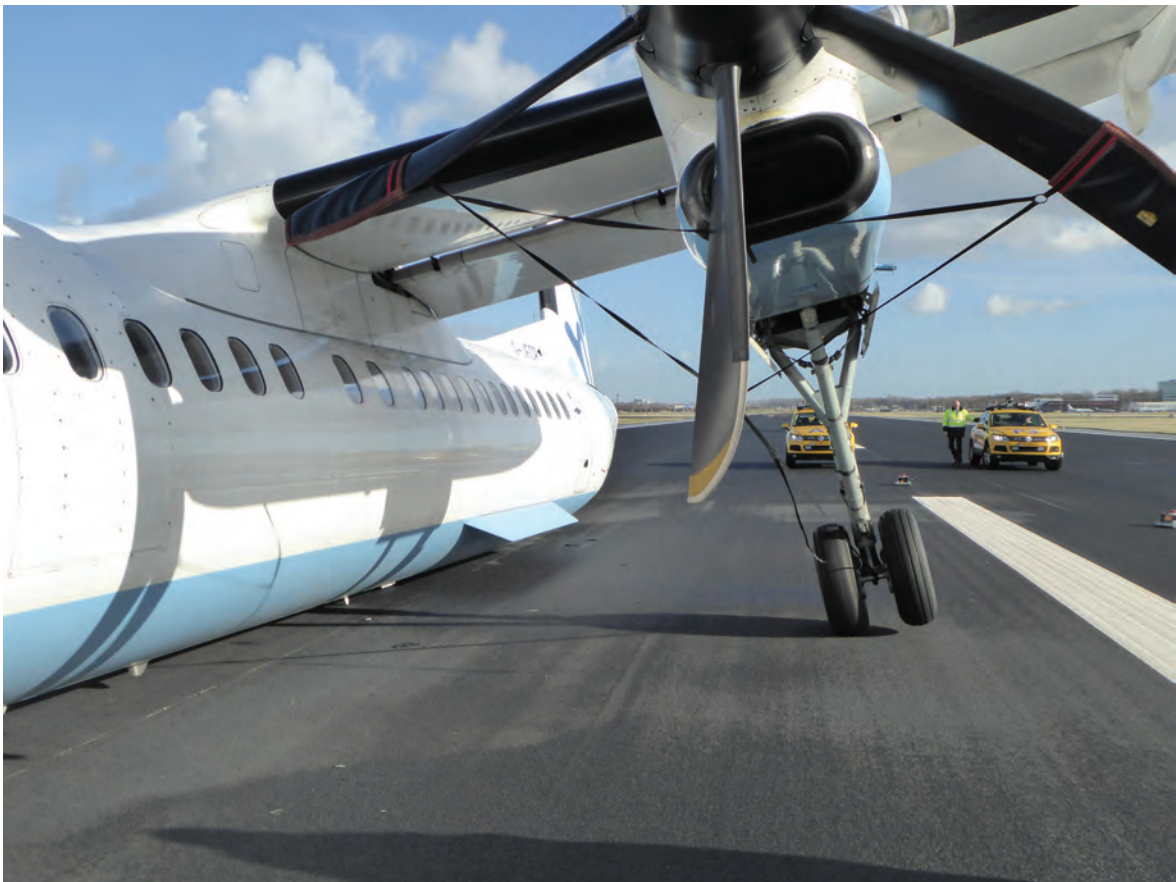
The left-hand MLG was extended and supported the weight of the aircraft at an angle. There was no visible damage to the gear attachment points.

Figure 5: left-hand nacelle and MLG after occurrence. (source: Dutch Safety Board)

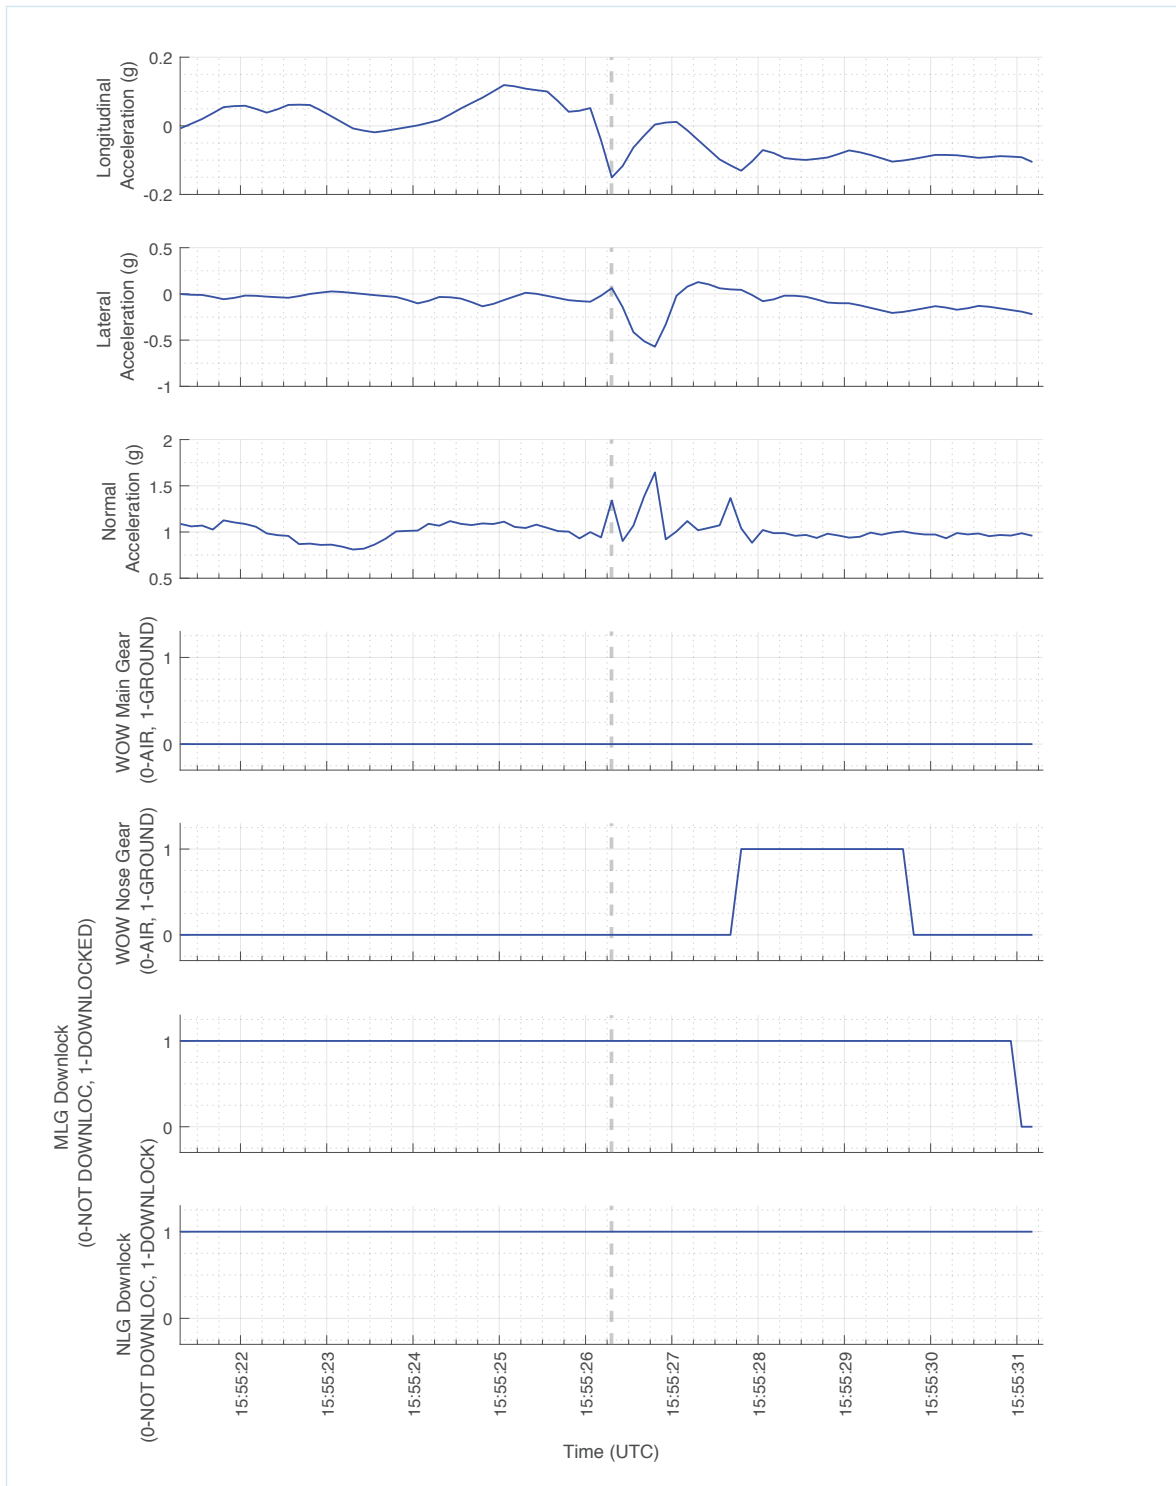
A close-up of the linear accelerations and weight on wheels (WOW) sensor information at touchdown is depicted in Figure 10. Initial point of contact with the ground occurred at approximately 15:55:26.3 UTC. At this time, a vertical acceleration of 1.367 g⁴ was measured. Shortly after this, at 15:55:26.8 UTC, a large magnitude peak of 1.66 g in normal (vertical) acceleration was observed. At the same time, a lateral acceleration of approximately -0.571 g⁵ was recorded. Consecutively, a third larger magnitude peak of 1.387 g in normal acceleration was observed at 15:55:27.7 UTC.

Figure 10: Time-history plot of the linear accelerations in the direction of the aircraft body axes, weight on wheels sensor information and the MLG and NLG down lock parameter. The dotted grey line indicates the point of initial contact with the ground ⁷.

⁷ WOW main gear indication in the graph shows no indication. WOW main gear is triggered when both MLG are on the ground and carry weight. It is expected (and collaborated in the video evidence) that when the right MLG contacted the ground and collapsed, the left side was not yet carrying weight. At no moment were both MLG on the ground and carrying enough load to activate the WOW sensors.

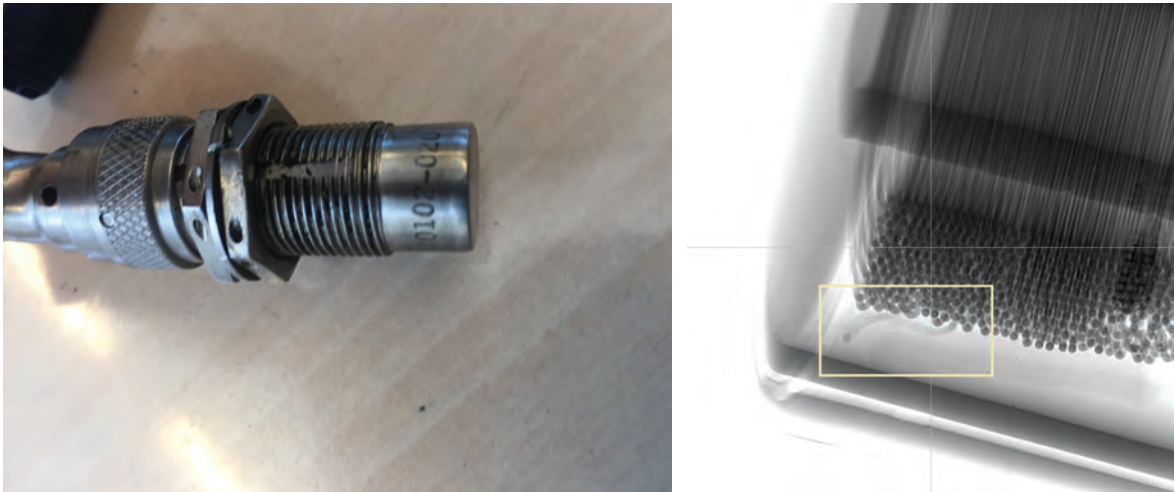
During the investigation the proximity sensors were removed from the brace and were tested separately. X-ray photography showed that one of the sensors’ wire spools showed a irregularity in the wire. When tested under room temperatures, the sensors did not show any malfunction or erratic readings. The sensors were then exposed to sub-zero temperatures and slowly warmed up to room temperature, comparative to the situation the aircraft was in coming down from altitude during the approach, when temperatures changed from -19° C to +8° C.

Figure 18: proximity sensor, and x-ray of sensor showing irregularity in loom.

During testing, one of the sensors showed indications out of the normal spectrum. This is in line with the PSEU fault readings initiated during the approach. The fault most likely caused the doors to remain open and the down lock actuator not activated after the MLG was fully down during the approach. This is in line with the PSEU logic described earlier.

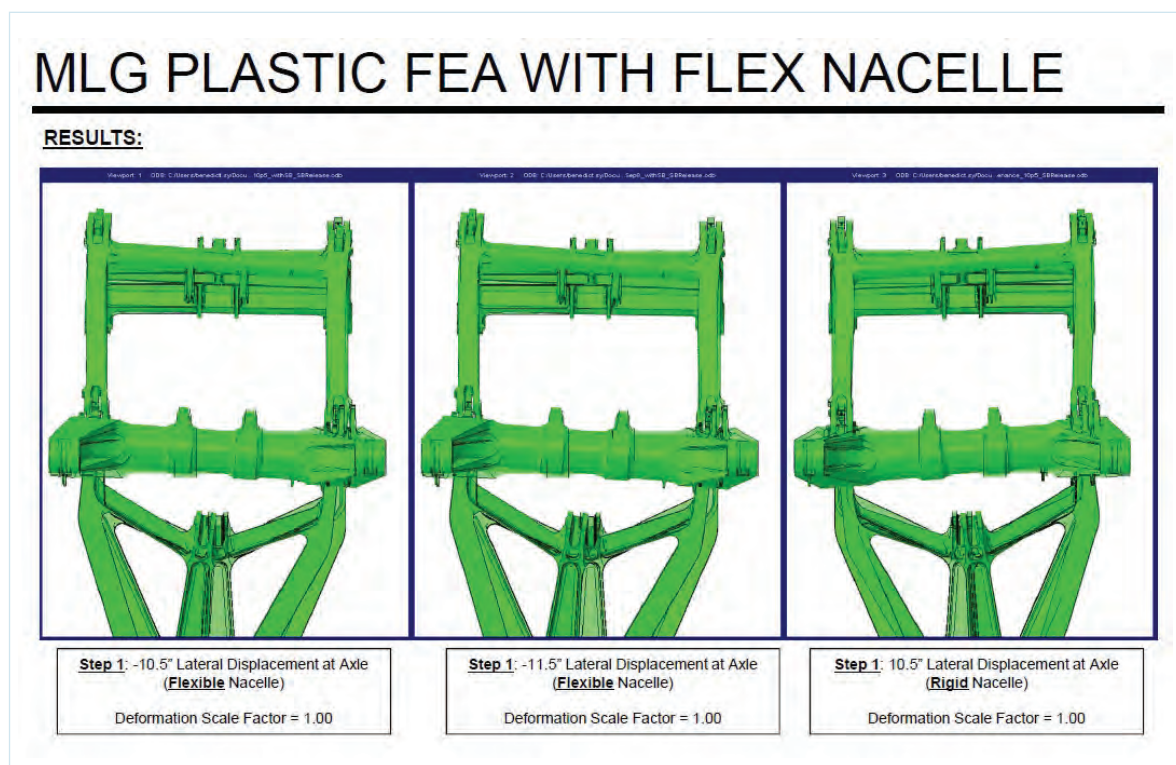
Figure 19: results of plastic deformation analyses. (source: landing gear manufacturer)

Further testing predicted that if a stabilizer brace assembly was installed at the time the yoke was deformed to the extent it was observed, the aft stabilizer brace should also have suffered permanent deformation. From the graph shown above, the aft stabilizer brace would have experienced permanent plastic strain even at relatively low lateral displacements. No permanent deformation was found in the aft stabilizer brace of the accident aircraft. If the aft stabilizer brace would have been deformed, it could not have been installed properly in the fixture as shown above. From the statements from the maintenance crew, there was no issue installing the brace assembly in the fixture. It is therefore highly unlikely that the aft stabilizer brace assembly from the accident was installed when the deformation of the yoke occurred.

Analyses predicts that if a stabilizer brace assembly was installed at the time the yoke was deformed to the extent it was observed, the yoke attachment lugs for the aft stabilizer brace should also have suffered permanent deformation. No deformation was found on the lugs for the aft brace on the accident yoke. It is therefore highly unlikely that ANY stabilizer brace assembly was installed when the deformation of the yoke occurred. This leads to the conclusion that the deformation of the yoke took place when the aircraft was not in a flying condition.

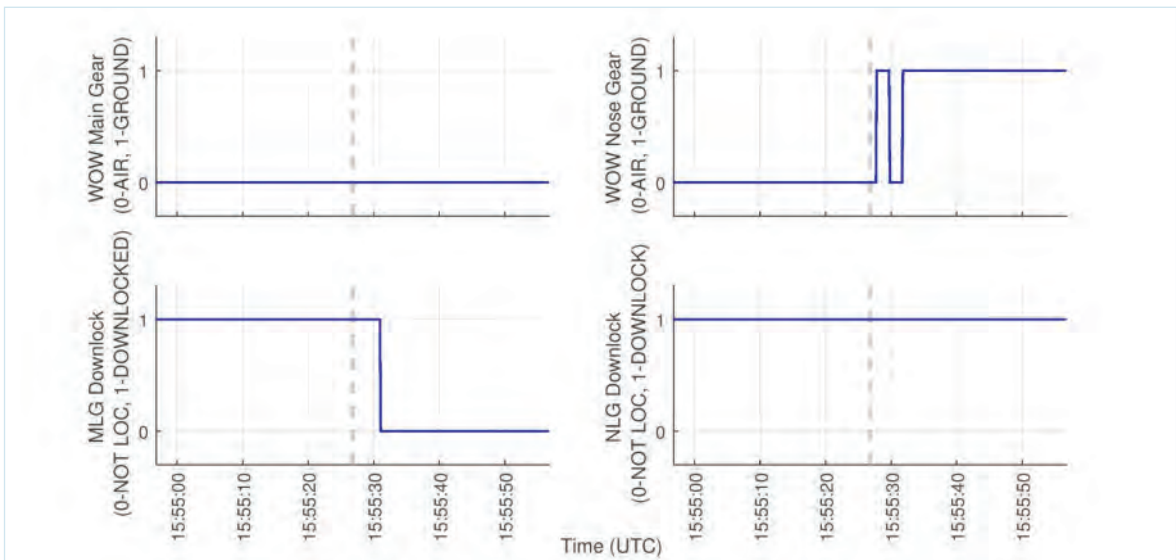
Considering the WOW sensor signal and MLG and NLG down-lock sensor signals in Figure 22, it was observed that the MLG WOW sensor unit indicated AIR during the complete approach and landing. The MLG WOW sensor unit is composed of two sensors. If one of the sensors indicates AIR, the MLG WOW parameter will indicate AIR. It is not possible to derive the AIR/GROUND state of each of the sensors separately. In contrast to the MLG, the NLG WOW sensor switched to GROUND at 15:55:29 UTC, switched back to AIR until 15:55:31 UTC and finally remained at GROUND. The MLG down lock parameter indicated DOWNLOCKED up to approximately 4 seconds after initial ground contact. After that, the parameter switch to NOT DOWNLOCKED. The NLG down-lock parameter indicated DOWNLOCKED during the whole landing run. WOW sensor parameters are sampled at a frequency of 1 Hz, down-lock sensor values are sampled at 0.25 Hz.

Figure 22: Time-history plot of weight on wheels sensors and gear downlock parameters as obtained from the decoded FDR data.
