National Transportation Safety Board

Aviation Accident Final Report

Location:	Fort Lauderdale, FL	Accident Number:	DCA17MA022
Date & Time:	10/28/2016, 1751 EDT	Registration:	N370FE
Aircraft:	MCDONNELL DOUGLAS MD 10-10F	Aircraft Damage:	Substantial
Defining Event:	Landing gear collapse	Injuries:	2 None
Flight Conducted Under:	Part 121: Air Carrier - Non-scheduled

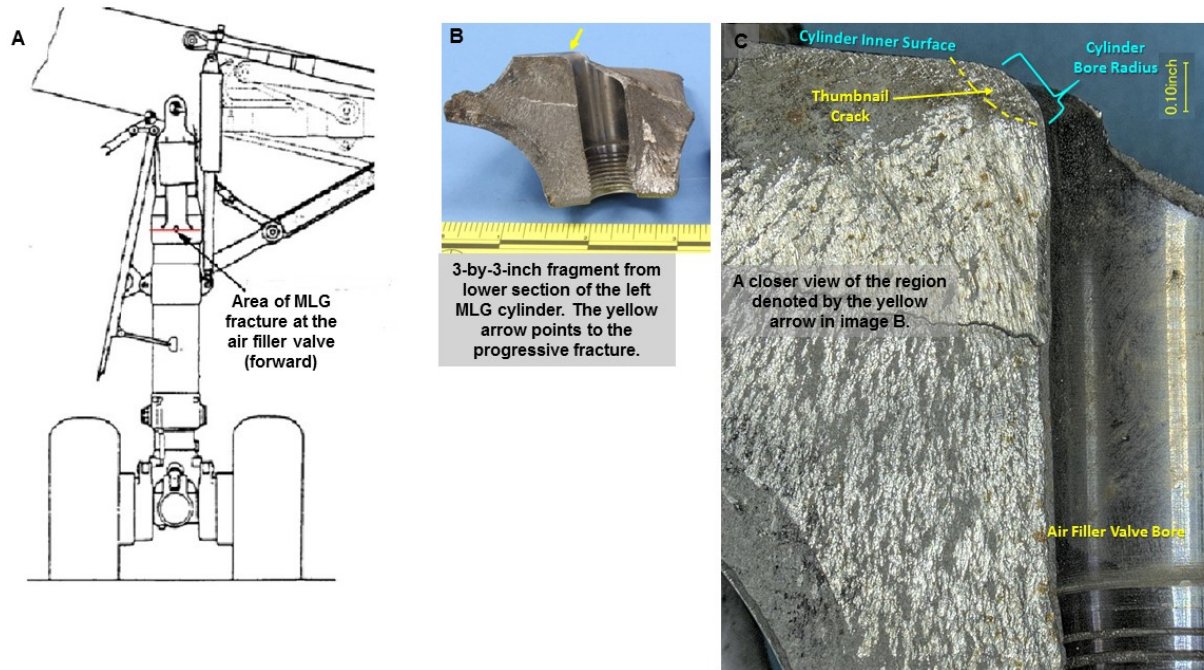
Metallurgical examination of a 3-by-3-inch fragment of the left MLG cylinder (see images B and C in figure 1) and the mating fracture region on the largest piece of the fractured left MLG (see figure 2) found indications consistent with overstress fracture having emanated from the air filler valve bore. The overstress features emanated from a small thumbnail crack, located at the radius between the cylinder inner diameter surface and the air filler valve bore surface. This thumbnail crack was observed on both mating fracture surfaces of the MLG and the 3-by-3-inch fragment, and it exhibited features (such as crack arrest marks) consistent with a pre-existing crack that progressed to fracture of the MLG. The observed features in the initiation region of the thumbnail crack were found to be consistent with fatigue cracking, as exhibited by the fatigue striations observed during microscopic examination. Later propagation regions of the thumbnail crack revealed features consistent with mixed mode fatigue, overstress, and

intergranular fracture. These findings confirmed that once the crack progressed to a critical length, the left MLG cylinder fractured in overstress due to the loads imposed during landing.

Figure 1. A diagram of an MD-10-10F left MLG (A), photograph of the 3-by-3-inch fragment from the lower section of the accident left MLG cylinder (B), and closer view of the region pointed out in image B (C).

The left MLG cylinder and fragments found on the runway were examined at the NTSB Materials Laboratory. A small thumbnail crack was observed on the 3-by-3-inch fragment at the radius between the cylinder inner diameter surface and the valve bore surface that was consistent with a pre-existing crack before the complete fracture of the MLG. Most of the fracture surface area had been damaged by smearing, consistent with post-fracture impact

damage. Surface contamination, such as rust and dirt, were also present. A small area next to the radius exhibited features (such as crack arrest marks) consistent with progressive crack growth. The progressive crack growth was found to be fatigue cracking, as exhibited by the fatigue striations found on microscopic examination of the thumbnail crack.

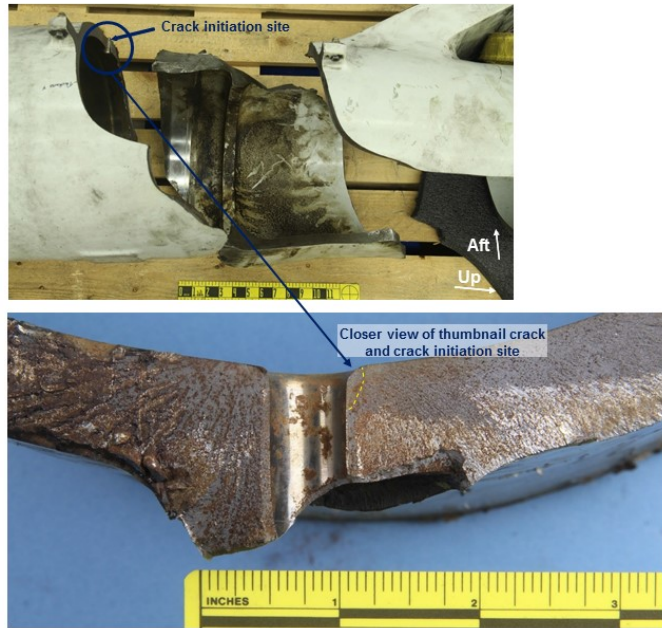
Figure 2. Photographs of largest piece of fractured left MLG pointing to the crack initiation site (top) and a closer view of the crack initiation site, with a yellow dashed line highlighting the mating thumbnail crack (bottom).

The most prominent quality of the crack initiation site was a feature consistent with a corrosion pit. No indications of nickel, chrome, or cadmium plating were found at the radius or along the smooth sections of the air filler valve bore, as stipulated by maintenance instructions. The absence of a protective coating, over time, could lead to corrosion pitting. Any corrosion pitting or mechanical damage to the protective coating incurred during maintenance can lead to fatigue cracking.

Metallurgical examination of the main fracture region of the left MLG cylinder found almost all of the fracture surfaces exhibited a dull luster with a rough surface, with radial lines and chevron marks. These features were consistent with overstress fracture in low ductility (hardened) metal alloys and having emanated from the air filler valve bore on the MLG. A flat, thumbnail-shaped crack observed at the bore location corresponded with the mating crack face on the 3-by-3-inch fragment.

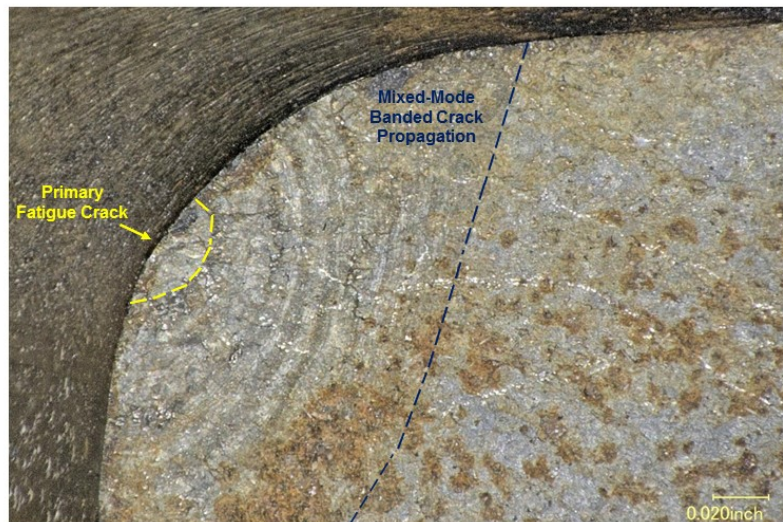
Figure 3. Closer view of the primary fatigue crack region (highlighted by the dashed yellow line) and the region of mixed-mode crack propagation (highlighted by the dashed blue line).

The examination also found that the thumbnail crack was not exclusively consistent with fatigue crack propagation, but rather contained bands of other failure modes. After the initial fatigue cracking from the crack initiation site, an intergranular fracture band surrounded the first 0.02 inch of fatigue, followed by a band of fatigue striations. After this, three overstress bands (exhibiting dimple rupture features) alternating with fatigue were observed, followed by a final mixed fatigue and overstress band (see Fatigue Analysis later in this section for more information). The distance from the fatigue crack to the intergranular region measured 0.019 inch. The measured width of the intergranular band was 0.013 inch.

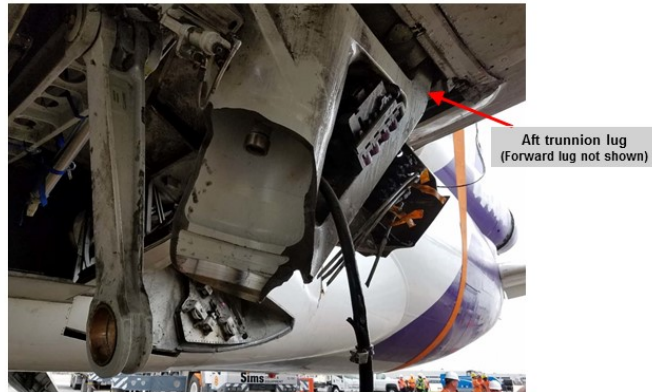
The airplane came to rest off the left side of runway 10L near the A4 taxiway. The outer cylinder of the left MLG was fractured midway through the air filler valve bore on the aft side. The outer cylinder of the left MLG shock strut fractured around its entire circumference; the upper portion of the cylinder remained intact and attached to the airplane at the forward and aft trunnion lugs (figure 1 shows a diagram of an MD-10-10F MLG and figure 2 shows the upper portion of the accident MLG). No anomalies were noted with the trunnion lugs or trunnion bolt attachment points.

Figure 2. Upper portion of the left MLG attached to the airplane.

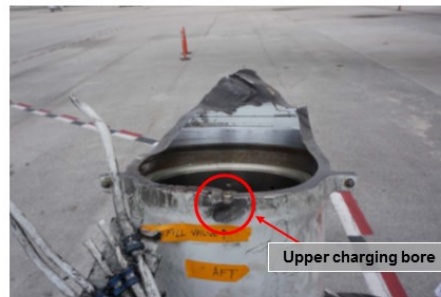
The inboard side lugs and bolt and nut for the retract actuator attach points and the fixed door attach points remained intact. On the aft side of the lower section of the fractured gear, about half of the upper charging bore was visible (see figure 3). On-scene examination identified features consistent with fatigue on the fracture surface of the outer cylinder in the area of the air filler valve bore (see Tests and Research for more information).

Figure 3. Aft side of the lower section of the left MLG cylinder and fill valve.

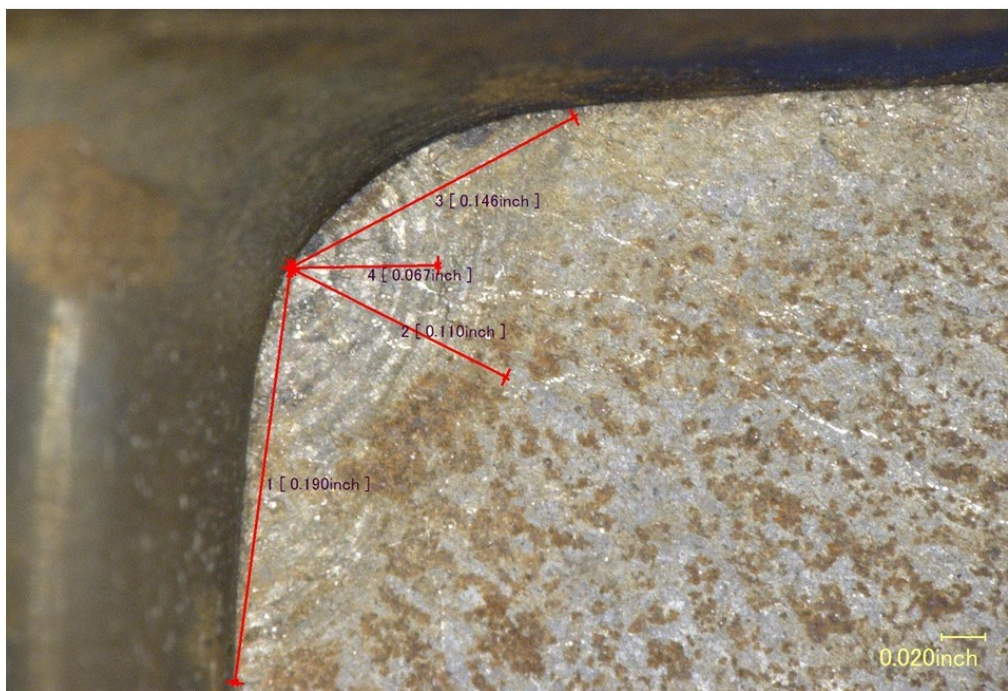
The estimated total number of cycles for each band are summarized below (figure 4 shows a closeup view of the fatigue striation region); the number in parentheses represents the total striation quantity summation to that point:

- Striation count in 1st fatigue thumbnail (origin to intergranular band): 526
- Striation count in 1st fatigue thumbnail (intergranular band to overstress band 1): 165 (691 total to this point)
- Striation count before overstress band 1: 691
- Striation count in 2nd band: 253 (944)
- Striation count in 3rd band: 242 (1186)
- Striation count in 4th band: 218 (1404)

Figure 4. A closeup view of the fatigue striation region.
