KNKT.14.12.29.04

Aircraft Accident Investigation Report

PT. Indonesia Air Asia
Airbus A320-216; PK-AXC
Karimata Strait
Coordinate 3°37'19"S - 109°42'41"E
Republic of Indonesia
28 December 2014

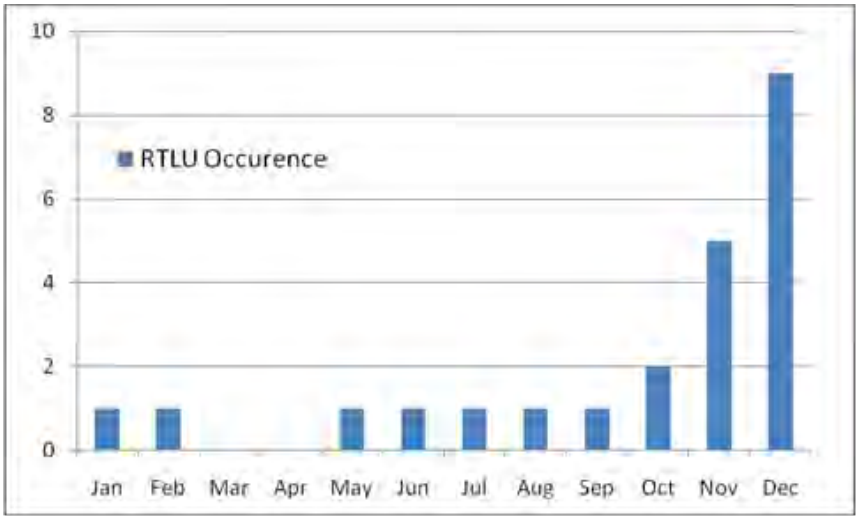
Figure 7: Numbers of the RTLU Occurrences in 2014

The numbers RTLU occurrences as per PK-AXC 1 Year Maintenance Report were summarized in the following graph.

The workaround solution of the maintenance staff on the RTLU problems were mostly by resetting computer by either resetting the FAC push button and followed by AFS test or pulling the associated CBs and the rectification was performed according to the A320 TSM.

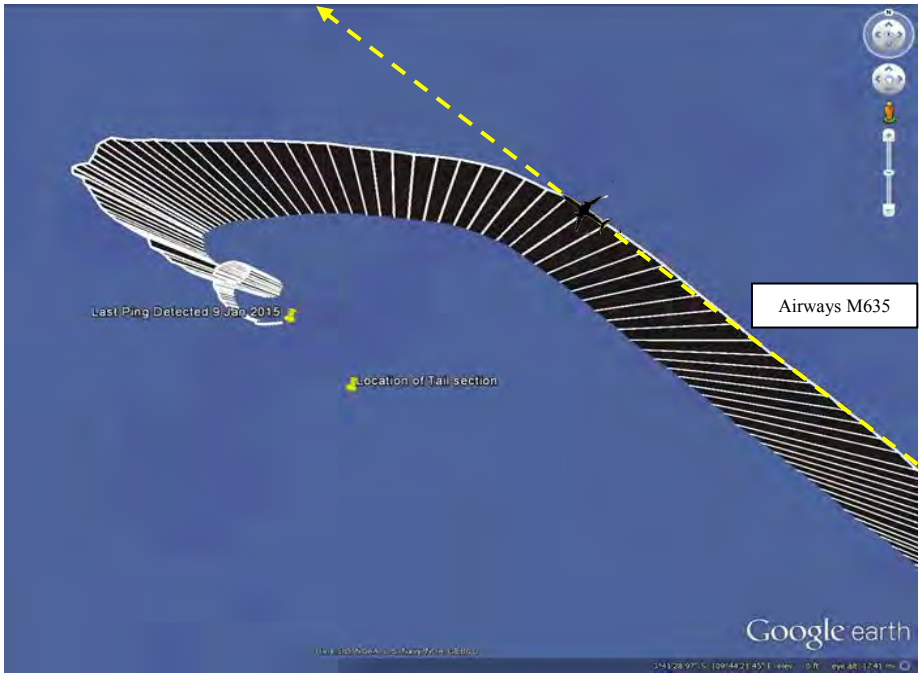
Figure 19: Flight path based on FDR data superimposed to the Google Earth

Subsequently the aircraft entered a steep turn and climb, eventually reaching high angle of attack, the stall warning activated and continued until the end of the recording. The FDR and CVR recording ended at 2320:35 UTC.

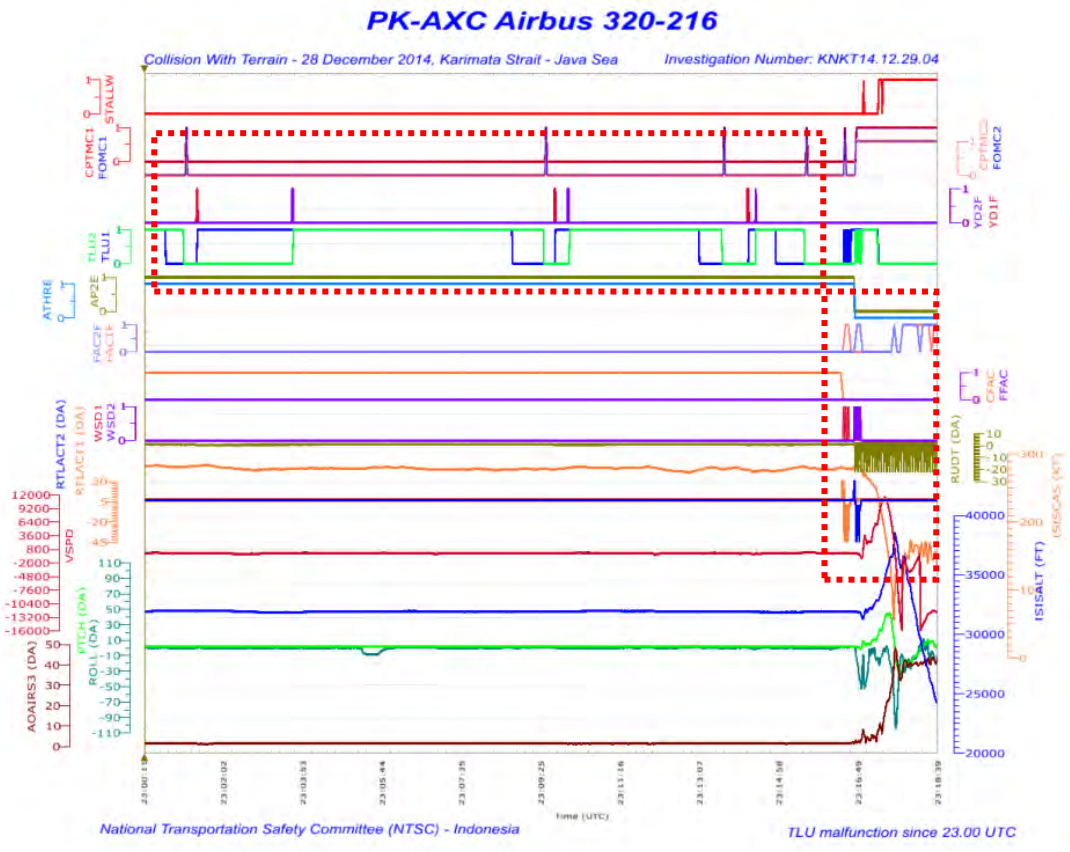
Figure 20: RTLU problems and pilot actions

The red box with the dash line on the graph shows:

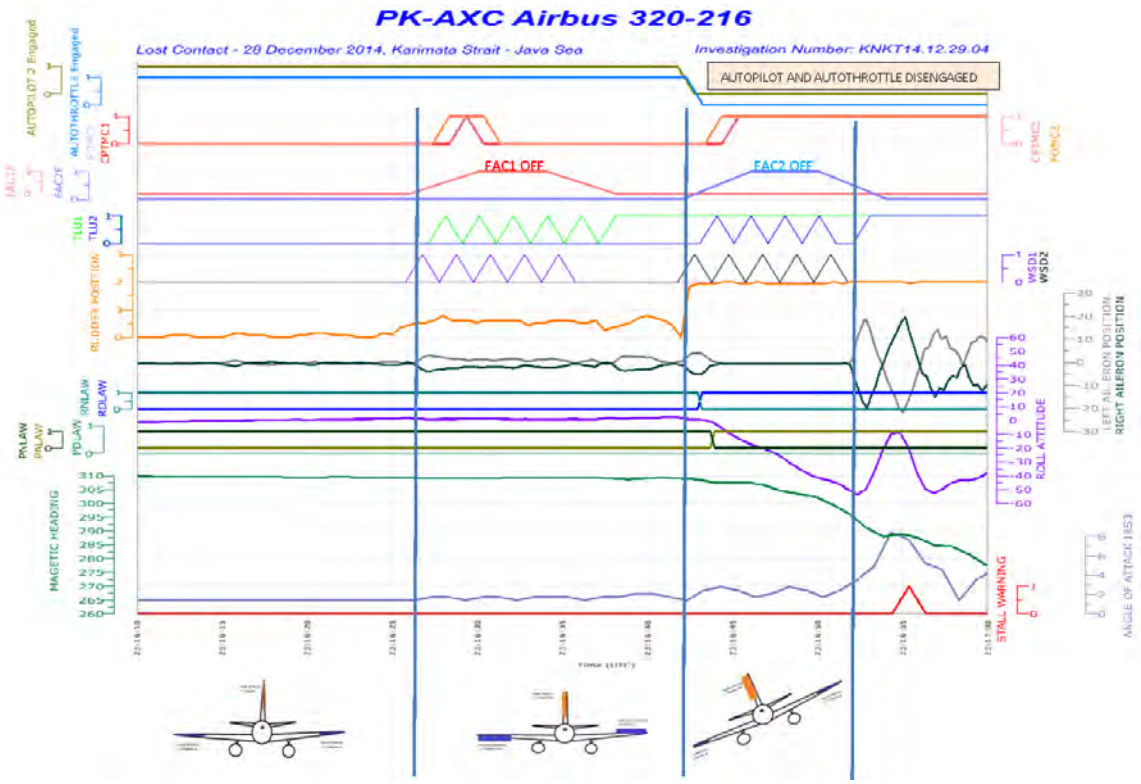
Figure 21: FDR parameters after the fifth Master Caution

The fifth Master Caution at 2316:28 UTC was triggered by FAC 1 FAULT.

- Flight control law reverted from Normal Law to Alternate Law
    - Rudder deflected 2° and aileron deflection 0°.
- The aircraft started to roll.
- At 2316:54 UTC the FAC 2 was back to ON and all fluctuating parameters stopped. The autopilot and auto thrust remained disengaged. Flight control law remained in Alternate Law.

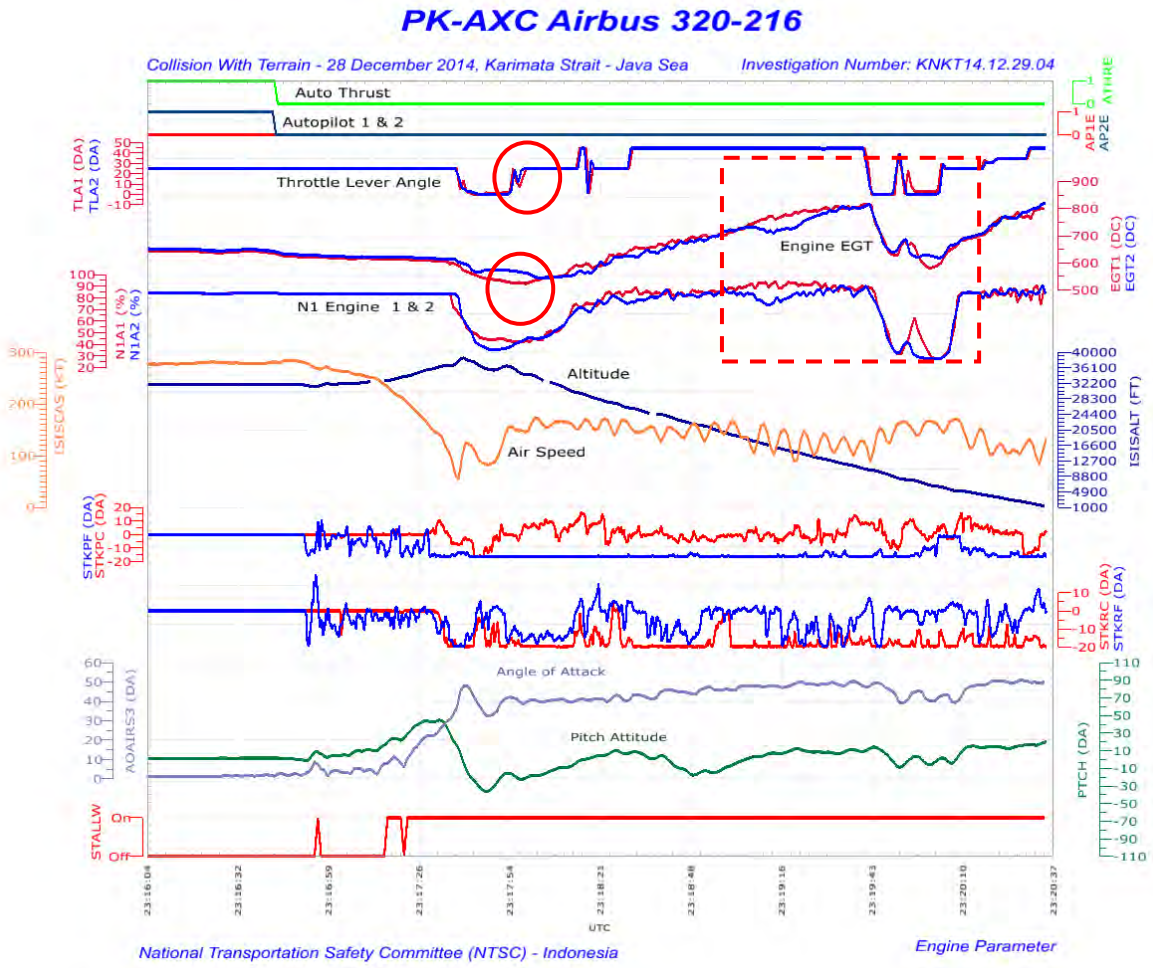
Figure 23: Thrust levers and side-sticks movement

- At 2317:41 UTC the aircraft reached the highest altitude of 38,500 feet (ISIS) and largest roll angle at 104° to the left. The aircraft then descended with a rate up to 20,000 feet per minute momentarily afterward the rate of descent was recorded at average of 12,000 feet per minute until the end of recording.

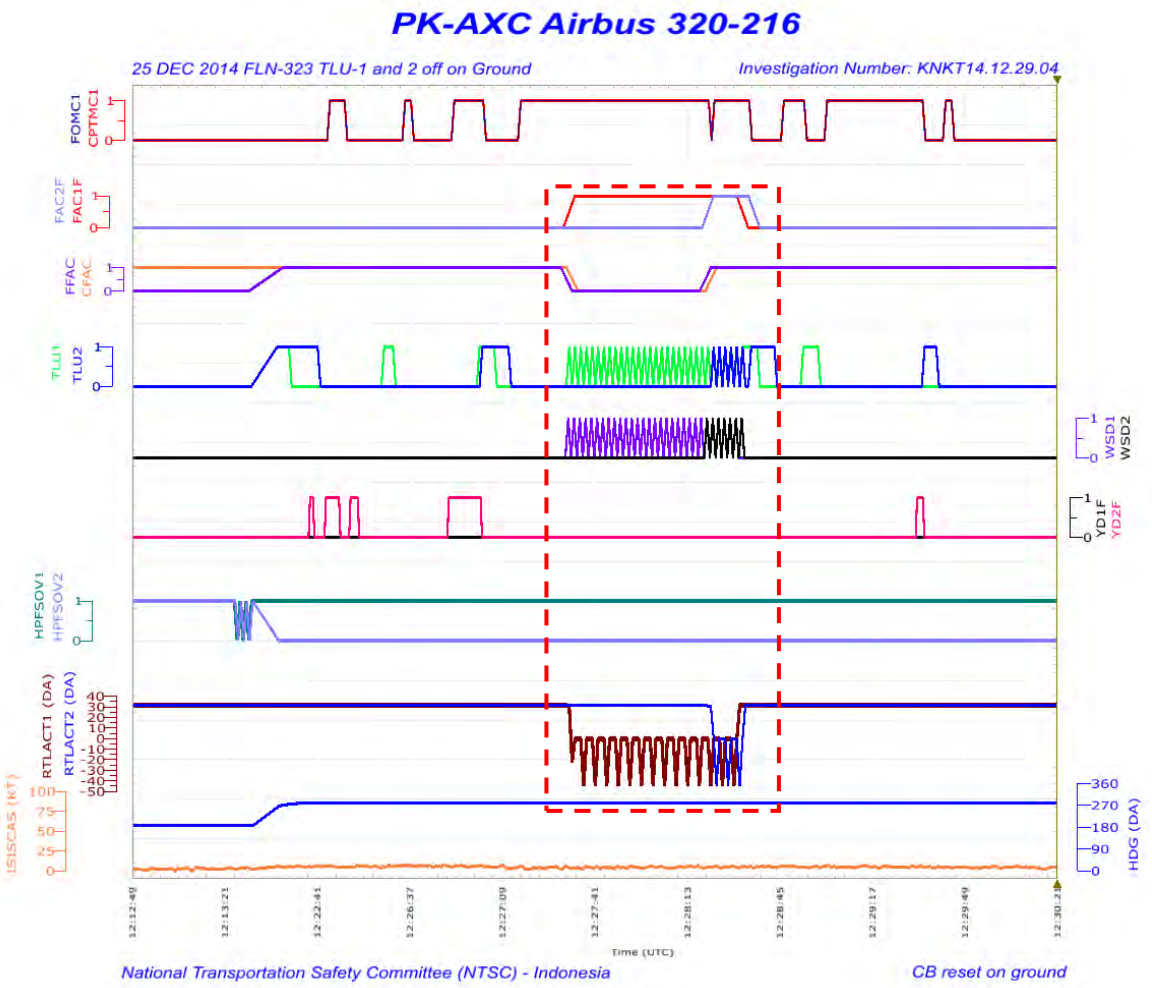
Figure 24: The FDR parameters of FAC fault followed by CB reset on the ground at 25 December 2014

The graph of the FDR data shown in figure above was the event where the FAC CBs were reset by the maintenance crew while the aircraft was on the ground on 25 December 2014. The red dash lined square shows the FAC OFF, and parameters of component controlled by FAC such as the Rudder Travel Limiter Unit (RTLU), Windshear Detection (WD) and Rudder Travel Actuator (RTLACT) fluctuated, affected by the FAC CB resetting.

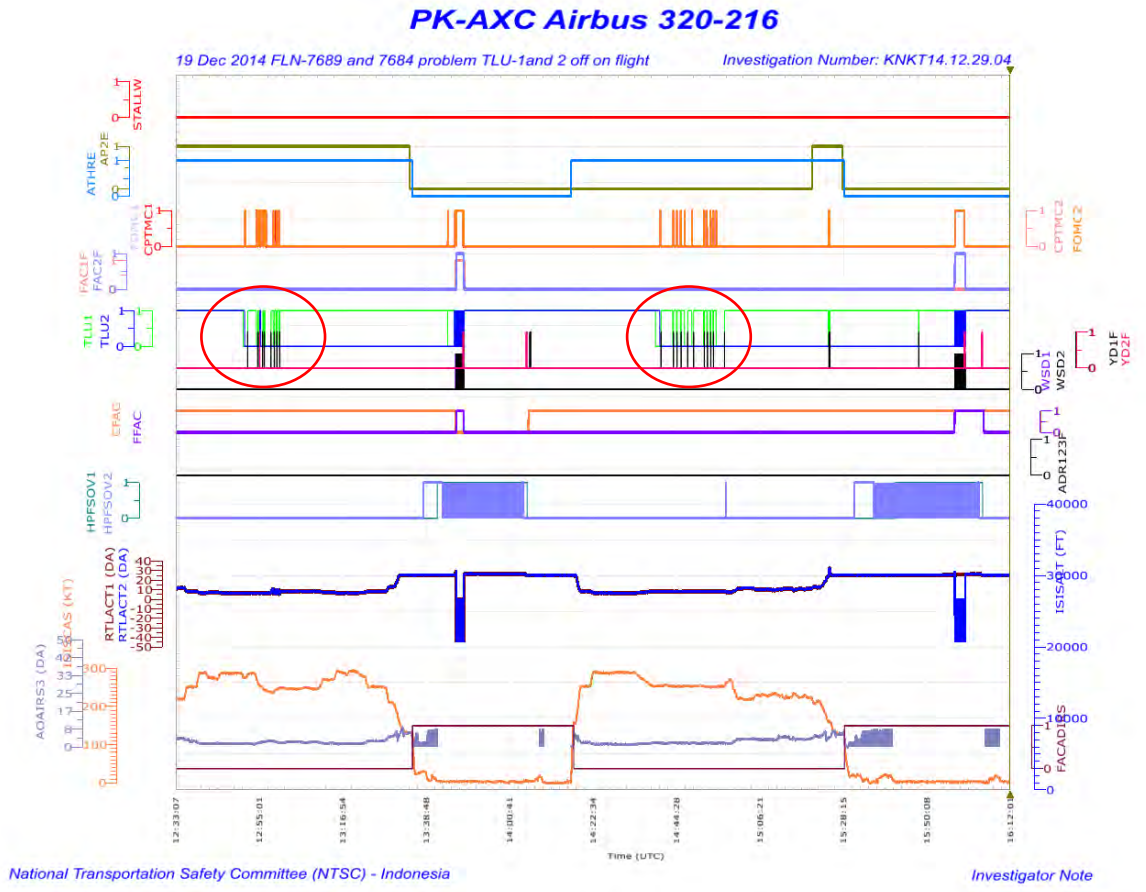
The FDR contained data of the last 74 flights including the accident flight. The failure of the RTL unit and FAC recorded on the FDR were as follows:

6.	24 Dec 2014	323	53	RTLU-1 Off	RTLU1 fault during climb not reset for entire flight
7.	27 Dec 2014	7683	70	RTLU-1 Off	RTLU1 fault in descent RTLU2 fault and master caution during taxi in

On the 19 December 2014, PK-AXC operated flights QZ7684, from Jakarta (Soekarno-Hatta) Airport to Surabaya Airport, and QZ7689 from Surabaya Airport to Jakarta (Soekarno-Hatta) Airport. During these two flights the RTLU system faulted twenty two times resulting in a master caution alert. Each RTLU fault was satisfactorily resolved by the crew using the ECAM FAC reset procedure.

Although the fault occurred multiple times, it did not follow any regular pattern or phase of flight. During flight QZ7684 the RTLU faults occurred during climb and initial cruise. However, during flight QZ7689 the faults occurred during cruise and descent, including two faults during the landing approach.

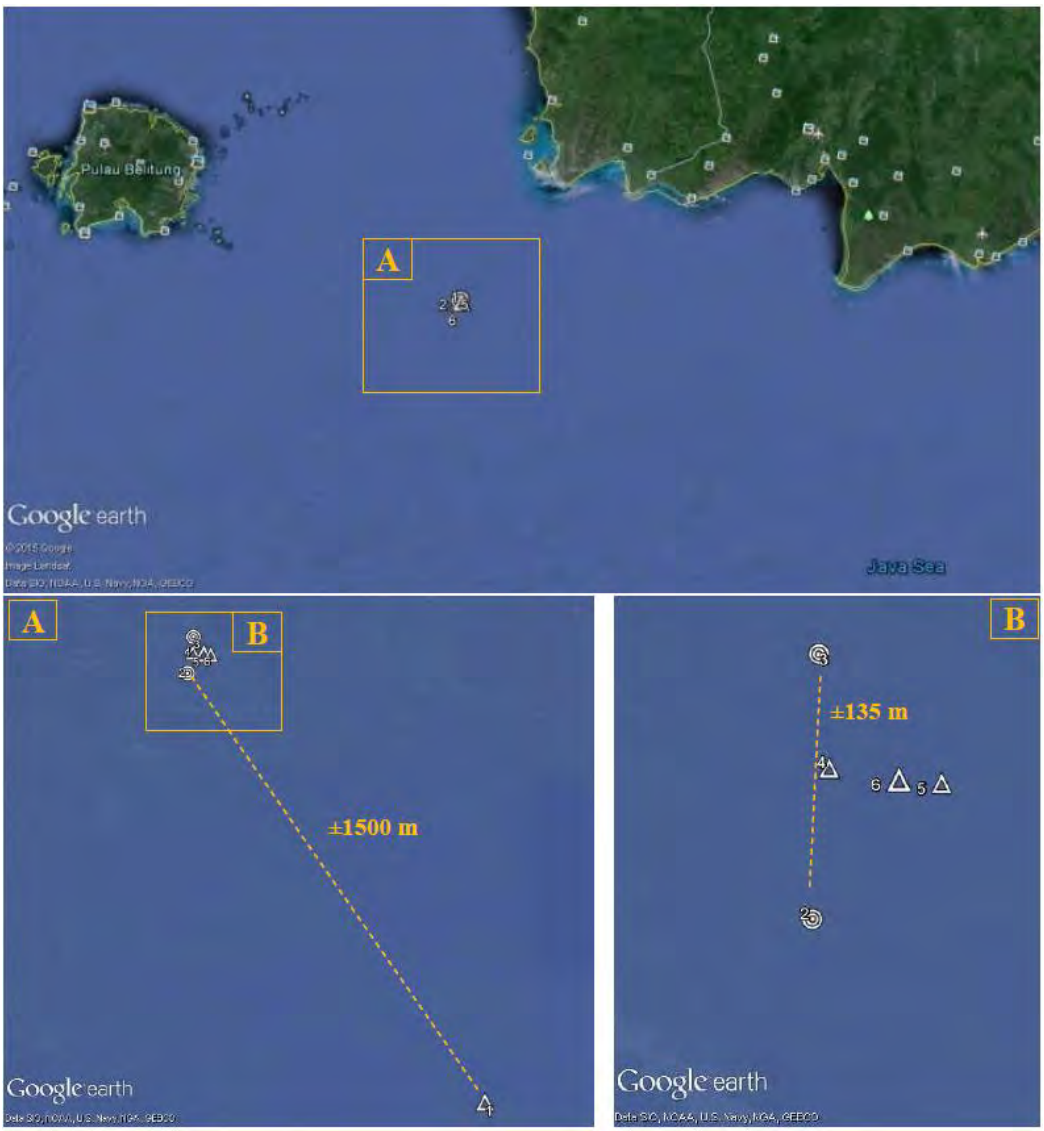
Figure 30: Wreckage Diagram superimposed on Google Map

The tail section and fuselage were recovered and transferred to Kumai Harbour at Pangkalan Bun and afterward to Jakarta. The part sections recovered contain of vertical stabilizer and aft section of the fuselage up to section 73. The recorders were detached from its rack.

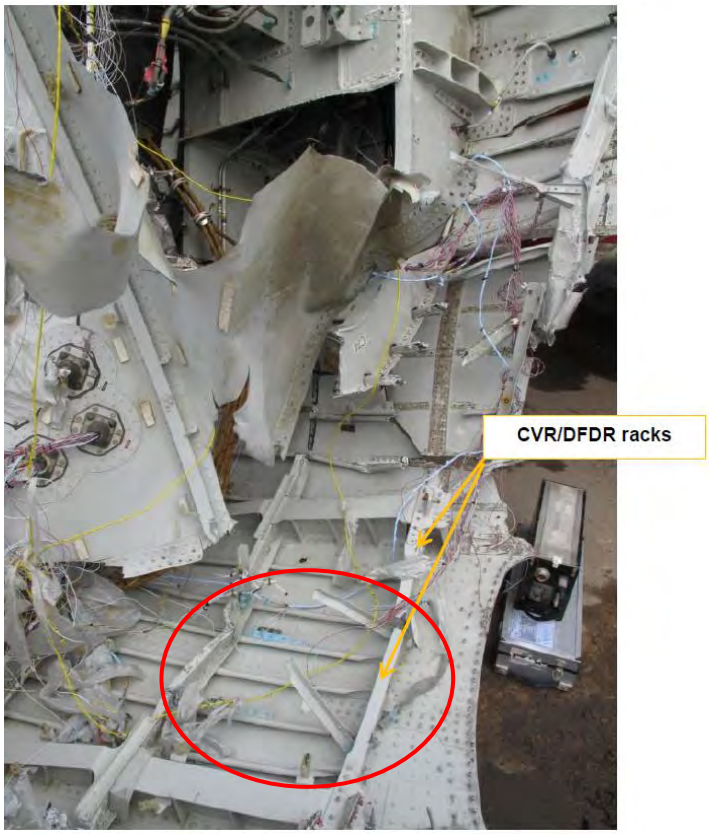
Figure 31: The FDR and CVR racks

The distance between Tail to FDR and CVR was about 1500 m. The distance between FDR and CVR was about 135 m.

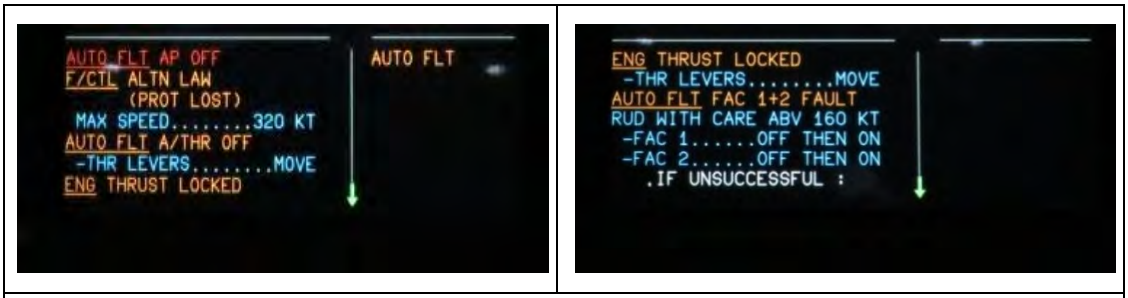
Figure 33: The page 1 and 2 of the ECAM messages after CBs of FAC 1 and 2 being reset

61	Flight Simulation 1 (1.16.1), page 50, Figure 33	**Figure 33: Display of the ECAM message during RTLU 1+2 malfunction**	The ECAM message displayed on Figure 33 contains FAC 1 FAULT that does not correspond to RTLU 1+2 malfunction.	The BEA suggests replacing the ECAM message displayed on Figure 33 with the one corresponding to RTLU 1+2 malfunction only (cf. document "Flight synopsis-phase1-withECAM" provided to KNKT during the meeting of July 2015).	Accepted
62	Flight Simulation 1 (1.16.1), page 51	Figure 36 + During stall the PFD indicated: - Flight director commanded to set pitch up (climb); - Vertical Speed Indicator indicated down; - Speed below stalling speed.	This paragraph is ambiguous and the reader could understand that the statements of these three bullets and what is seen on Figure 36 represent exactly what happened during the accident flight. The behavior of the aircraft in a situation of stall at high angle of attack is not known. Therefore the [illegible] are not representative at all of the real aircraft in a situation of a developed stall and cannot serve as a reference in this investigation.	The BEA suggests to suppress the figure 36 and the following sentences : ~~During stall the PFD indicated:~~ ~~- Flight director commanded to set pitch up (climb);~~ ~~- Vertical Speed Indicator indicated down;~~ ~~- Speed below stalling speed.~~	Accepted

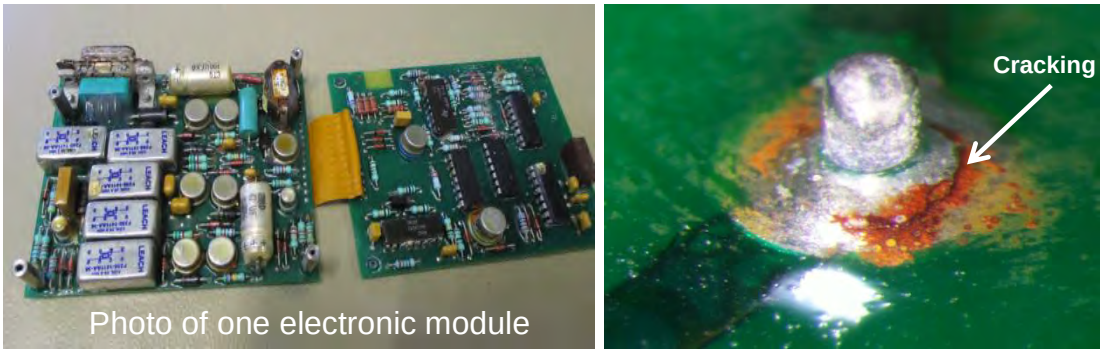
Figure 35: Electronic Module of RTLU

- The cracking of a solder joint of both channel A and B resulted in loss of electrical continuity and led to RTLU failure.
- The existing maintenance data analysis led to unresolved repetitive faults occurring with shorter intervals. The same fault occurred 4 times during the flight.

According to the Airbus information, there were three Technical Follow-Ups (TFUs) regarding the AUTO FLT RUD TRV LIM 1(2) (SYS) problems that were issued since 1993. TFU No. 27.23.51.004 was opened in 1993 regarding the problem of fatigue rupture of solder and closed on 1996. The problem found was “fatigue rupture of soldering” and the improvement made was “new electronic module”.
