ATSB TRANSPORT SAFETY BULLETIN
Aviation Level 5 Investigations
AB-2010-103
Final

Level 5 Factual Investigations: 1 October 2010 to 31 December 2010

Issue 4

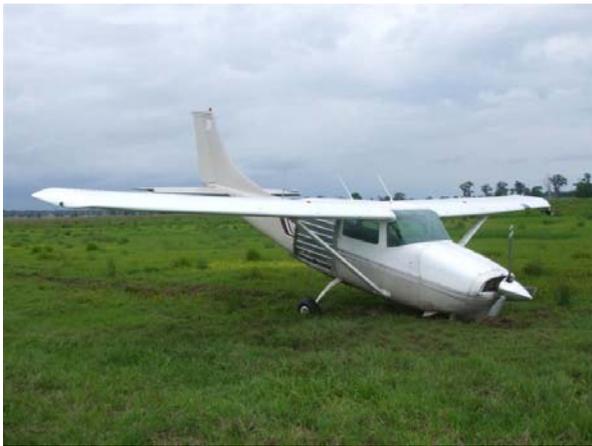
Figure 1: VH-EAL

The pilot reported that he had been distracted by the other aircraft operating in the area at the time and did not change the fuel tank selection during the descent or on downwind, as per his normal procedure. Also, the pilot stated that he forgot to turn the auxiliary fuel pump on as part of his response procedure following the engine failure, as required by the aircraft's pilot's operating handbook.
