# **Aviation Occurrence Report**

**TransAsia Airways Flight GE222**

**ATR72-212A, B-22810**

**Report Number: ASC-AOR-16-01-002**

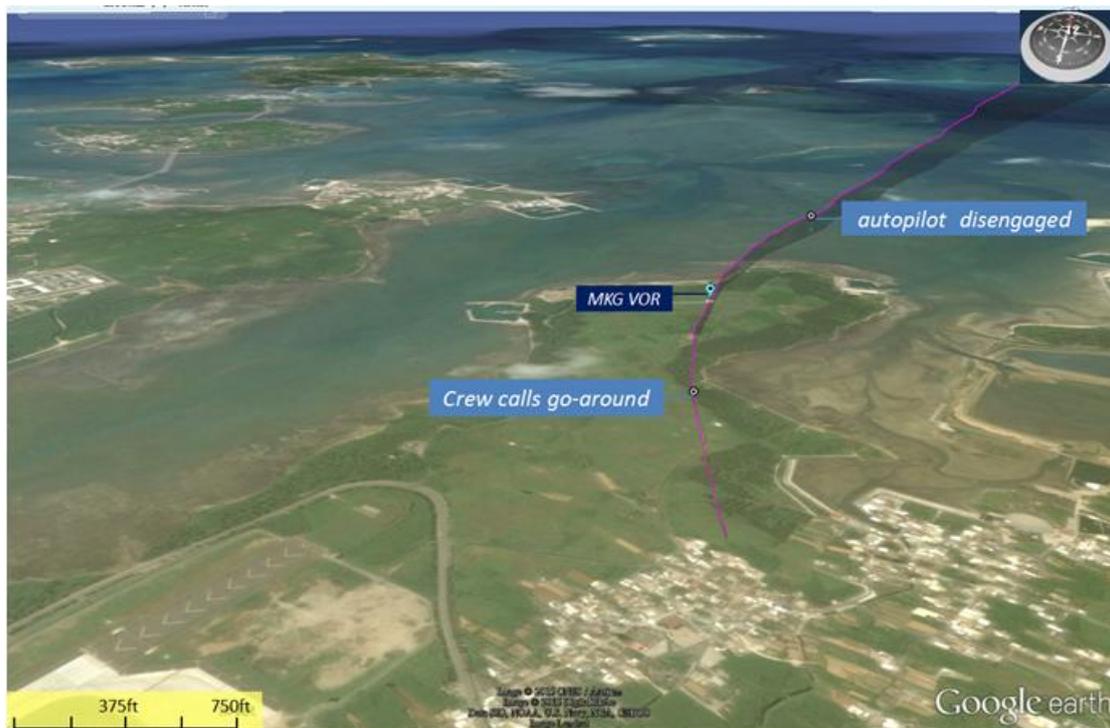
Figure 1.1-1 Final approach track

aircraft started to conspicuously deviate from the intended settings (see Figure 1.1-1), but there was no conversation between the flight crew regarding the aircraft entering an undesired state.

At 1906:11, both pilots called “go around” at 72 feet and both engine power levers were advanced. Two seconds later, the aircraft hit the foliage 850 meters northeast of the runway 20 threshold. The aircraft sustained significant damage and consequently collided with a residential area. Due to the high impact forces and post-impact fire, the aircraft was totally destroyed.

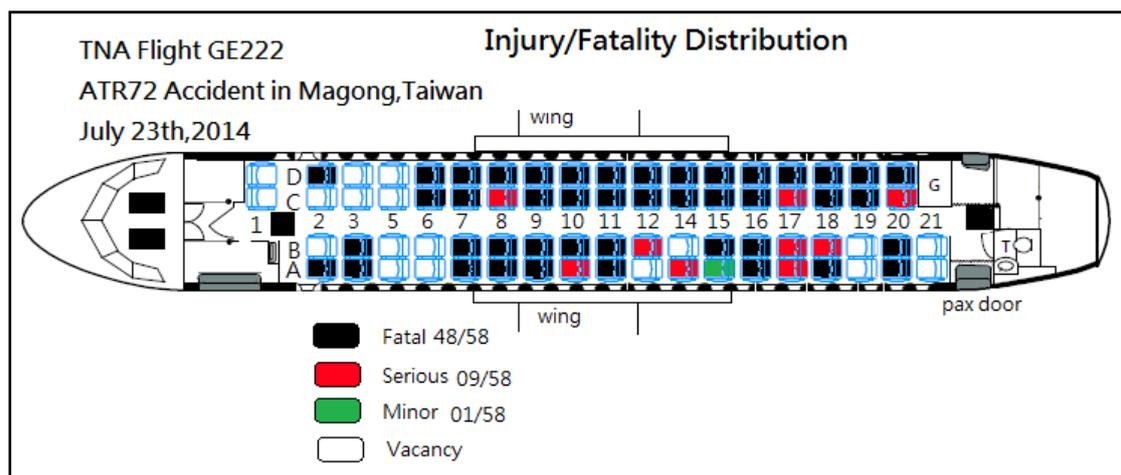
Figure 1.2-1 Injury and fatality distribution

Figure 1.2-1 shows the injury and fatality distribution via seat location. The passenger seating positions were based on the airline seating plan and interviews with the surviving passengers.

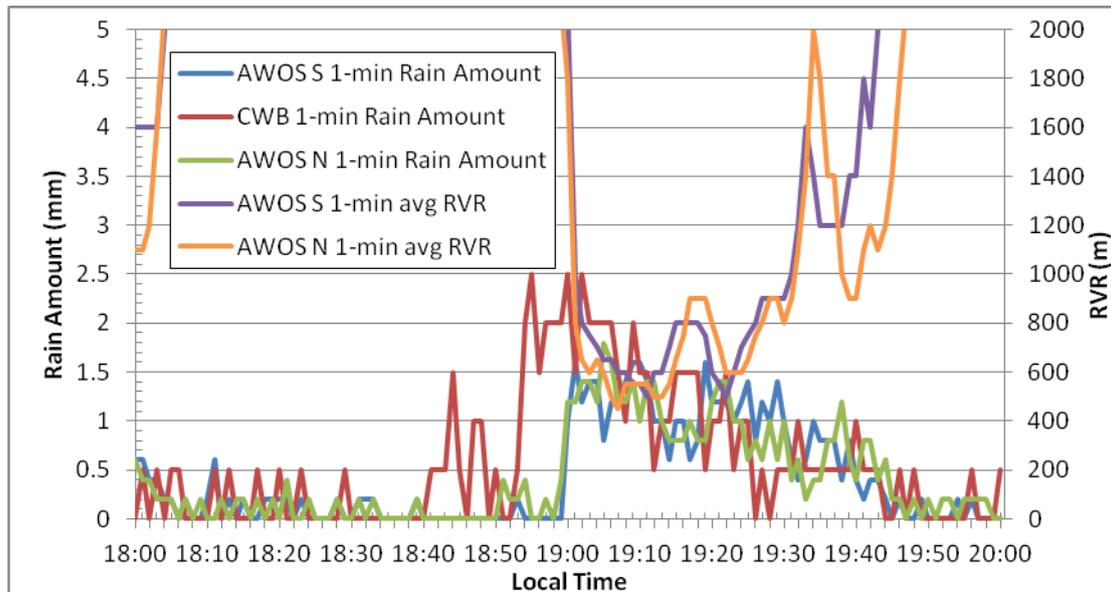
Figure 1.7-5 AWOS rainfall and RVR

the occurrence site. The wind gradually turned westerly from south-southwest between 1837 and 1847 hours, and then returned to the south-southwest at 1932 hours. One-minute average wind speed increased from 9 knots at 1858 hours to 31 knots at 1913, gusting to 36 knots at 1911 hours. Rainfall began to intensify at 1900 hours, accompanied by the runway visual range (RVR) reducing from more than 2,000 meters at 1859 hours, to between 500 and 900 meters between 1901 and 1931 hours. RVR returned to more than 2,000 meters at 1947 hours.

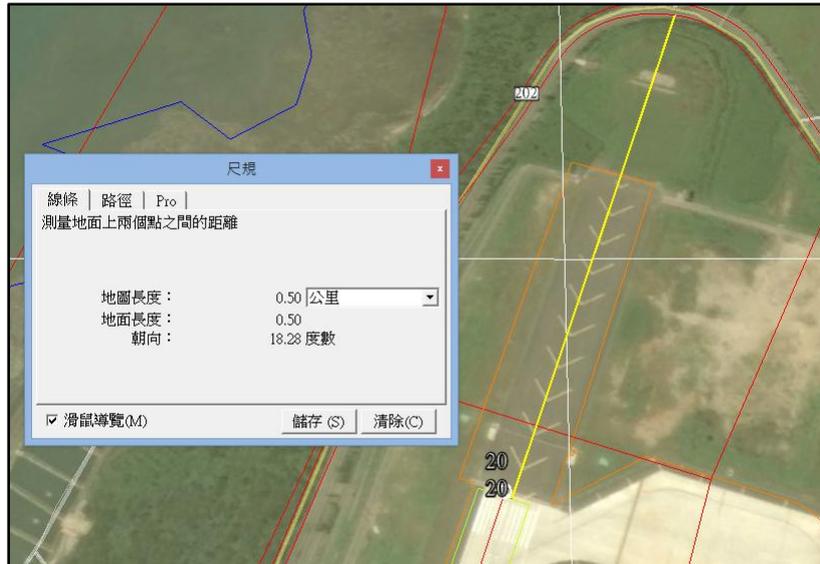
Figure 1.10-3 Available distance measured from Runway 20 (image from Google Earth)

There was no approach lighting system for runway 20. According to ICAO Annex 14 section 5.3.4 and the CAA Civil Aerodrome Design and Operations Specifications section 5.3.4, where physically practicable, a simple approach lighting system shall be provided to serve a non-precision approach runway. A simple approach lighting system shall consist of a row of lights on the extended center line of the runway extending, where possible, over a distance of not less than 420 meters from the threshold.

Measurement of the extended center line for runway 20 indicated that about 500 meters was available for an approach lighting system within the airport area, as shown in Figure 1.10-3.

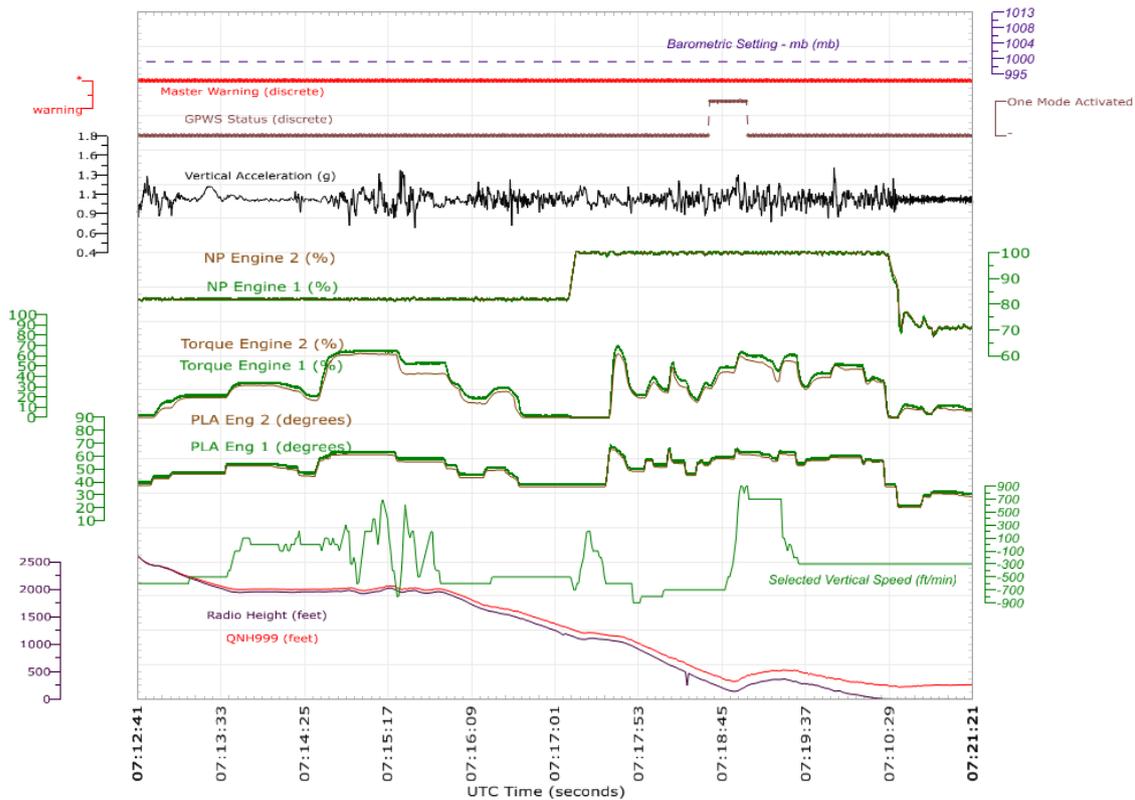
Figure 1.11-6 GE220 flight data plot (below 2,500 feet)

The flight crew had flown the occurrence route in the same aircraft earlier in the day as TNA flight GE220. On that flight, the aircraft took off from runway 27 at Kaohsiung International Airport at 1448:40 and landed on runway 20 at Magong Airport at 1510:36. Figure 1.11-6 displays the descent, approach and landing data below 2,500 feet for that flight. Between 1518:38 and 1519:01, one of the GPWS modes was activated during the descent from 296 feet to 235 feet (RA).

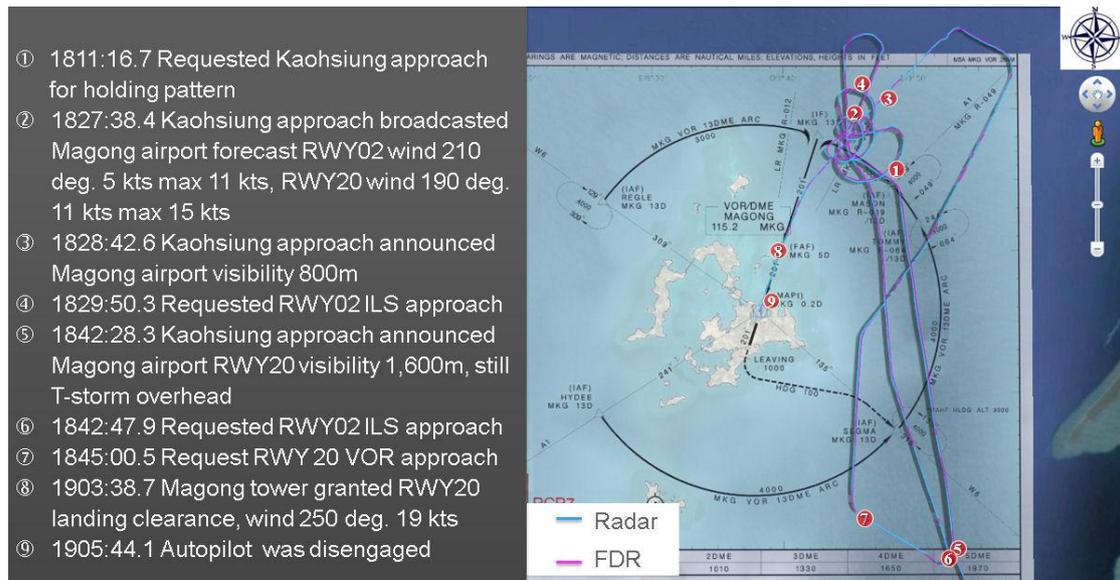
Figure 1.11-8 Superimposed GE222 flight path and VOR chart

the acceleration data recorded by the FDR, the position of the aircraft at every second was calculated, which enabled a reconstruction of the occurrence flight path. At 1906:18.9, the aircraft's last recorded position was N23°35'08.2", E119°38'21.1". Figure 1.11-8 displays key points along the occurrence flight path with the radar track superimposed with the Magong runway 20 VOR chart. Figure 1.11-9 presents the occurrence aircraft's trajectory during the last 40 seconds overlaid on a satellite image of the area.

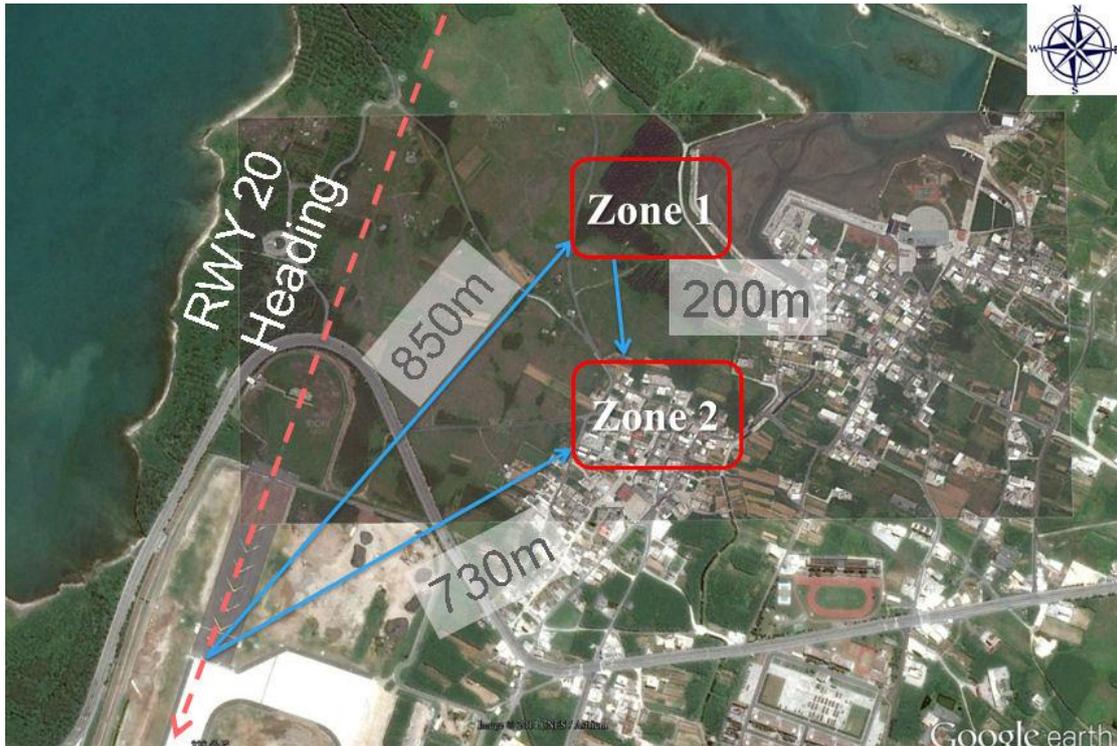
Figure 1.12-1 GE222 site survey zones superimposed on Google map

Figure 1.12-1 illustrates that the aircraft wreckage was distributed in two areas: the foliage or brushwood area (Zone 1); and the residential area (Zone 2). The aircraft impacted terrain approximately 850 meters north-east of the threshold of runway 20 at Magong Airport and then collided with a residential area on the outskirts of Xixi village approximately 200 meters to the south-east of the initial impact zone.

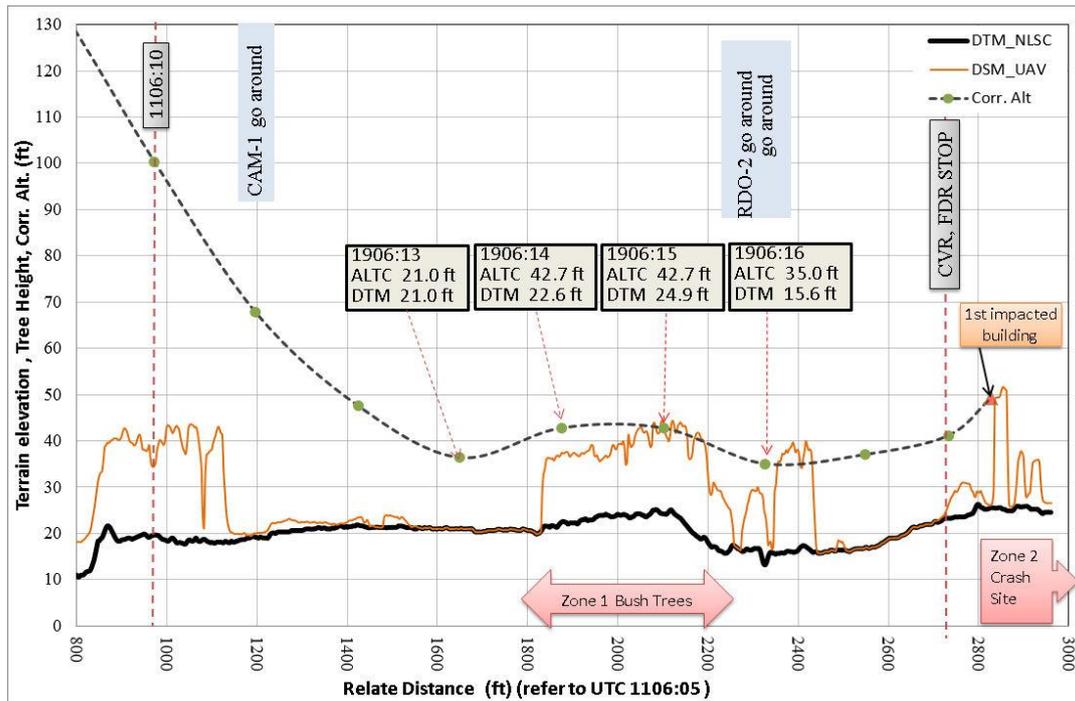
Figure 1.12-3 Comparison of terrain profiles

A set of terrain data (DTM<sup>44</sup>) from the National Land Survey and Mapping Center (NLSC) was obtained to compare with the UAV survey results. The results are shown in Figure 1.12-3. The comparative terrain profiles are depicted for the last 9 seconds of the occurrence flight and extend a further 200 meters to ensure coverage of the wreckage display and associated collateral damage.

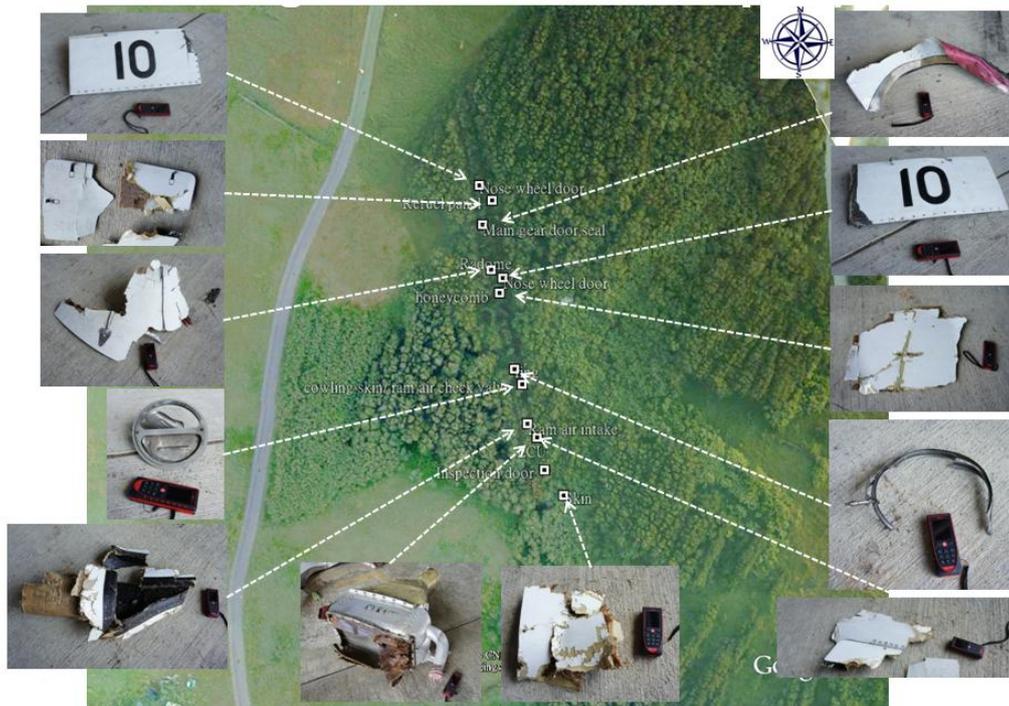
Figure 1.12-6 Superimposed aircraft wreckage distribution and component photos

Some aircraft wreckage was found along the swathe through the foliage. Those pieces of wreckage were identified as: nose landing gear aft doors, radome, left-hand heat exchanger, ram air inlet, ram air check valve, left-hand main landing gear door, belly fairing inspection doors, and belly fairing panels. The superimposed aircraft wreckage distribution and identified components on the UAV's orthogonal image<sup>45</sup> is shown in figure 1.12-6.

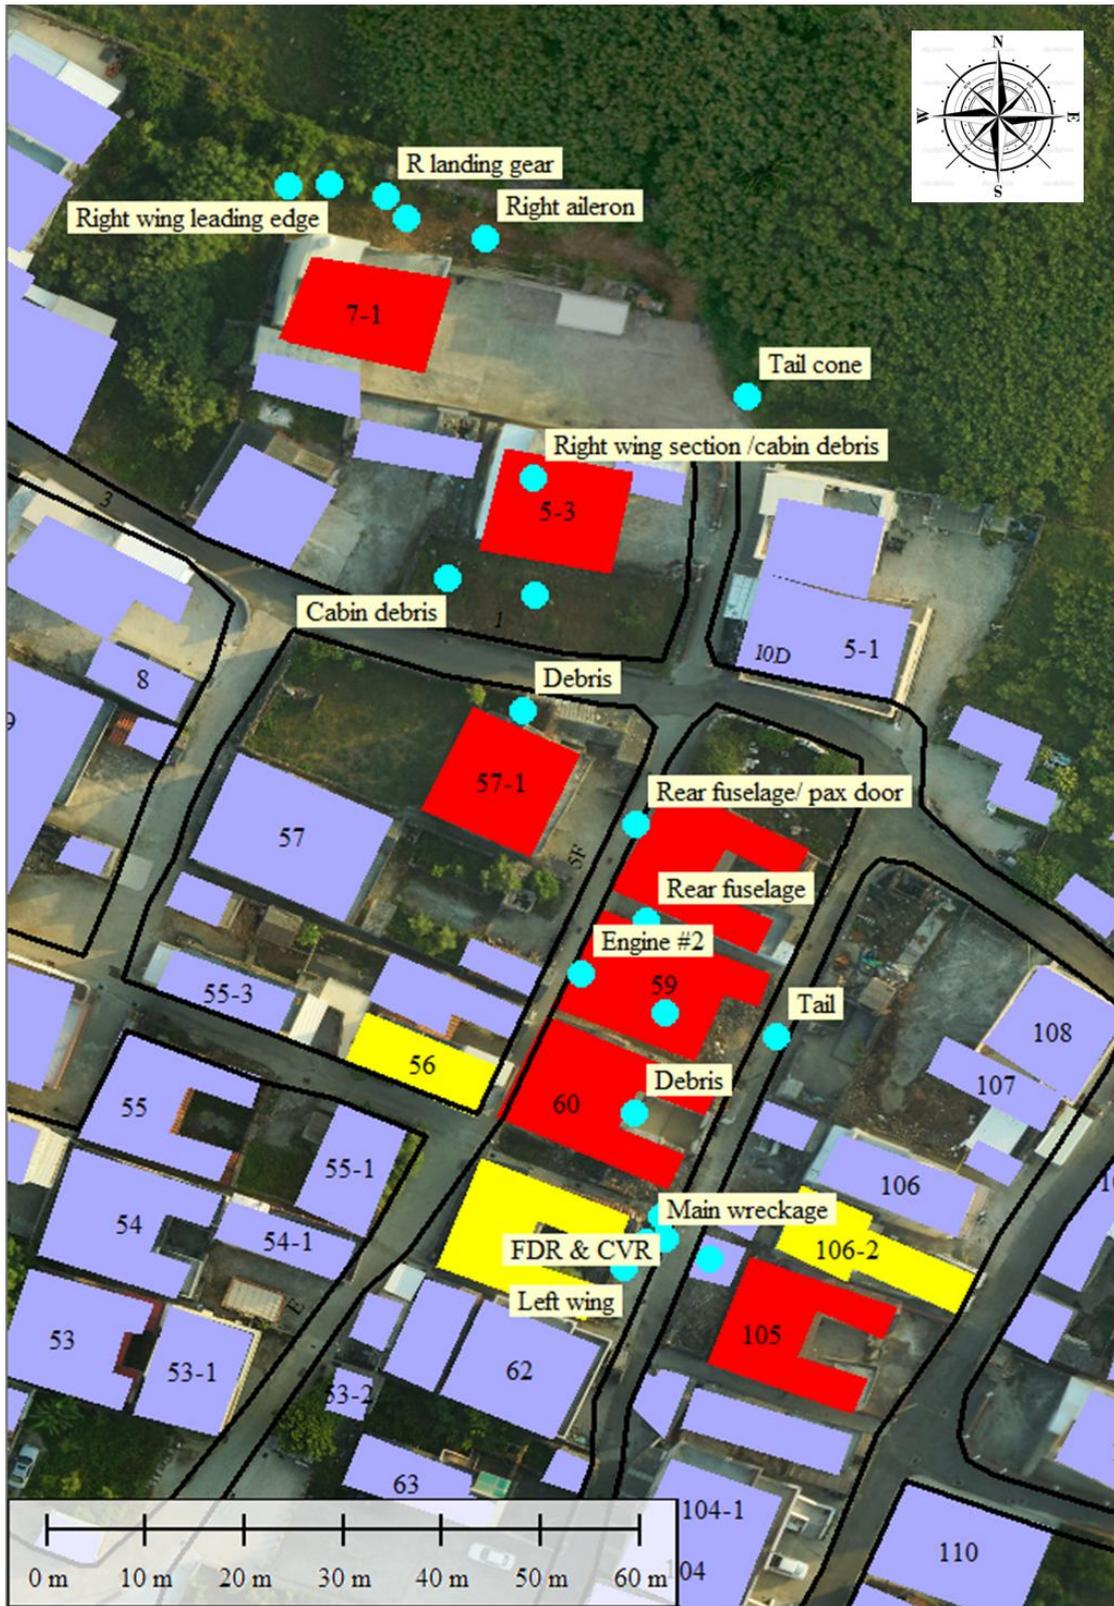
Figure 1.12-7 Wreckages distribution overlaid on Xixi village street map

Zone 2 was located in a residential area of Xixi village. The trajectory of the aircraft was from north to south. The aircraft collided with multiple buildings and broke apart into several major sections. The main wreckage site, which included the cockpit, forward fuselage, left wing, and no.1 engine came to rest in a street in the south of Zone 2. The distance between the main wreckage site and the first building collision was about 120 meters. Figure 1.12-7 depicts the aircraft wreckage distribution overlaid on a Xixi village street map. The red area indicates extensive damage to housing; the yellow area indicates houses with minor damage; and the light blue area indicates undamaged houses. In addition, smaller items of debris such as passenger seats, window frames, baggage, and fuselage skin were scattered throughout Zone 2 over an area of approximately 80 meters by 120 meters. The aircraft main wreckage distribution and damaged buildings are shown in Figure 1.12-8.

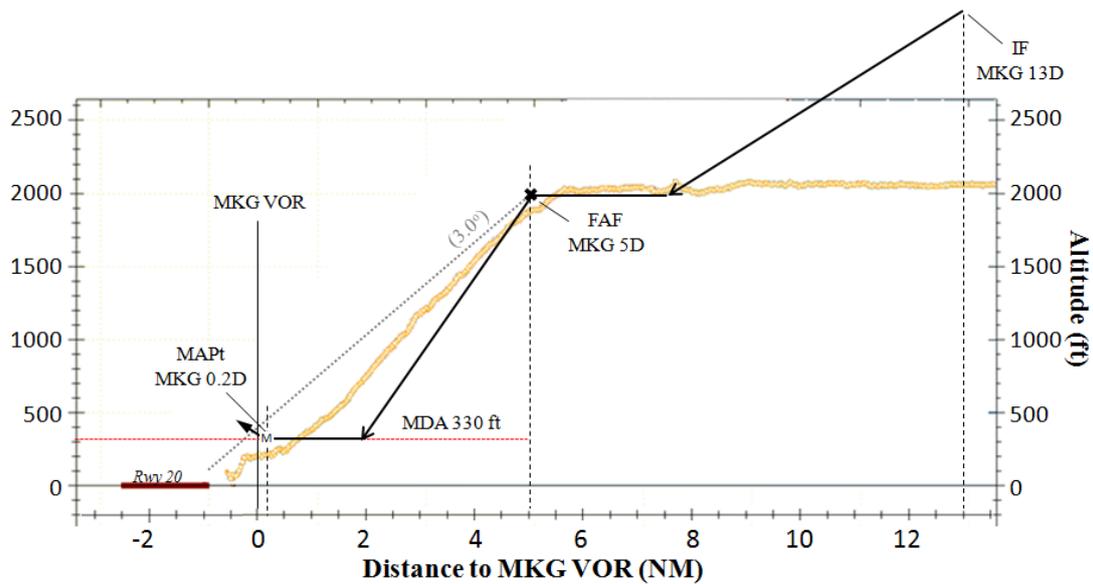
Figure 2.2-1 GE222 approach profile

approach, the first officer obtained permission from the captain to preset the next altitude to 400 feet (1859:15). The aircraft then started to descend (1902:50) with a selected vertical speed of -700 feet/min. Based on weather data and the sound of the windshield wipers increasing in speed on the CVR (1903:36.1), the aircraft probably penetrated heavy thunderstorm rain around then. Three seconds after the “500 feet auto call-out” was annunciated, the selected altitude was reset to 300 feet while the aircraft was descending through 450 feet (1905:12.4). When the aircraft had descended to 344 feet, the selected altitude was reset to 200 feet and the aircraft kept descending (1905:25.7). The sequence of flight crew actions regarding the decision to continue the approach below the MDA is shown in Table 2.2-2. The GE222 approach profile is shown in Figure 2.2-1.

There was no discussion by the crew on whether the required visual references had been obtained before the captain as the pilot flying (PF) continued to descend the aircraft below the MDA. The first officer, in his capacity as the pilot monitoring (PM) did not object or intervene but rather coordinated with the captain's decision to descend below the MDA in contravention of standard operating procedures (SOPs).

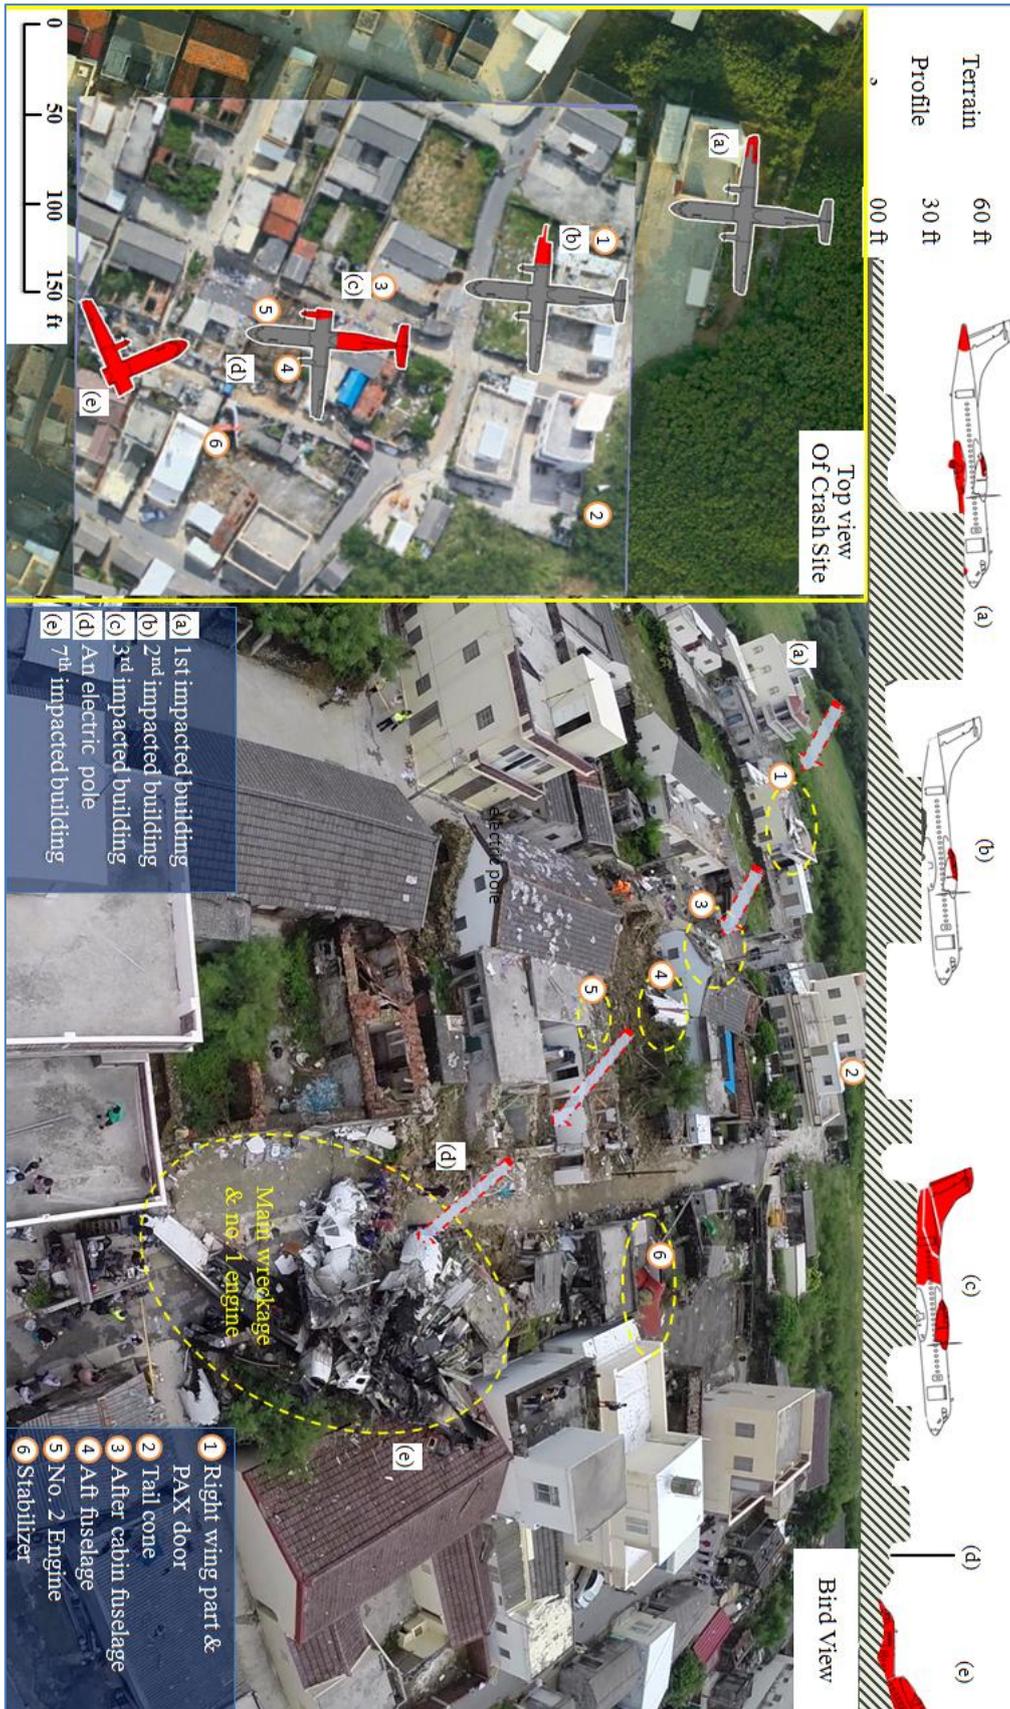
Figure 2.2-3 Aerial image of occurrence site superimposed with the main wreckage and final flight trajectory

The aircraft's right wing also collided with the northern wall of the first impacted building. After the first impact, the aircraft's direction of movement was altered to about 170 degrees and it then collided with several other buildings before it finally came to rest. Figure 2.2-3 shows an aerial image of occurrence site superimposed with the main wreckage and final flight trajectory.

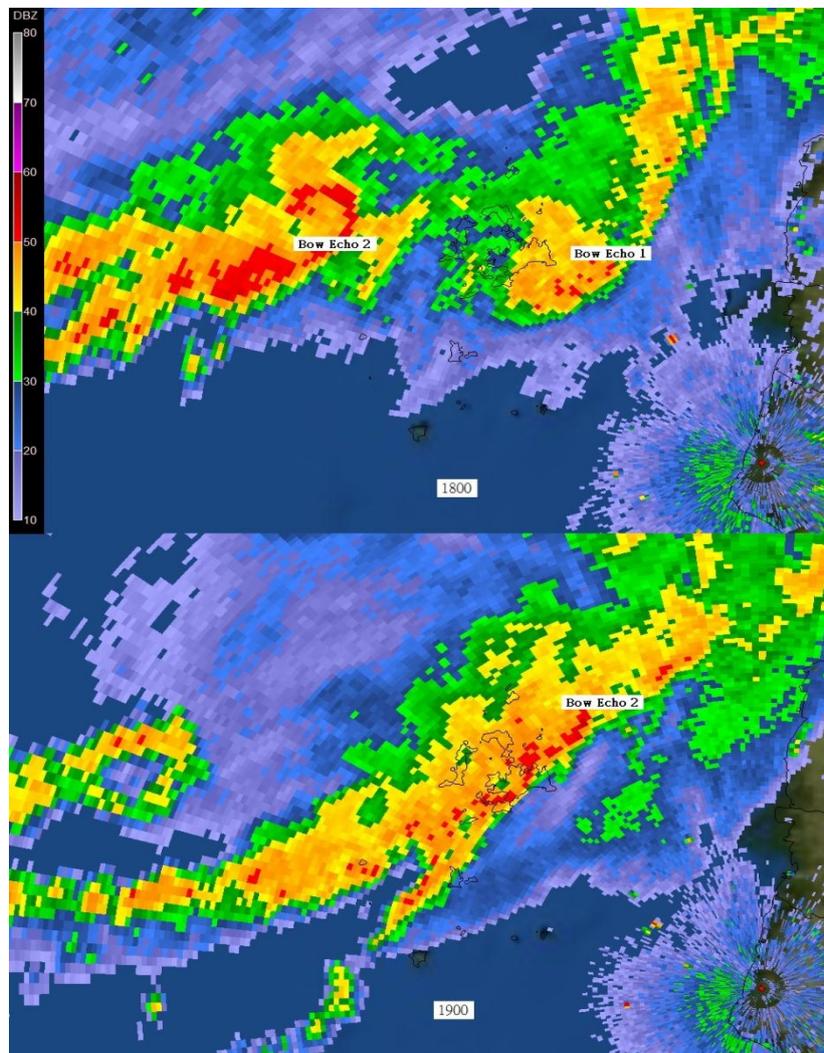
Figure 2.8-1 Rainband activity at Magong before the occurrence.

Magong Airport was affected by the outer rainbands of Typhoon Matmo at the time of the occurrence. The automated weather observation system (AWOS) and radar data showed that these rainbands were similar to squall lines. The radar images (see Figure 2.8-1) indicated that two waves of rainband passed through Magong Airport before and during the occurrence. The first bow echo affected Magong Airport from 1738 to 1803; the second echo was from 1901 to 1945. These bow echoes may cause significant changes in wind speed and wind direction with associated heavy rain showers.

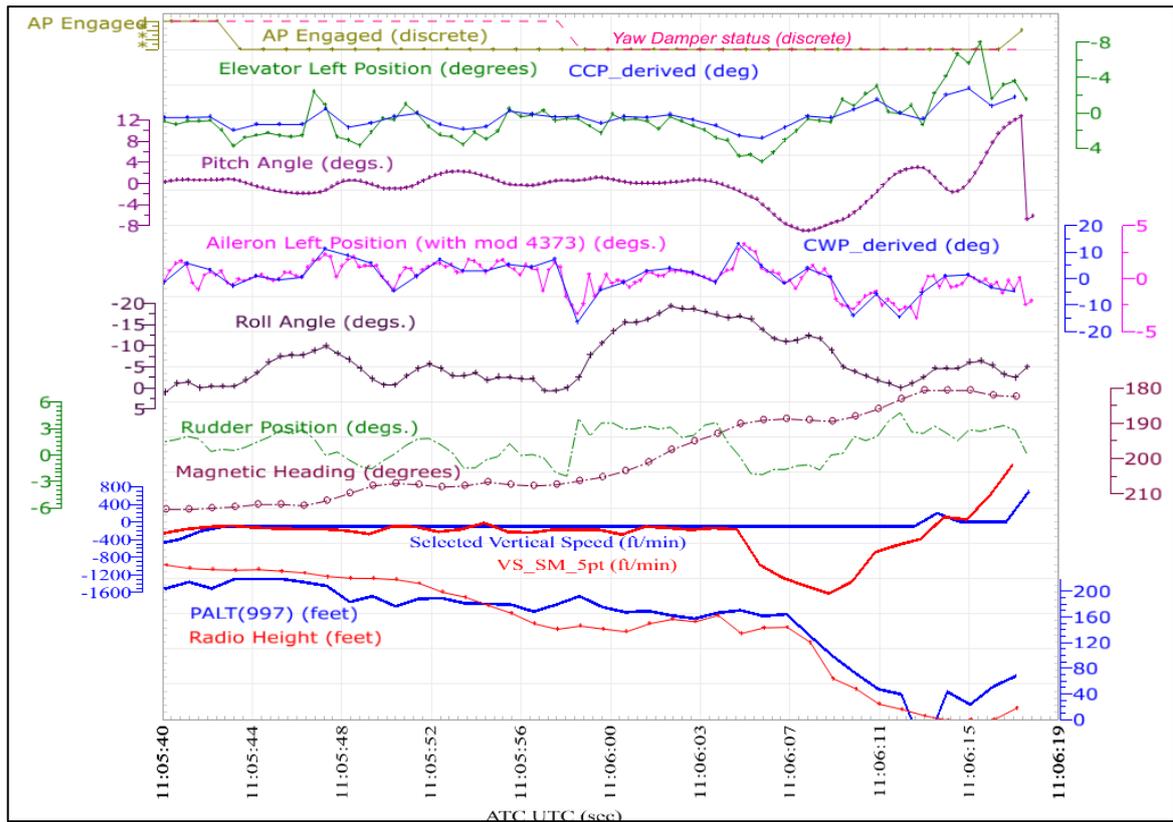
Figure 2.9-1 Relevant FDR and derived parameters

Based on the FDR data and the technical information provided by the ATR, the vertical speed, control column position, and control wheel position of the occurrence flight after the autopilot was disengaged were calculated. Relevant FDR parameters and the three derived parameters are depicted in Figure 2.9-1. Derived vertical speed is denoted as "VS\_SM\_5PT", derived control column position and control wheel position are denoted as "CCP\_derived" and "CWP\_derived", respectively.

The occurrence aircraft's increased rate of descent from 150 ft/min to 1,600 ft/min between 1906:05 and 1906:10 was the result of an elevator control input by the captain. The nose down pitch angle of the aircraft was a maximum of 9 degrees. While descending, the aircraft turned to the left as a result of left aileron input. That is, the aircraft behavior was consistent with the control surface inputs.

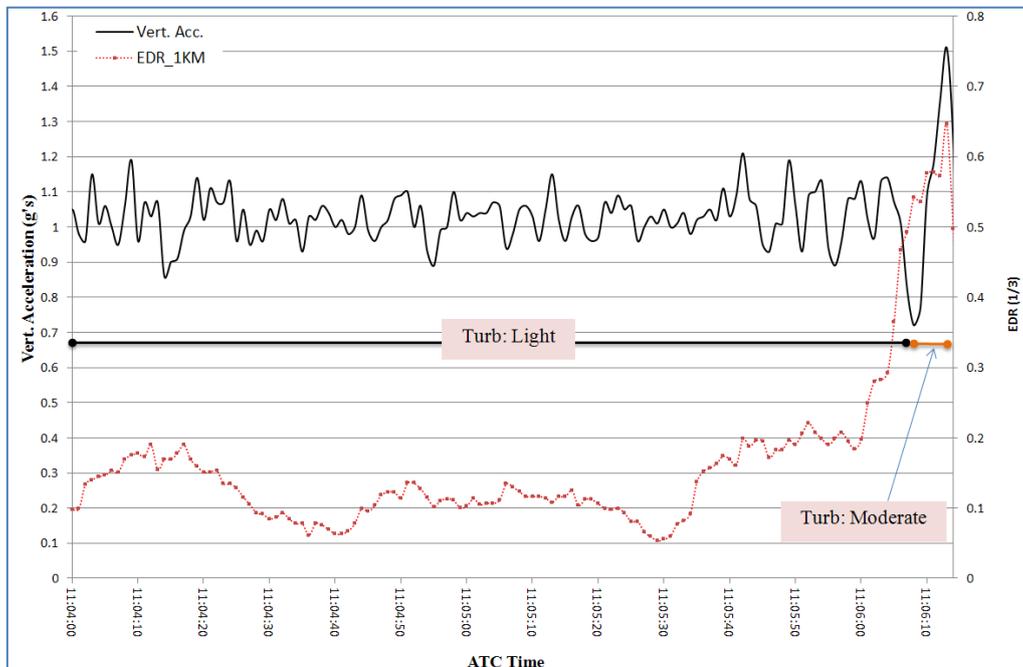
Figure 2.9-2 GE 222 vertical acceleration and calculated EDR (last two minutes)

Based on the FDR data, the vertical acceleration for the last two minutes of the occurrence flight is shown in Figure 2.9-2. The plot indicated that the vertical acceleration fluctuated between 0.8 and 1.2 g's until 1906:08, the vertical acceleration reached the minimum value of 0.72g's. The decrease of the vertical acceleration probably had a relationship with the pitch down maneuvers of the aircraft. The vertical acceleration then started to increase when the flight crew decided to go around. The vertical acceleration reached the maximum of 1.51 g's at 1906:13, when the aircraft hit the trees.

Stated in the ICAO Annex 3, the EDR is an aircraft-independent measure of turbulence. The relationship between the EDR value and the perception of turbulence is a function of aircraft type, and the mass, altitude, configuration and airspeed of the aircraft. The EDR values of the occurrence flight were calculated and shown in Figure 2.9-2. Similar to the vertical acceleration, the EDR values were less than 0.2 most of the time during the last two minutes of the flight. About 1906:00, the EDR value started to increase and reached the maximum of 0.65 just before the aircraft contacted with the trees.

Compare with the FDR data, between 1906:00 and the end of the flight, the occurrence aircraft had large amount of pitch and roll angle changes. The increased vertical acceleration and EDR values probably are cause by the combination of the turbulence and the aircraft maneuver. Based on the values, the turbulence strength of the occurrence flight during the last 2 minutes could be classified as “light to moderate” level.

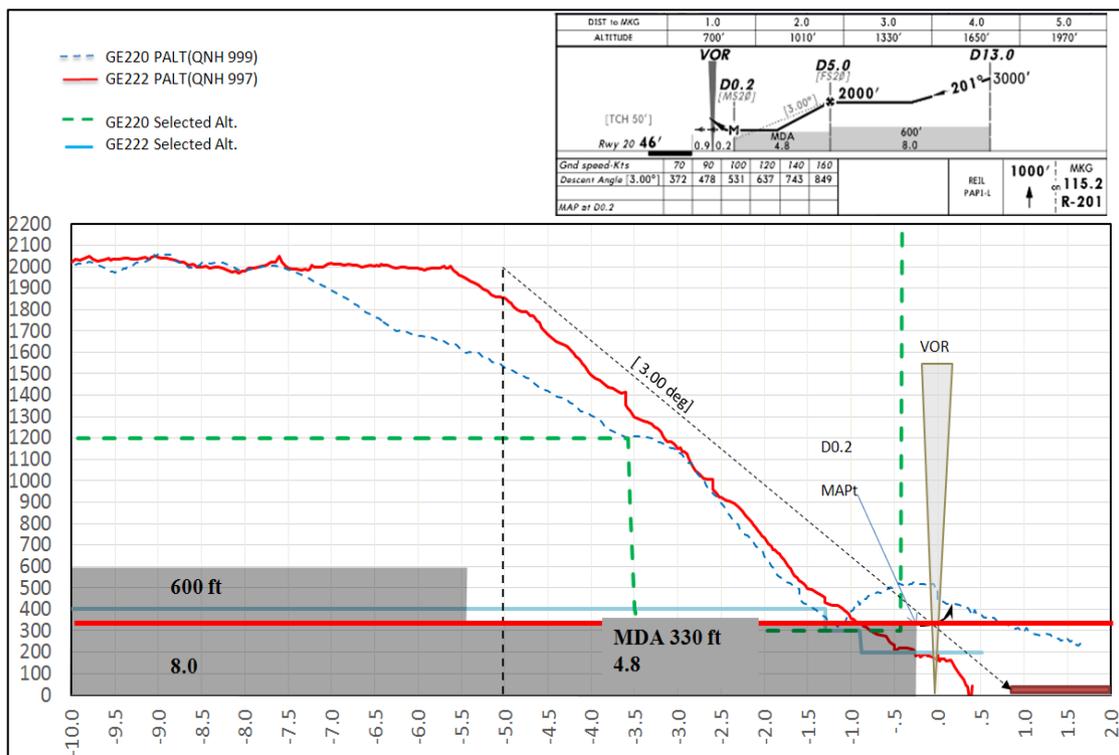
Figure 2.11-1 GE222 and GE220 flight profiles

The parameters and threshold values setting of the TNA FOQA program were in accordance with the manufacturer's suggestions. Based on the airline's FOQA system, on the day of occurrence, flight GE 220 triggered three red events: altitude below 500 feet - heading deviation greater than 20 degrees, GPWS warning triggered 24 seconds and level off below 1,400 feet above field elevation (AFE) exceeded 10 seconds. The occurrence flight GE222 triggered two red events: excessive bank angle on final approach below 100 feet AFE, and high rate of descent on approach between 500 and 50 Feet AFE. See Figure 2.11-1 for GE222 and GE220 flight profiles.

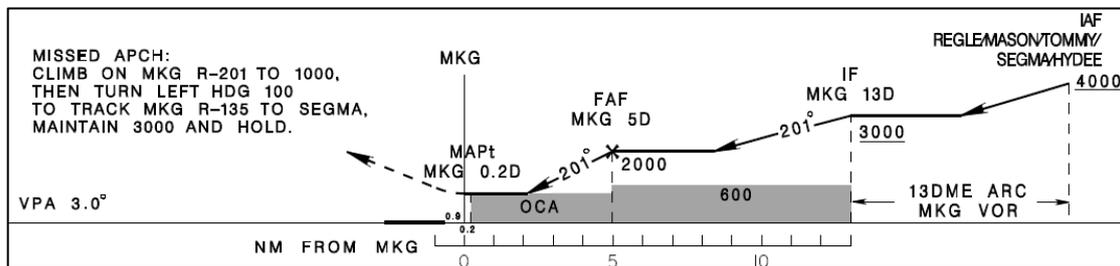
Figure 2.12-2 Magong MAPt location and runway 20 VOR approach procedure

According to the AIP, the distance from the runway 20 VOR missed approach point (MAPt) to the runway 20 threshold is 1.1 nautical miles (2,037.2 meters) (see Figure 2.12-2). The distance is longer than the published visibility landing minima of 1,600 meter.

The CAA used the PANS\_OPS Designer software to calculate the OCA for the runway 20 VOR approach. The CAA advised that the calculations indicated if the MAPt was located at the threshold, the OCA would be 394 feet. If the MAPt was at 1.1 nm from the threshold, the OCA could be lowered to 328 feet. The investigation team asked the CAA to re-calculate the OCA for the runway 20 VOR approach by moving the MAPt to different locations toward the threshold. The results indicated that moving the MAPt to 0.8 nm (1,460 meters) from the threshold, the OCA was 328 feet.

With the same OCA, if the MAPt was set closer to the runway threshold, it would have increased the likelihood of crews being able to visually identify the runway in the future.
