# National Transportation Safety Board

## Aircraft Accident Brief

**Accident Number:** LAX03MA292  
**Operator:** Sundance Helicopters, Inc.  
**Aircraft and Registration:** Aerospatiale AS350BA, N270SH  
**Location:** Near Grand Canyon West Airport, Arizona  
**Date:** September 20, 2003  
**Adopted On:** October 30, 2007

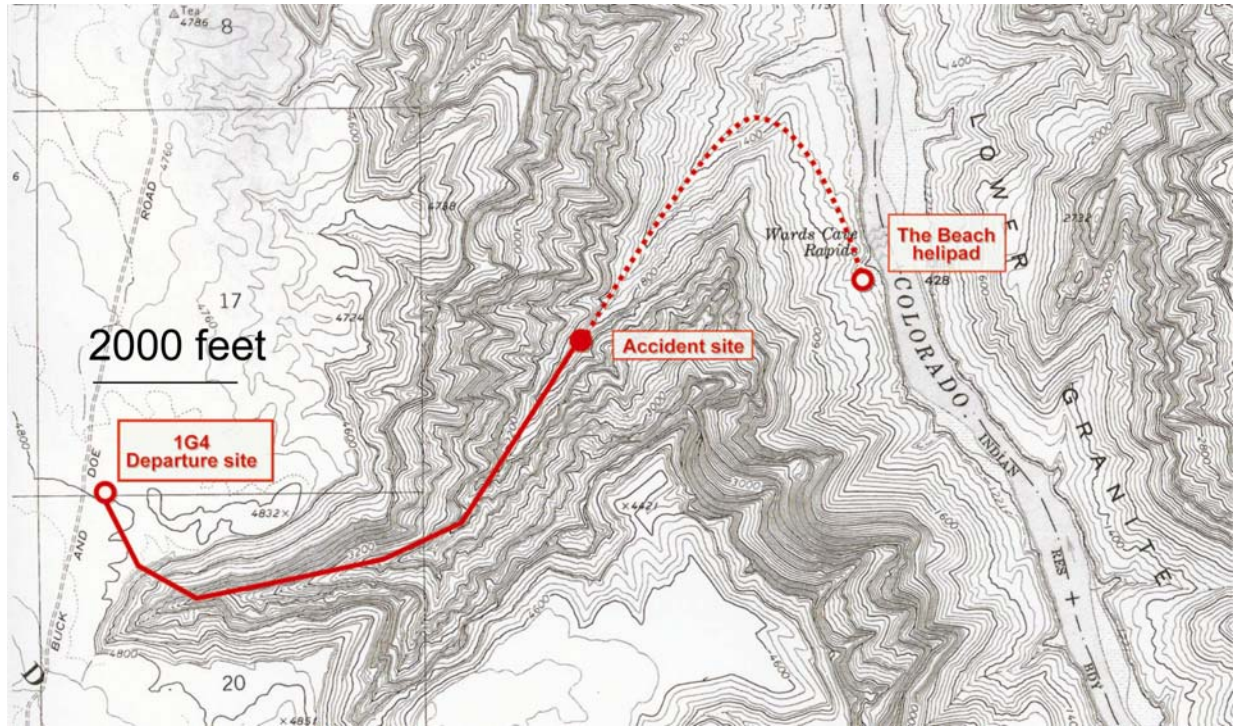
**Figure 1.** Topographic chart showing the 1G4 departure site, the accident site, and the prescribed route through Descent Canyon to the Beach helipad.

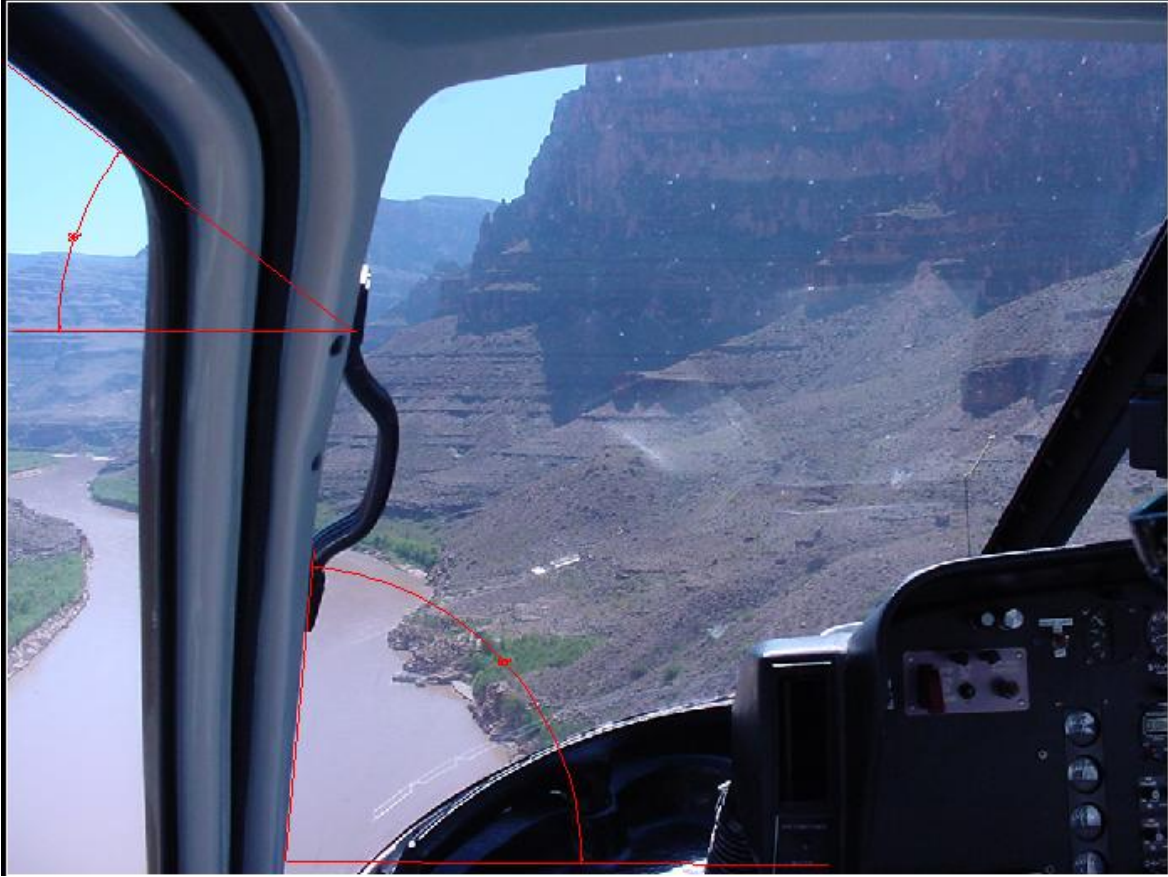
The study used a digital image from the earlier flight that was taken from inside the accident helicopter and that depicted the helicopter in a level attitude to establish assumed values for the level attitude by determining reference angles for the helicopter's left-door frame and the horizontal terrain. The study compared these reference values with reference lines from canyon terrain features to estimate the accident helicopter's pitch and bank angles in three other images that were taken by the passenger on the earlier flight (see figure 5).

**Figure 5.** View of the level attitude reference angles for the accident helicopter.
