Assessment Summary Sheet for UKAB Meeting On 11 September 2013

AIRPROX REPORT No 2013020

Date/Time: 20 Apr 2013 1315Z (Saturday)

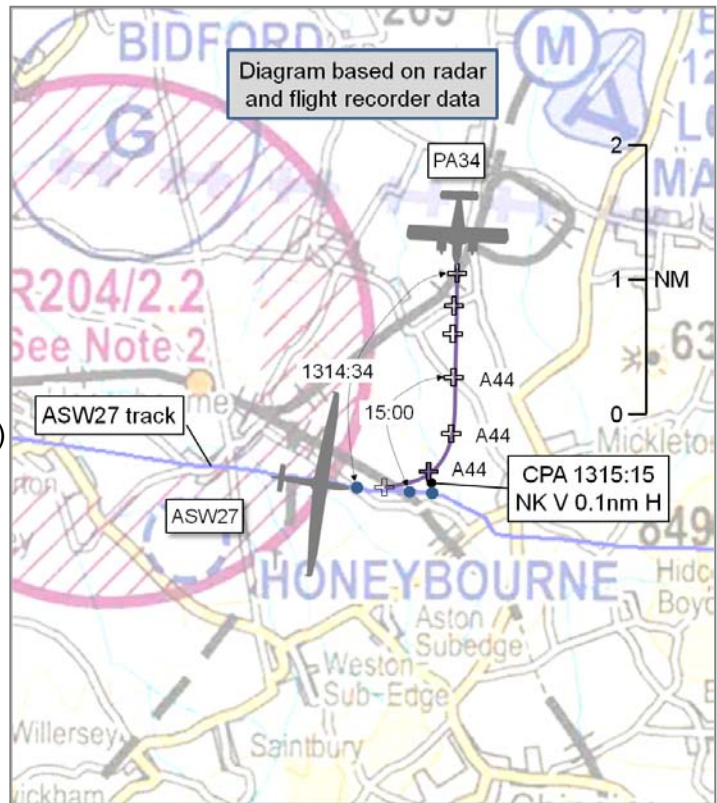
THE ASW27 PILOT reports flying a cross-country task from Dunstable whilst listening out on Gliding Common frequency (130.100MHz). His turning points were Leighton Buzzard - Great Malvern – Bletchley – Cottam, with the Airprox occurring on the 2nd leg between Great Malvern and Bletchley. Visibility was >20km in VMC, the glider was coloured white, and FLARM was fitted. Close to Evesham, about 3min prior to CPA, he had completed a thermal climb to approximately 5000ft and commenced a cruise (glide) with IAS varying between 80kt and 50kt and heading between 090° and 100° as he responded to areas of lift/sink along track. Whilst flying at 4300ft QNH, with wings-level, at about 60kt, and in an area of rising air, he looked L and saw an ac approaching from his 9 o'clock about 50-100m away, at high speed and at the same level in a slightly climbing attitude. The other ac, a small twin-engine type, made a steep turn to the R so that it passed above and behind. The ASW27 pilot assessed the minimum separation to be about 30ft vertically and 10m laterally. The period between first sighting and the other ac passing to the rear was 2-3sec. There was no doubt in his mind that a collision would have occurred had the other ac not taken what he took to be avoiding action. He postulated that he had not seen the other ac until late either because his lookout was inadequate or the ac had approached from a blind spot under his L wing.

Cause: A late sighting by the PA32 pilot and effectively a non-sighting by the ASW27 pilot.

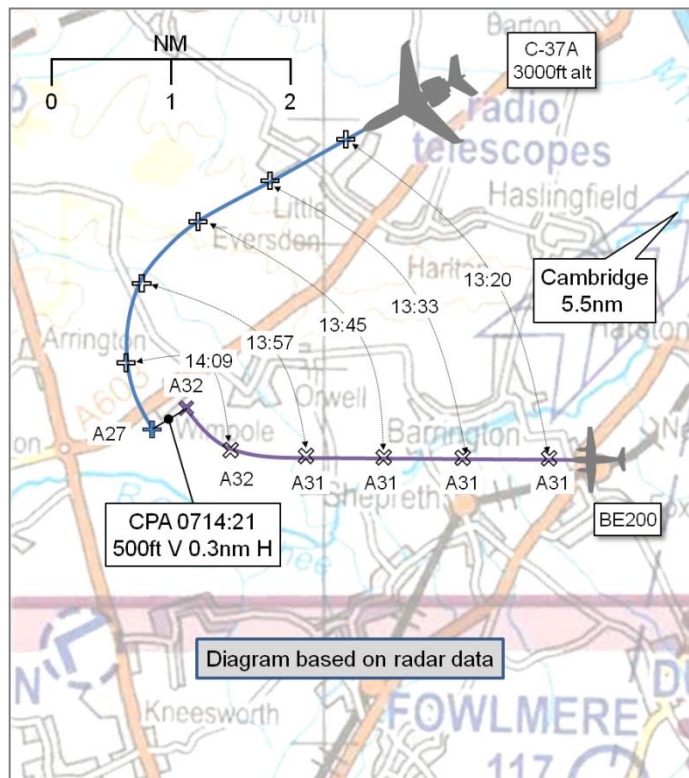
THE C-37A PILOT (a military Gulfstream V) reports en-route from Turkey to Cambridge, IFR, heading 051° at 180kt and 3000ft, squawking Modes S and C. The flight deck crew complement was 2 pilots and an engineer. He reported receiving a BS, he thought, from Cambridge TWR on 125.9MHz. Whilst positioning for the RNAV(GNSS) RW05 at Cambridge, he received an RA from a white BE200 at co-altitude (he believed). Having entered the local IFR pattern at Cambridge, the TWR pointed out traffic holding SE of the airport. He saw the traffic and reported visual. As he turned to heading 051° to intercept final for the GPS approach, he received an RA from the same traffic. He descended 500ft and increased the rate of turn onto heading 070° to avoid the traffic. Once clear of traffic he re-established course and landed uneventually. He assessed the vertical separation as 0ft and horizontal as 1nm.

Cause: The C37A pilot turned into conflict with the BE200.

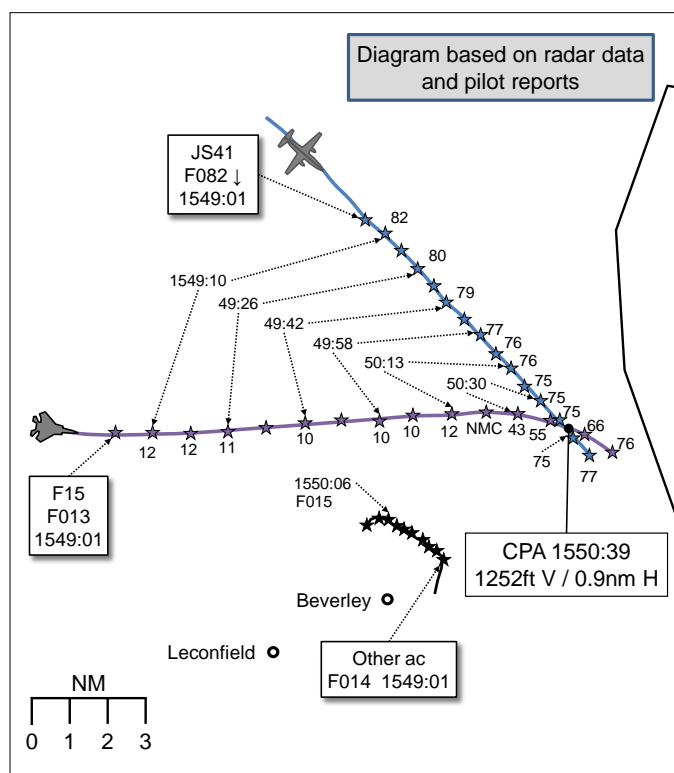
THE JETSTREAM (JS41) PILOT reports descending to FL75 in intermittent IMC at 245kt under a DS from LATCC(Mil) NE. The crew received TI on LL traffic that they correlated with a return indicating 6000ft below on the aircraft's TCAS display; LATCC(Mil) NE advised them to turn on to 140° to remain clear of the other ac, and then handed them over to Humberside Radar [UKAB Note 1: the heading of 140° was to achieve the gap between radar returns required by DS minima against an ac squawking 3/A 7010 which was not physically involved in this Airprox]. During their initial call to the Humberside APR controller, and before 2-way communication had been established, the crew received a TA, on the previously correlated traffic, they thought. The return which they could see on their TCAS display was climbing and was indicating 3000ft below them [UKAB Note 2: this was in fact the F15 and not the ac squawking 3/A 7010. The JS41 pilot subsequently reported that he did not notice that the two events were related to different TCAS returns because the crew were scanning between the TCAS, the instruments and the sky]. The crew reports that 'within a second' of receiving the TA they received an RA instruction to climb and the Pilot Flying (PF) disengaged the autopilot and followed the instruction. A few seconds later the TCAS indicated that the conflict had been resolved. However, when they subsequently established 2-way communication with Humberside Radar, the controller issued an avoiding action turn on to 190°. The crew informed APR that they were clear of conflict, hdg 190° and descending to FL75; normal communications were established and the ac continued to its destination. The crew did not see the F15 other than on the TCAS display.

Cause: The F15E pilot climbed into conflict with the JS41, which he did not see.

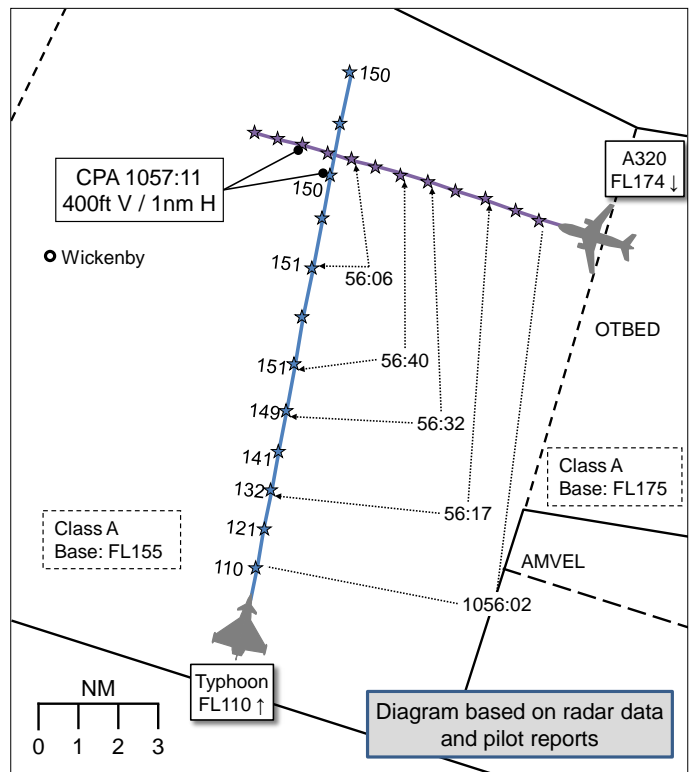
THE APR CONTROLLER reports that the A320 was released passing OTBED and on initial contact the crew requested a DS to leave CAS early. The APR trainee passed the Doncaster information and instructed the crew to descend to FL130. The OJTI saw the Typhoon climbing through FL80 and instructed to A320 crew to stop descent at FL160 which was read back he thought. APR continued to monitor the A320's progress and informed the crew that they would be remaining within CAS. The OJTI observed the A320 descending past FL160 and made broadcasts to the crew to maintain FL160, but did not receive any response initially. APR saw the Typhoon level at FL150 and the A320 descend to FL153 before climbing back to FL160. APR assessed the CPA as 1.5nm H and 300ft V.

Cause: The A320 pilot descended into conflict with the Typhoon following a misheard clearance and uncorrected read-back error.

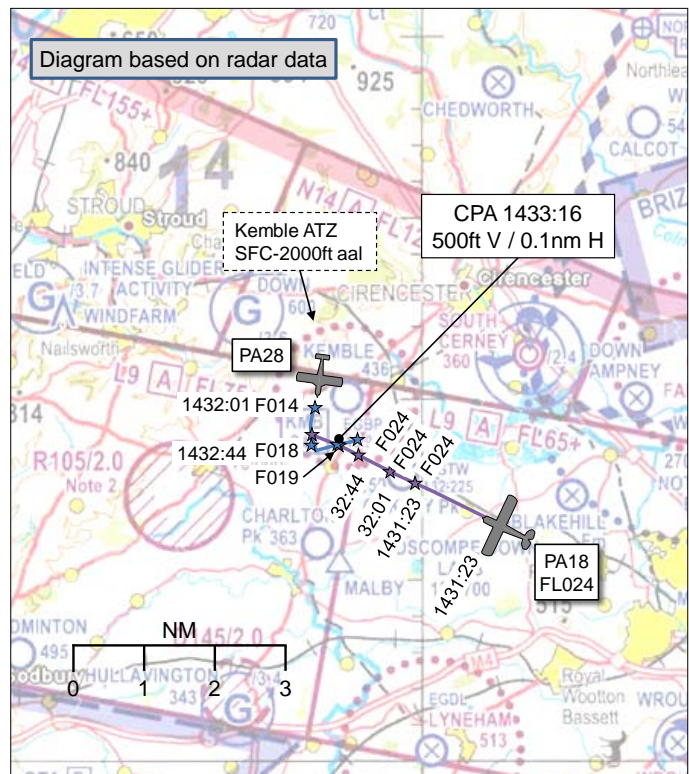
THE PA28 PILOT reports flying a visual circuit detail at Kemble, under a BS he thought, with a student as the handling pilot; visibility was '50km plus' with a cloud-base of 'at least 3500ft'. They were LH downwind for RW26, hdg 080°, at 1000ft QFE, flying at 95kt, when they saw the PA18 approaching 'head-on' and close enough 'to easily read its registration.' He expressed concern that 'Had we been climbing into the overhead for a departure, the ac would have been invisible below our nose and a collision quite probable.' The pilot reported the event on Kemble Information's frequency.

Cause: The PA28 pilot was concerned by the proximity of the PA18.

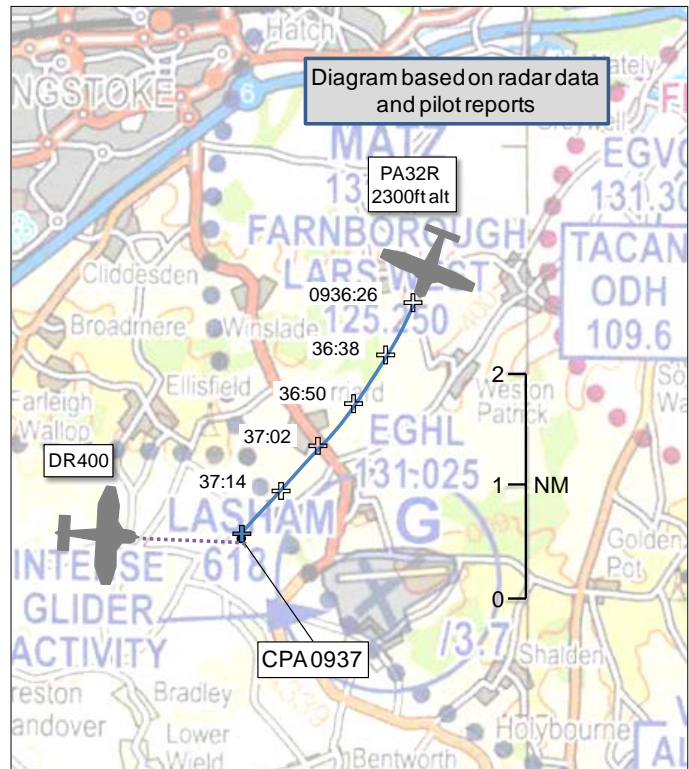
THE DR400 PILOT reports conducting glider tug operations to the W of Lasham A/D in support of the first day of the week-long 2013 Club-Class Nationals & Lasham Regionals gliding competition. He was operating under VFR, in VMC, without an ATS, in contact with Lasham Radio [131.025MHz]. The yellow and black ac had navigation, strobe and landing lights selected on; the ac was not fitted with an SSR transponder but was fitted with FLARM. He had just released a glider and was returning to the A/D for a downwind join for RW27. Descending through approximately 1500ft QFE, about 0.5nm NW of Lasham A/D, and heading 090° at 110kt, he saw a low-wing, single-engine, retractable-undercarriage ac 'at the last minute' on a reciprocal hdg, displaced slightly to the L at a range of about 100yds. The other ac was at the same height and passed down his LH side 'a wing span away'. He banked R to increase separation and heard the other ac's engine as it passed.

Cause: A late sighting by both ac.

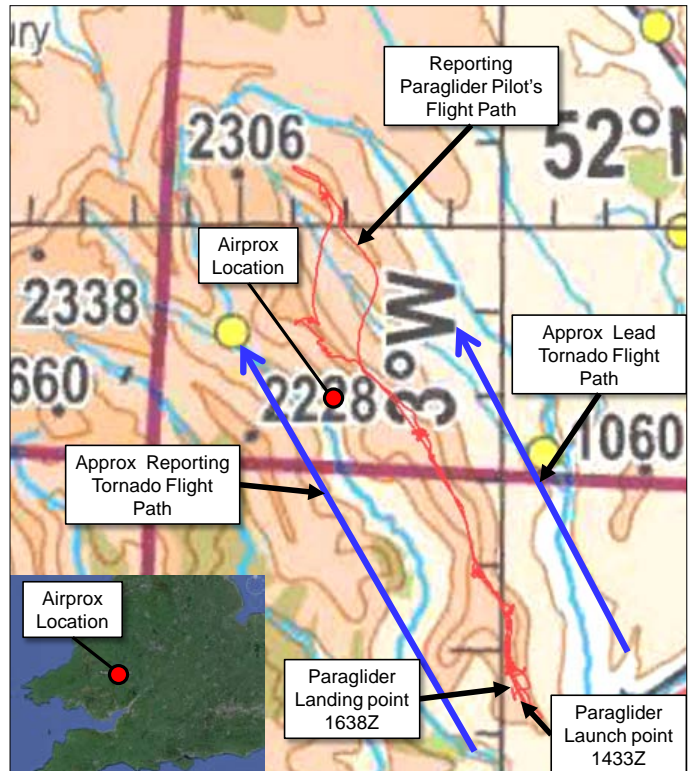
THE TORNADO PILOT reports operating at low level as the No 2 of a pair of ac with navigation lights and strobes turned on, squawking Mode 3/A 7001, with Modes C and S selected. They had booked in to LFA 7 from 1630-1710Z, and the formation were flying N-bound along two valleys separated by a ridge. His ac was hdg 340°, at 250ft, with the RPS of 1026hPa set, when the pilot saw several paragliders ahead and elected to pull up to 2000ft to avoid any unseen paragliders. During the climb, approximately another 10 paragliders were spotted slightly below and, as the crew were levelling off, the WSO spotted yet more paragliders above the aircraft. The pilot estimated that he saw the first paragliders at 1-2nm distance, and achieved a minimum separation of about 1000ft on these following his climb. Once clear, the aircraft was climbed further to avoid the paragliders which were estimated to be around 3500-4000ft. No NOTAM had been issued. A call was made on the formation frequency; the crew of the lead ac saw the paragliders from a distance but had no conflicts in the valley they were following.

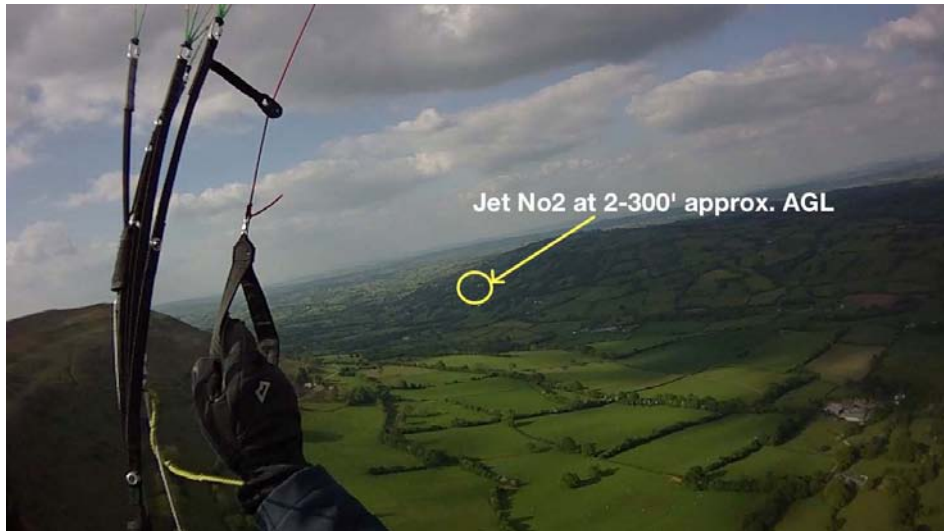
Figure 1. The Lead Tornado ac labelled 'Jet No2'

The paraglider pilot reports that he checked the NOTAMs in the morning before his flight but did not submit a CANP for his flight because he made the decision to fly shortly before he took off and he was planning to fly cross-country, which would mean notifying an extended and uncertain area. He commented that it was common for paragliders and sailplanes to use the launch site on the Pandy Ridge but he was not sure if a CANP had been submitted by one of the '15 or so Paraglider pilots flying that day'. Figure 1 shows a photograph from the paraglider pilot's helmet camera taken at 1633, looking N up the Pandy Valley, at 1600ft amsl, indicating the lead Tornado, which was the E'ly of the two and is labelled 'Jet No2'.

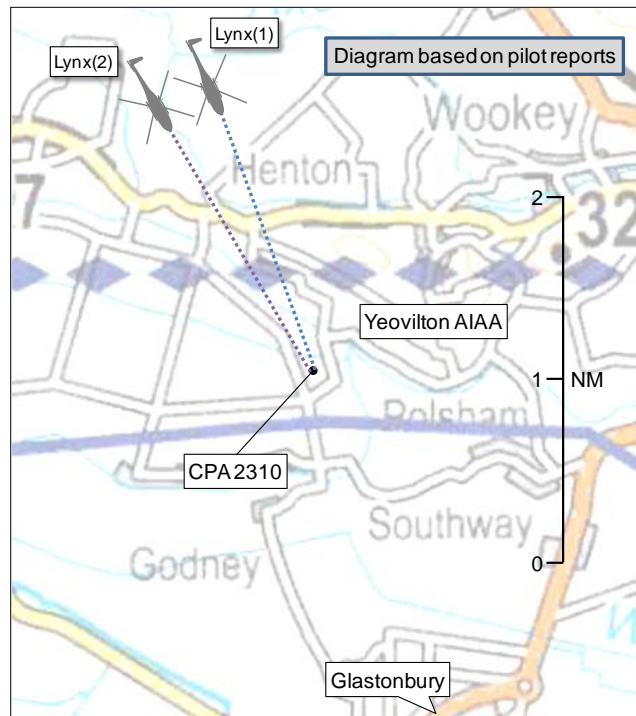
THE LYNX(1) PILOT reports conducting a night, low-level NVG navigation exercise at 200ft agl. The grey camouflaged ac had steady bright navigation lights and flashing red anti-collision beacon selected on, as was the SSR transponder with Modes A, C and S. The ac was not fitted with ACAS. The crew were operating under VFR, in VMC, with a BS from Yeovilton APP. The handling pilot was seated in the RH seat, with an instructor occupying the LH seat. Whilst heading about 150°, at 80kt, and prior to crossing a 200ft power line, the instructor observed another Lynx ac, subsequently identified as an ac from the same squadron, vertically displaced above by 20ft and offset to the R, approximately 50ft away on a marginally converging heading. The other ac appeared to be at a slightly faster speed. On sighting, the instructor intervened by taking control of the ac and rapidly altered course to the L, maintaining level flight. The RH seat pilot then reaffirmed his intention to cross the pylon and the instructor initiated a climb to clear it. The instructor contacted the other Lynx pilot on a squadron discrete frequency and ascertained that he had not seen the Lynx to his LH side.

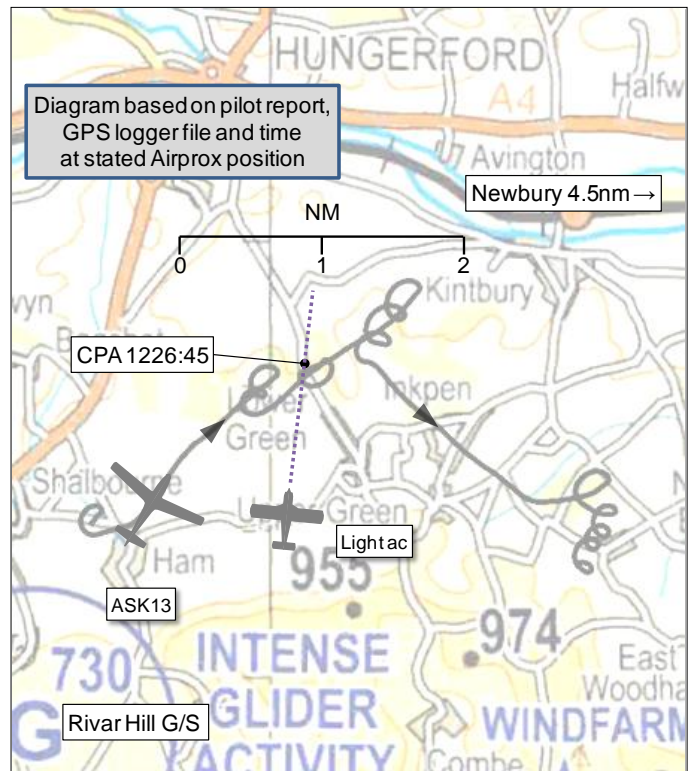
THE ASK13 PILOT reports conducting a training flight operating under VFR, in VMC, without an ATS. The blue and white ac was not fitted with lights, a radio or an SSR transponder but was equipped with FLARM. Whilst following 'a line of slight lift', at about 2200' QFE, heading 050° at 50kt, he heard a piston engine ac but was unable to see it. He made no large heading, altitude or speed changes as he could not establish the other ac's position. Within 20sec of first hearing it, he saw a predominantly white, low wing, single-engine piston light ac pass from R to L 50ft behind, 100ft above, and at 40°-50° to his heading. There was no indication that the other pilot had seen him or deviation apparent in his course or height; he assessed the risk of collision as 'High'.

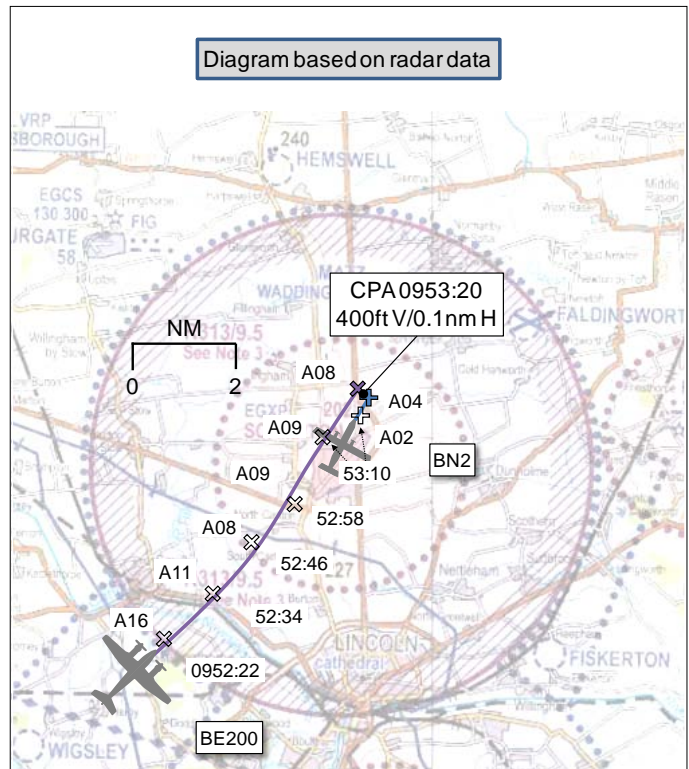
THE BN2 PILOT reports that he had booked out for a sortie from RAF Waddington, to depart to the W, climbing to FL100. He was operating under VFR, in VMC, in communication with Waddington ADC [121.300MHz]; the agreed ATS was not reported. The grey ac had navigation, landing and strobes lights selected on, as was the SSR transponder with Modes A, C and S. The ac was not fitted with an ACAS. He was cleared to taxi to the Foxtrot hold for RW02 RH at 0945 and, when approaching the hold, saw a 'light single', believed to be a Cessna, rolling to join the visual cct. Once this ac had rolled he was cleared to line up and wait. Around this time the BE200 pilot requested, and was cleared, to join; the controller passed TI on '2 in', one upwind and 'one on'. The BN2 pilot was then cleared to take-off with the Cessna in sight. Once the BN2 was airborne, the BE200 pilot was asked if he was visual with the departing traffic (which was not specified) to which he replied 'affirm'. About this time a 'HeliMed' called ready to depart, and was cleared not above 500ft. The BE200 pilot called extending upwind to fit in with downwind traffic. As the BN2 pilot was passing about 450ft, on RW track at 75kt in the climb and beginning to look L to turn W, the BE200 passed directly overhead, crossing from the dead side to active with an estimated 300ft V separation. The BN2 crew believed separation had been lost and that a significant risk of collision had existed.

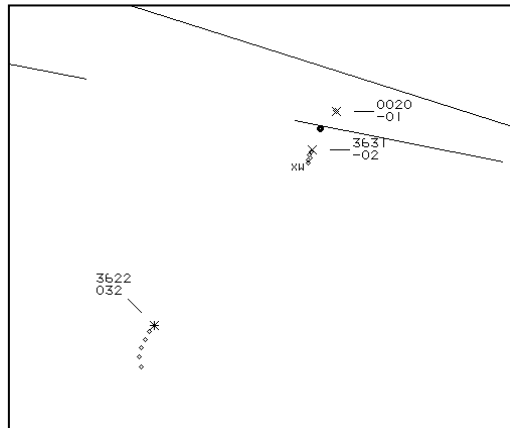
Figure 2: Incident Geometry at 0951:13.

The incident sequence commenced at 0951:13 as the BE200 pilot called ADC to “request join” and was instructed to “join runway 0-2 right hand, Q-F-E 1-0-1-7, one in, one shortly to depart.” The BE200 crew did not acknowledge or readback the joining clearance and airfield details. At this point the BE200 was 6nm SW of WAD, indicating descent through 3200ft, tracking 036°; the BN2 was at the hold, not yet airborne. Figure 2 depicts the incident geometry at this point; SSR 3A 3631 and 0020 were the unrelated ac being provided with an ATS by WAD ADC. The IP for WAD RW02RH is 4nm S and 1nm W of the RWY centre-line; at 0951:13, the BE200 was positioned 2.2nm W of the RWY centre-line.

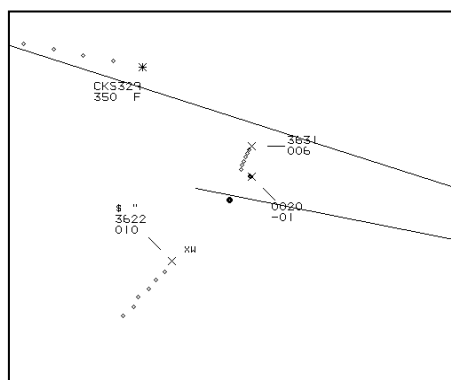
Figure 3: Incident Geometry at 0952:38.

At 0952:38, the ADC asked the BE200 crew “are you visual with the one [BN2] departing?” who replied that they were. Figure 3 depicts the incident geometry, with the BE200 1.5nm SW of WAD and the BN2 not yet airborne. At this point, the BE200 had closed to 0.7nm W of the extended RWY centreline and was tracking 045°.

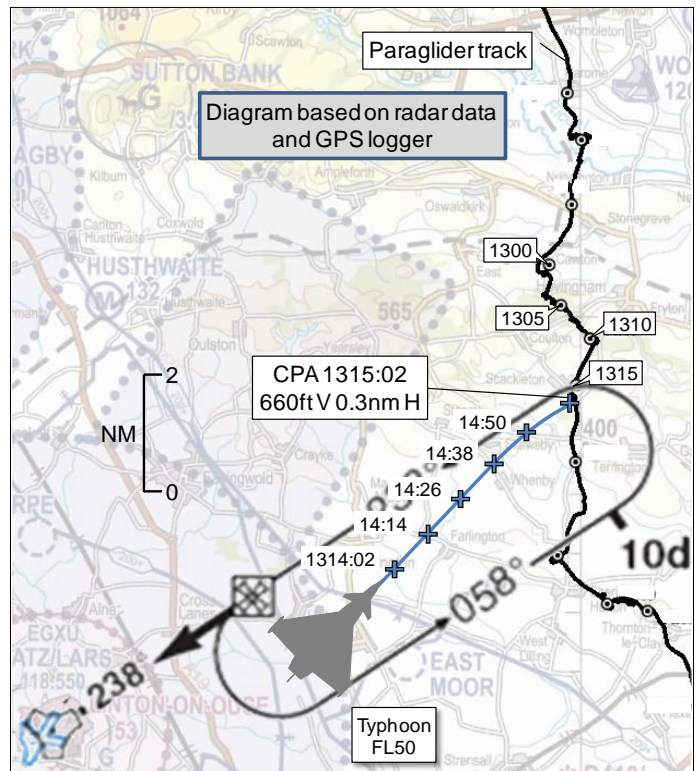
THE TYPHOON PILOT reports conducting an instrument rating test in the rear seat, with the examinee pilot in the front. He was operating under IFR in IMC, 200ft below cloud, with a TS from Linton DIR. The grey camouflaged ac had navigation lights and HISLs selected on, as was the SSR transponder with Modes A and C. When established in the Linton-on-Ouse RW03 TACAN hold at FL50, heading 043° at 230kt, DIR passed TI on non-squawking traffic 12 o'clock at 1nm with no height information. Both pilots subsequently became visual with 4 paragliders in the 10-11 o'clock position at an assessed range of 3000ft, which passed down the LH side about 200ft below. Having passed clear of the paragliders, care was taken not to direct jet exhaust towards them. He subsequently curtailed the TACAN procedure and left the hold. He also noted that the ac AI radar was unserviceable.

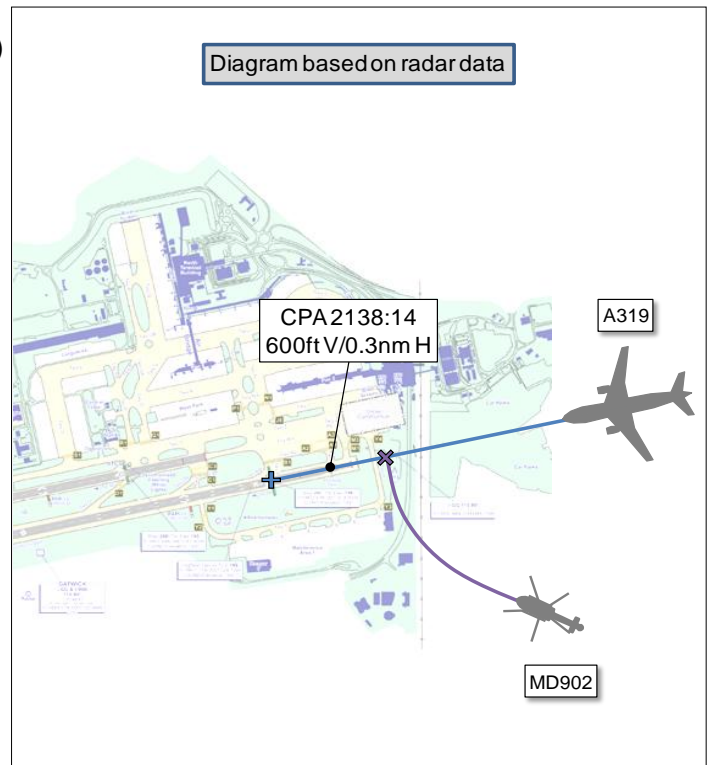
THE A319 PILOT reports being inbound to RW 26L at Gatwick on an IFR flight from Venice; beacon, strobes and landing lights were illuminated, SSR Modes S and C were selected. When checking into Gatwick TWR, he was informed of a helicopter 1nm S of the airport staying clear. As he came close to the RW threshold he noticed that the helicopter was crossing above his ac. As he passed 400ft agl the helicopter changed to amber on TCAS, without any audio alert. The helicopter indicated 500ft above as he passed 400ft Radalt. He was not informed that the helicopter was going to cross above his ac, and expressed concern that if he had had to go around from 600-400ft, he would have been only 500ft below the helicopter in more or less conflict. This would have made a go around from around 500ft impossible.
