DUTCH
SAFETY BOARD

Gear collapse during landing

The Hague, May 2018.

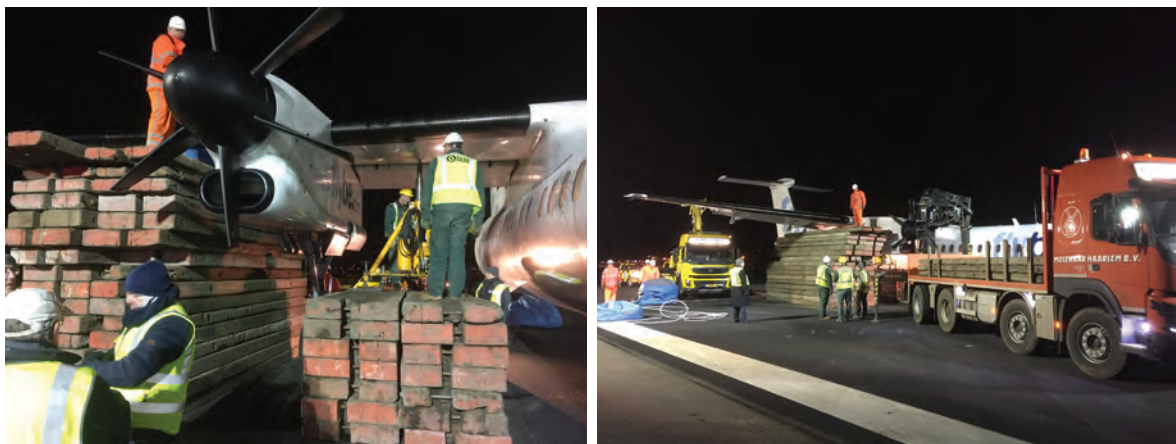
After the accident the aircraft was inspected for damage in the right-hand main landing gear area. The right-hand MLG was positioned in the wheel well, the wheel well was resting on the tarmac. After it was determined that there was no obvious damage, the aircraft was salvaged using long wooden beams, air cushions and hydraulic jacks. The jacks were positioned in accordance with the maintenance manual. The aircraft was raised high enough to make the extension of the right hand main landing gear possible. There was no visible damage to the gear attachment points and no evidence of contact between the tires and the nacelle side walls. The MLG was then manually lowered and locked into position without problems, without use of hydraulic power. There were no visible abnormalities on the main landing gear or the main landing gear support after the gear was lowered. After the aircraft was standing on its three landing gears, the aircraft was slowly towed into a hangar for further inspection.

Figure 6/a: lifting the aircraft using large wooden beams and hydraulic jacks. (Source: Dutch Safety Board)

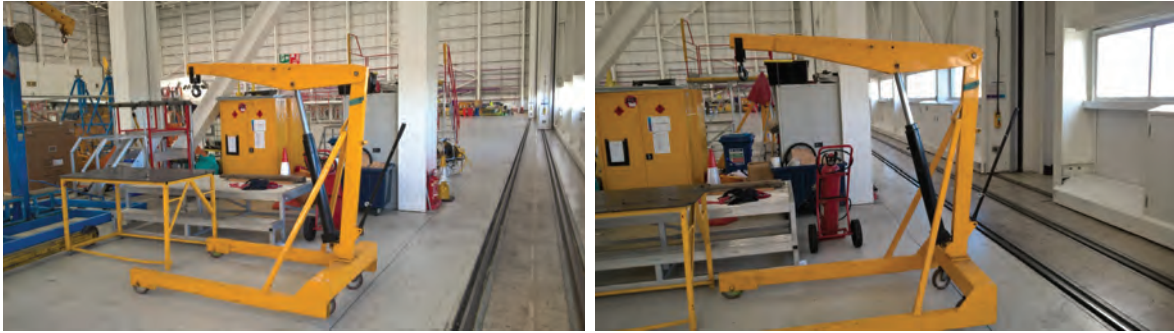
On the evening before the day of the occurrence, maintenance had been performed on the aircraft at one of the company’s sub-contractor’s maintenance facilities. Here, as part of scheduled maintenance, the right hand landing gear stabiliser brace assembly was replaced. The stabilizer brace assembly comes with pre-installed proximity sensors, thus by replacing the brace, the sensors are also replaced. Brace assembly with serial number MAL-SP-0556 was replaced with MAL-SP-0547. The maintenance crew reported nothing unusual was found during and after the maintenance activities.

Figure 7: example of manual cranes used to lift the main wheels from the ground when replacing the brace assembly. (source: maintenance facility)

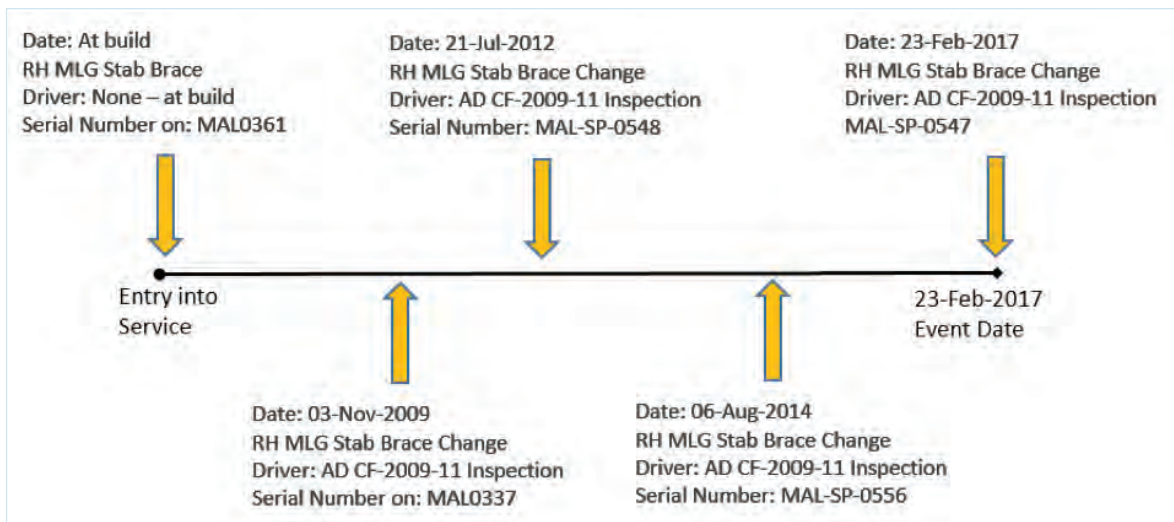
The operators Part-M maintenance records indicated the main gear fitting was original fit to the aircraft and has not been overhauled since delivery. There have been 5 stabilizer-braces installed to this leg during its service life. These changes have all been planned events due, either to, scheduled maintenance / modifications requirements or mandatory instruction (e.g. Airworthiness Directive). For illustration purposes, the following delineates the timeline of aircraft entry into service and associated stabilizer brace changes to event date are depicted in Figure 8.

Figure 8: timeline of aircraft entry into service and associated stabilizer brace changes.
