National Transportation Safety Board

Aviation Accident Final Report

Location:	Fort Lauderdale, FL	Accident Number:	DCA17MA022
Date & Time:	10/28/2016, 1751 EDT	Registration:	N370FE
Aircraft:	MCDONNELL DOUGLAS MD 10-10F	Aircraft Damage:	Substantial
Defining Event:	Landing gear collapse	Injuries:	2 None
Flight Conducted Under:	Part 121: Air Carrier - Non-scheduled

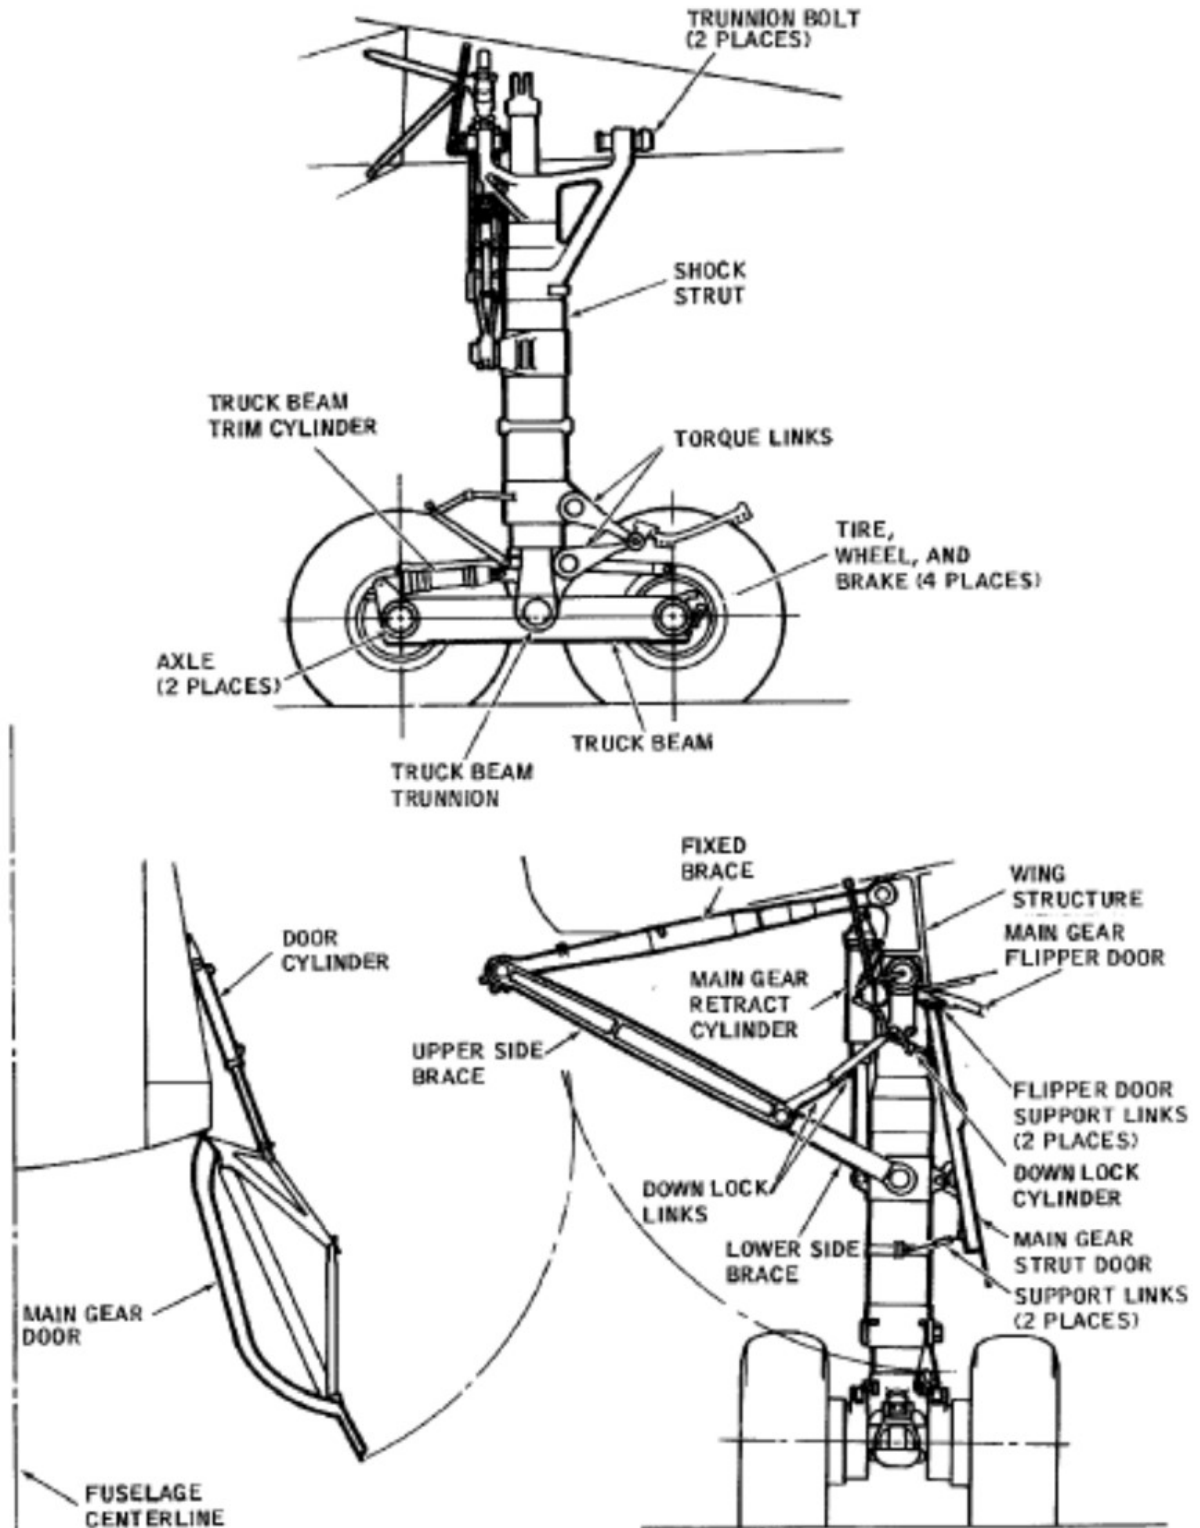
The airplane came to rest off the left side of runway 10L near the A4 taxiway. The outer cylinder of the left MLG was fractured midway through the air filler valve bore on the aft side. The outer cylinder of the left MLG shock strut fractured around its entire circumference; the upper portion of the cylinder remained intact and attached to the airplane at the forward and aft trunnion lugs (figure 1 shows a diagram of an MD-10-10F MLG and figure 2 shows the upper portion of the accident MLG). No anomalies were noted with the trunnion lugs or trunnion bolt attachment points.

Figure 1. Diagram of MD-10-10F MLG (right shown)
