MH370 - Definition of Underwater Search Areas

ATSB Transport Safety Report
External Aviation Investigation
AE-2014-054
26 June 2014 *(updated 12 August 2014)*

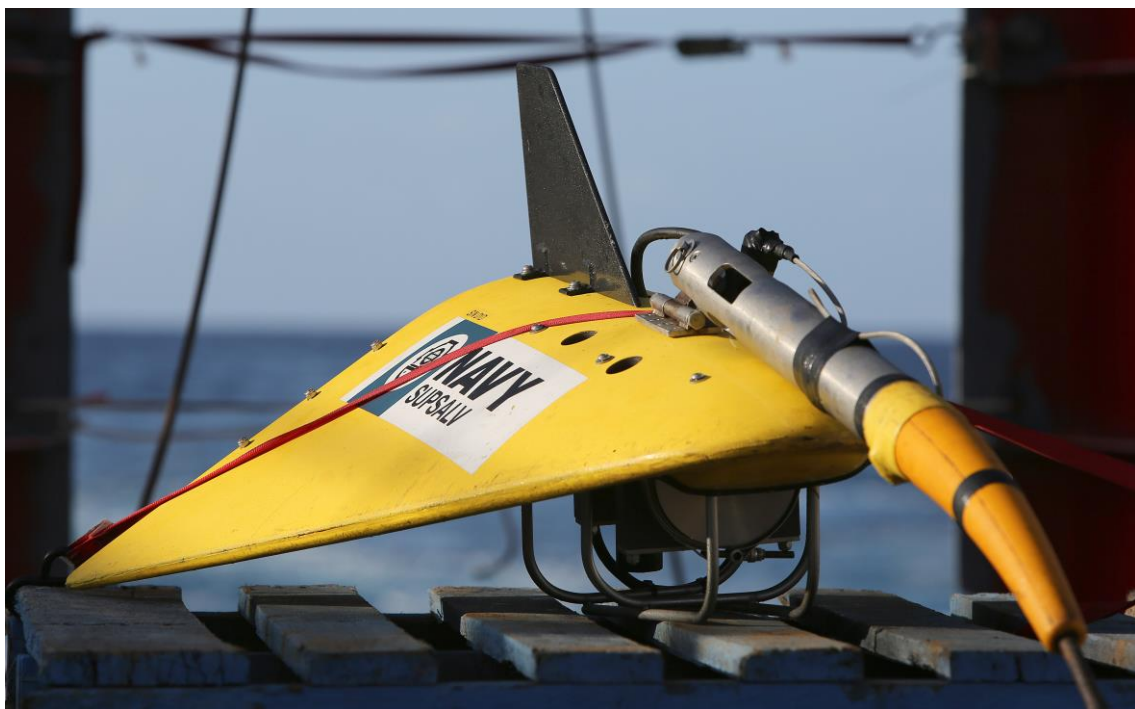
Figure 11: TPL towfish

- Detectable frequency range: 3.5 kHz – 50 kHz
- Maximum operating depth: 6,000 m
